ENG Consultants P/L  
Civil & Structural Engineering  
p: 03 9123 4001  
e: info@engconsultants.com.au

## Structural Integrity Report

SITE ADDRESS: No 8 Swanston Street, Geelong, VIC 3220 Australia

SCOPE: Structural Integrity Assessment of Heritage building

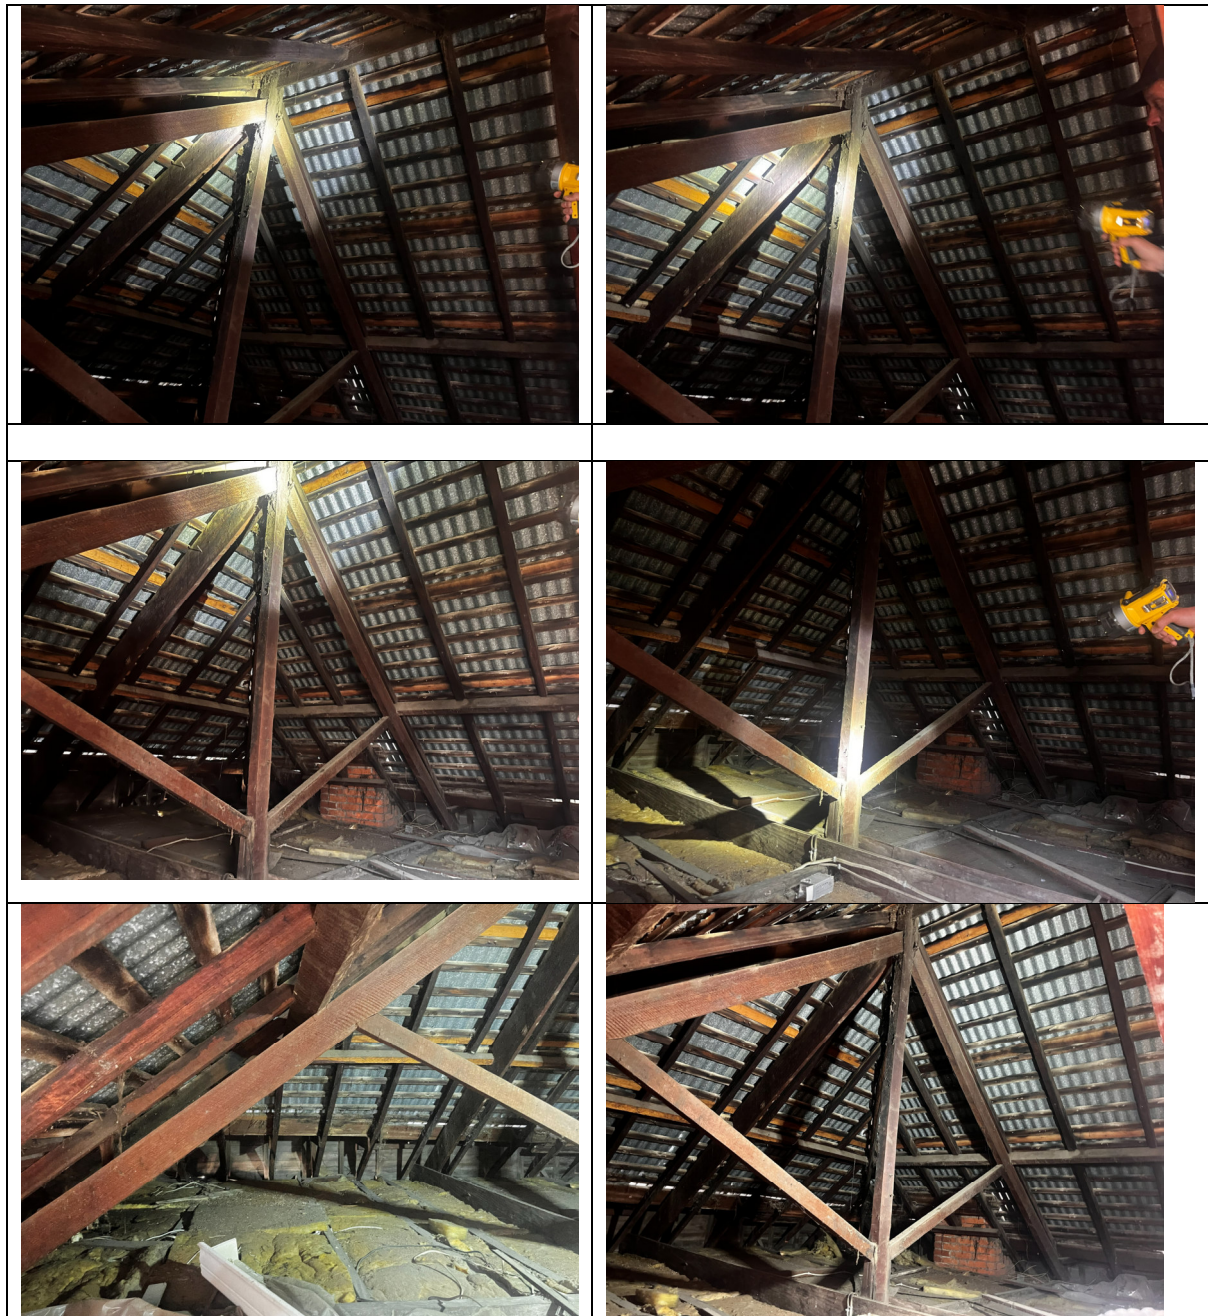
### *Roof Structure – Potential Truss Salvage (x2)*

Roof rafters display significant decay and likely termite damage. The roof structure is at risk of collapse. Two larger roof trusses appear to be in comparatively sounder condition; however, potential salvage is subject to engineering verification once removed and inspected at ground level.

Photos show two roof trusses potentially suitable for salvage subject to engineering verification after removal and ground-level inspection.

Two roof trusses may be salvaged and reused only after detailed engineering assessment, moisture testing, grading/defect assessment, connection redesign, and load-rating verification, refer to Appendix B for photos for roof trusses.

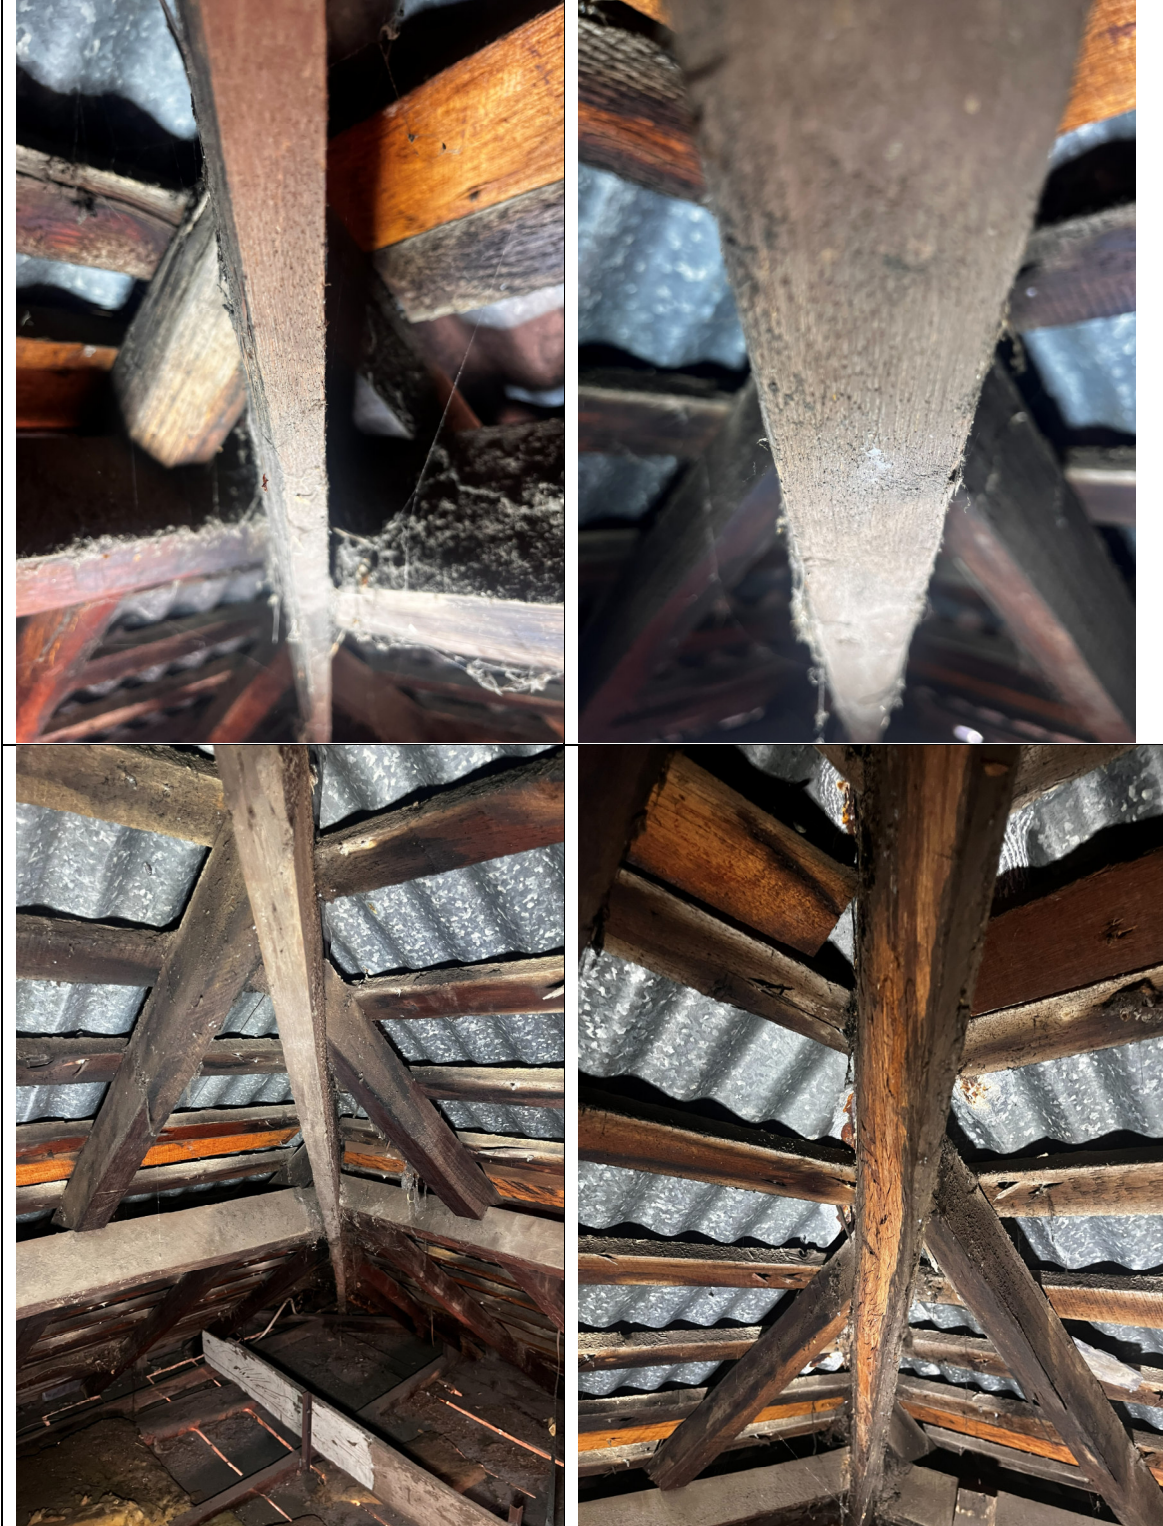
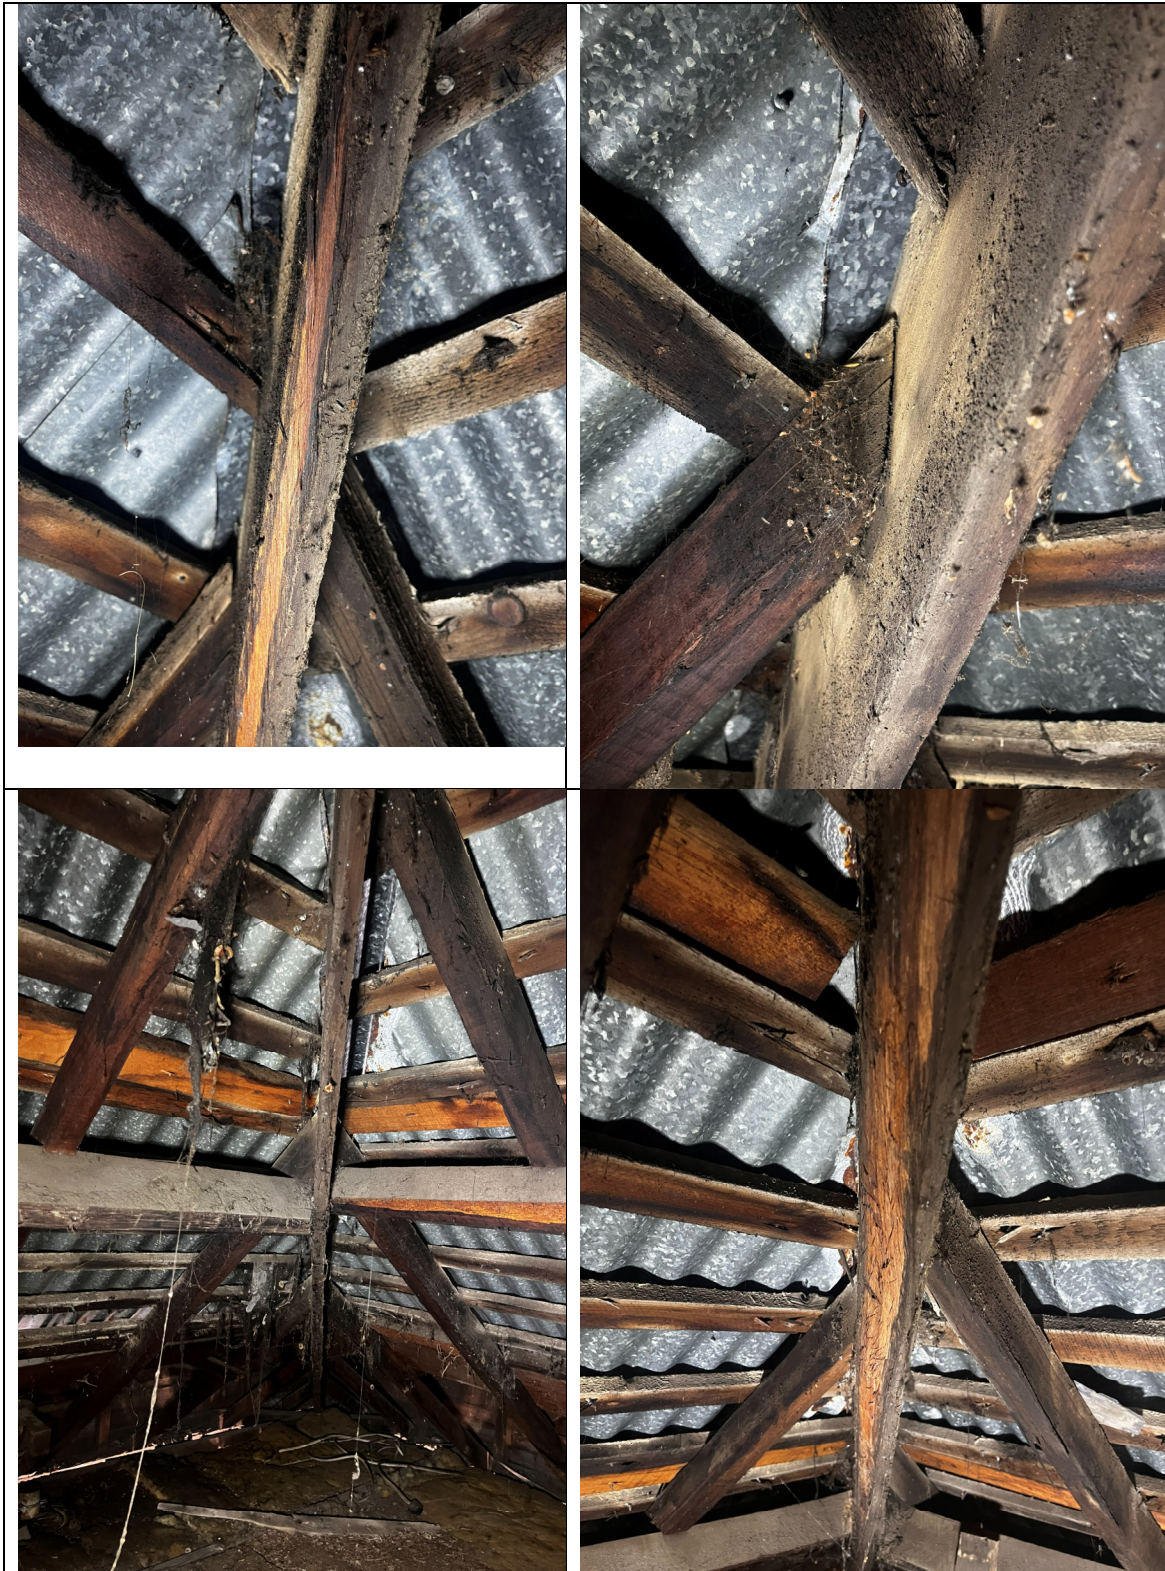
*Roof System – Hip Beams*

Photos show hip beams with severe deterioration and termite damage.

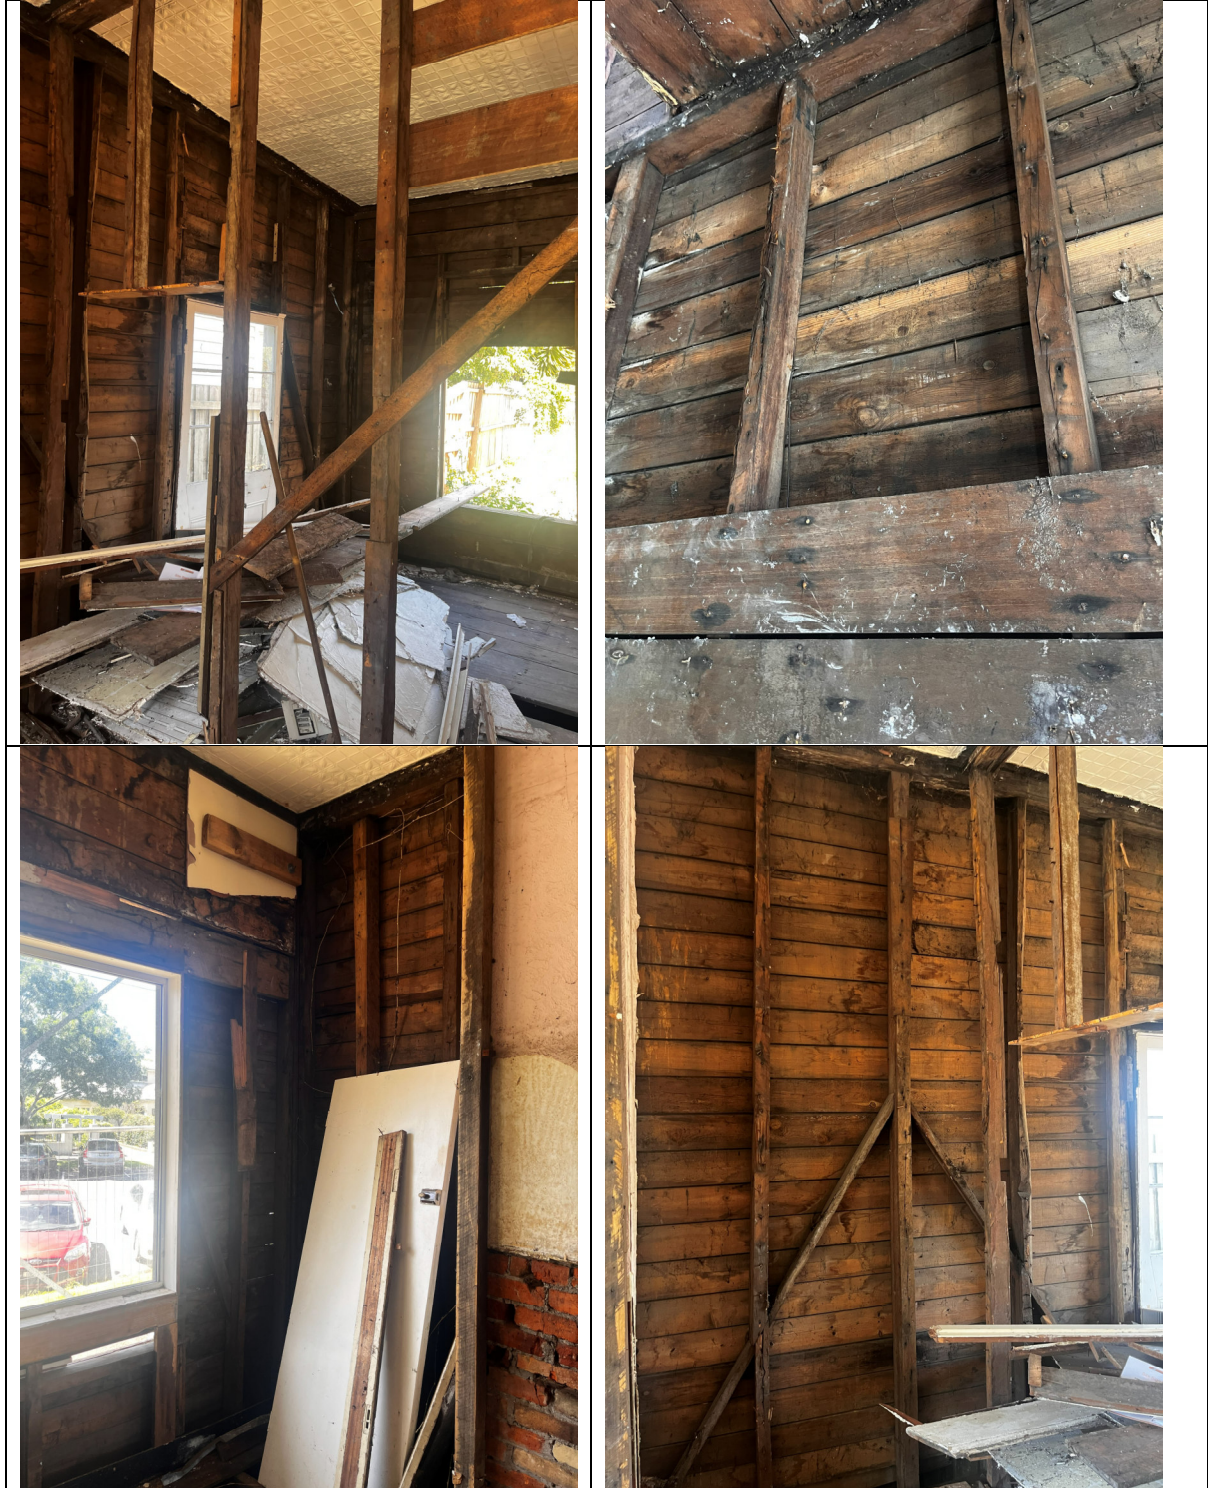
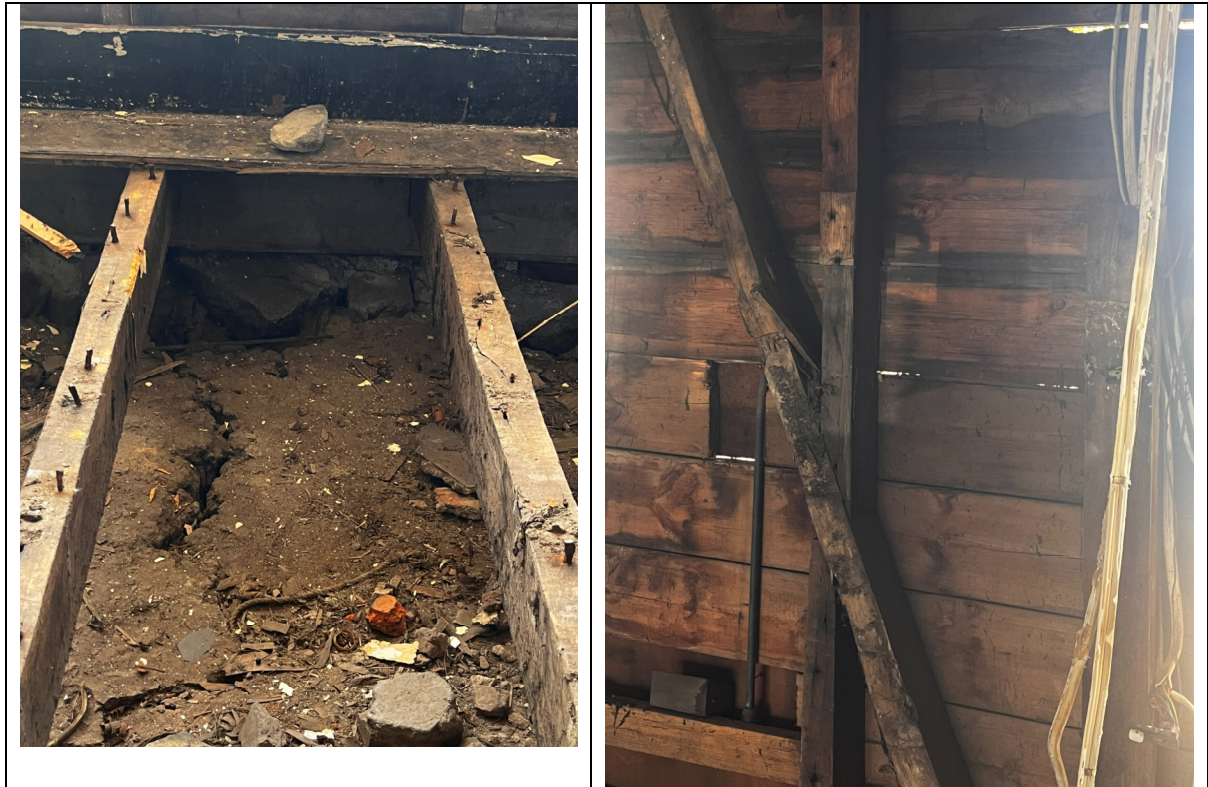
*Framing & Subfloor*

Visible timber wall framing exhibits heavy decay, loss of section, and loss of structural integrity. Wall framing is unable to provide adequate load transfer or lateral stability.

First and ground floors contain large openings, brittle and decayed boards, and significantly compromised joists. Load paths have been altered or removed entirely. The associated chimney structure is deteriorated beyond repair.

Photos show severely deteriorated timber framing/subfloor members in accessible areas.

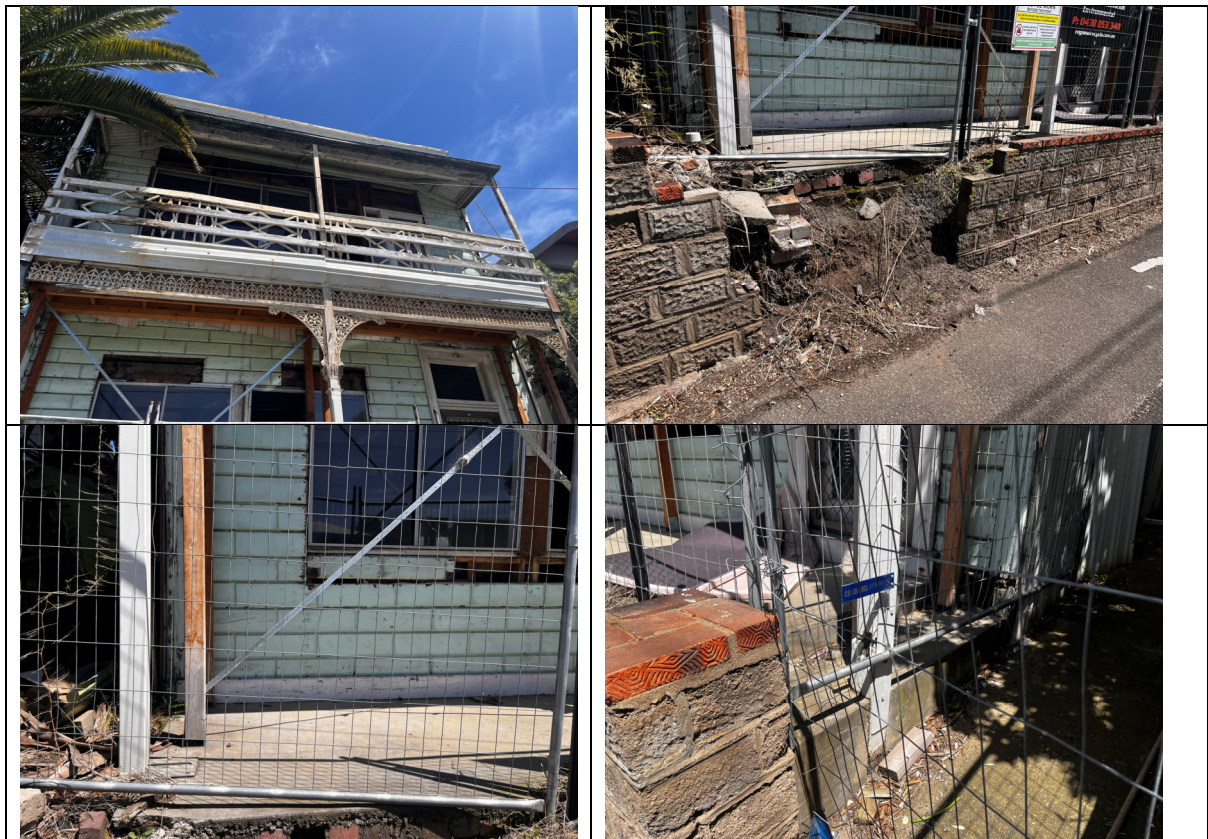
*Frontage & Retaining Wall*

The substructure was largely inaccessible. Observable portions suggest differential movement, and the existing front retaining wall is deteriorated and will require replacement.

Photos show deteriorated frontage and retaining wall, requiring replacement.

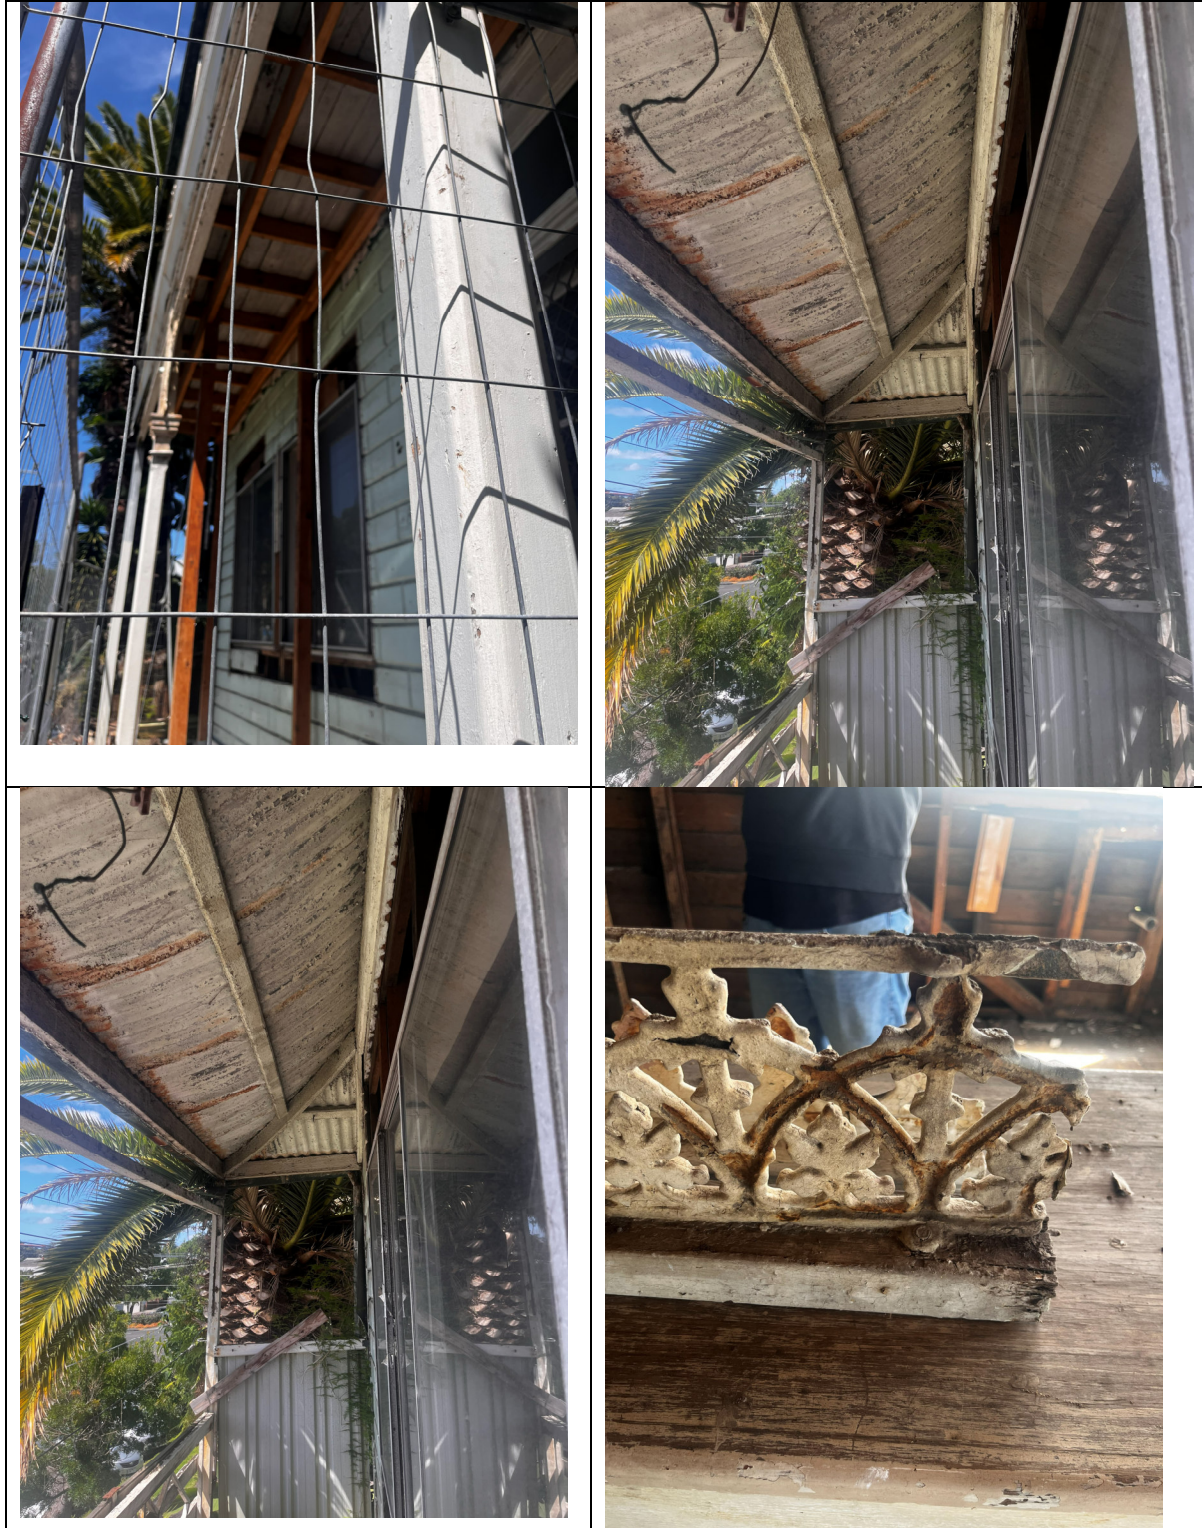
*Balcony / Verandah*

The balcony is currently propped, with decking severely decayed and balustrade elements missing or compromised. Fascia/primary beams show deterioration. Several verandah posts are missing and have been replaced with temporary supports.

Photos show balcony/verandah with severely deteriorated structural elements (unsafe; demolition required).
