# **Arboriculture Impact Assessment (AIA)**

**49 Forest Road South,  
Lara.**

**July, 2026**

This **Arboriculture Impact Assessment (AIA)** has been commissioned by Modica Developments in relation to Planning Permit Application 574-2026 for development at 49 Forest Road South, Lara.

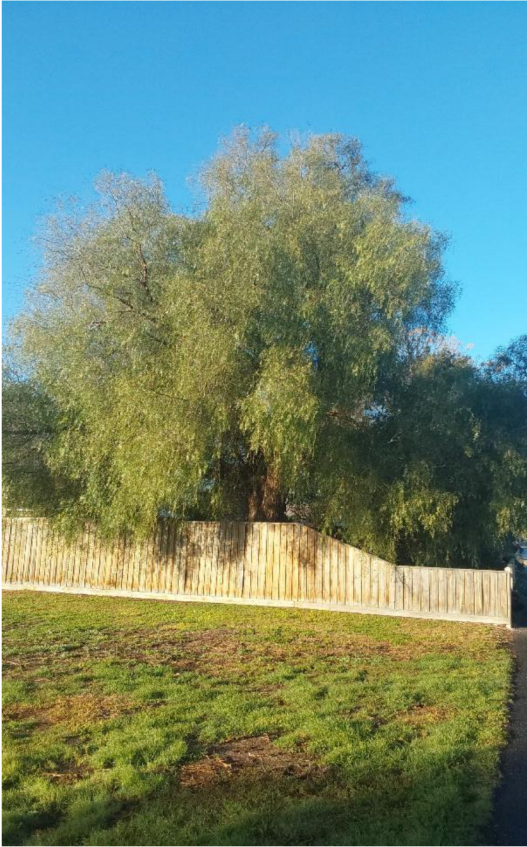
**Tree 1**

| Tree No. | Genus | Species | Common Name | Origin | Age | Height | Structure | Health | ULE | Arboriculture Significance | Buttress Diameter (m) | DBH stem 1 (m) | DBH stem 2 (m) | DBH Stem 3 (m) | Canopy Spread | Canopy M² | DBH @ 1.4m (Single) | DBH @ 1.4m (Multi) | TPZ (m radius) | SRZ Radius (m) | Comments |
|---|---|---|---|---|---|---|---|---|---|---|---|---|---|---|---|---|---|---|---|---|---|
| 1 | Shinus | molle | Peppercorn Tree | Exotic | Mature | 9 | Fair | Good | Long (a) | Moderate | 1.38 | 0.95 | | | 18 | 254.4690049 | 0.95 | 0.00 | 11.40 | 3.79 | DSH taken at 1.6m |

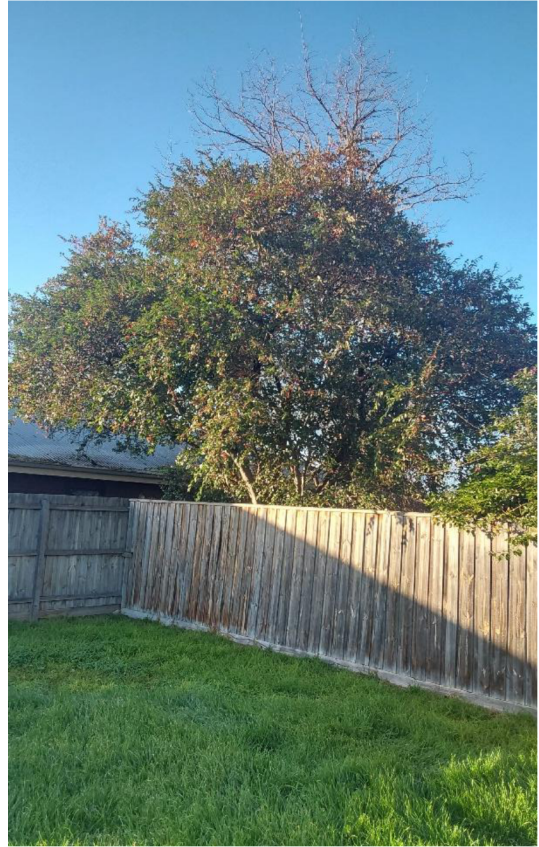
**Tree 2**

| Tree No. | Genus | Species | Common Name | Origin | Age | Height | Structure | Health | ULE | Arboriculture Significance | Buttress Diameter (m) | DBH stem 1 (m) | DBH stem 2 (m) | DBH Stem 3 (m) | Canopy Spread | Canopy M² | DBH @ 1.4m (Single) | DBH @ 1.4m (Multi) | TPZ (m radius) | SRZ Radius (m) | Comments |
|---|---|---|---|---|---|---|---|---|---|---|---|---|---|---|---|---|---|---|---|---|---|
| 2 | Cotoneaster | sp | Cotoneaster | Exotic | Mature | 6 | Fair | Fair | Med (a) | Low | 0.38 | 0.22 | 0.14 | 0.12 | 6 | 28.27433388 | 0.00 | 0.35 | 4.20 | 2.20 | |

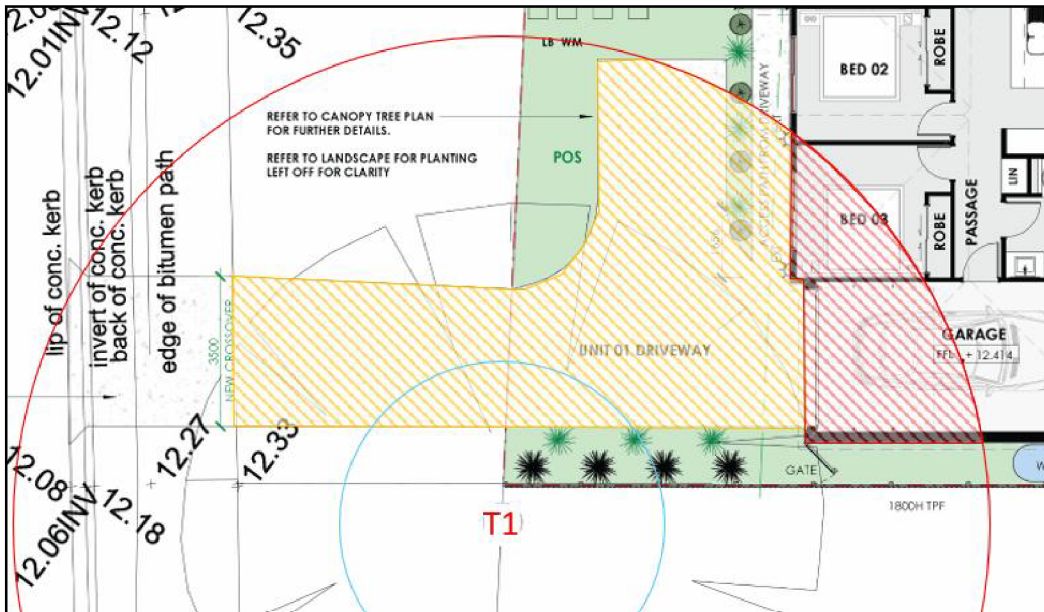
| | <b>Total<br/>TPZ Area m<sup>2</sup></b> | <b>Encroachment<br/>Area m<sup>2</sup></b> | <b>Encroachment<br/>Percentage</b> | <b>Shallow<br/>Encroachment<br/>Area m<sup>2</sup></b> | <b>Encroachment<br/>Percentage</b> | <b>Total<br/>Encroachment<br/>%</b> |
|---|---|---|---|---|---|---|
| Tree 1 | 408 | 19.7 | 4.8% | 66 | 16.1% | 20.9% |

Figure 1. Tree 1 has been calculated as having a Major impact of 20.9% impact encroachment.

As per AS4970-2025 Protection of trees on development sites, major impacts have been measured on Tree 1 through the proposed construction activity. These impacts are categorized into deep impact sections accounting for 4.8% of the Notional Root Zone (NRZ) due to Unit 1 garage and dwelling footings, and shallow impacts, with 16.1% of the NRZ affected by the driveway construction methodology.

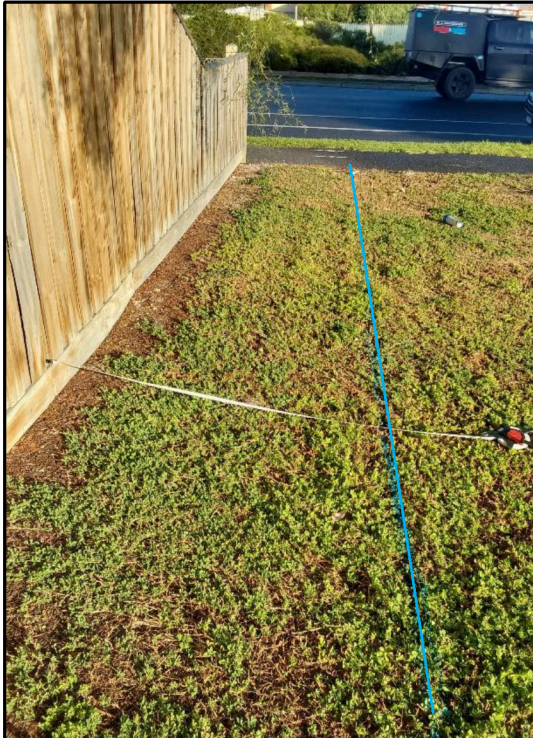
Due to the requirements to provide additional evidence of tree viability as per AS4970-2025, Non-Destructive Dig (NDD) procedures were carried out along the alignment of the proposed driveway and to a potential depth of 130mm below original grade, which is typical for driveway construction. The alignment of the NDD was specifically subject to the Structural Root Zone (SRZ) area of Tree 1. Figures 4-6 below indicate an extremely poor soil condition where *Aizoon pubescens* (Carpet Plant) was the only plant present within the general area of the subject tree. This weed plant is a strong indicator of degraded soil profiles, further supporting the Consulting Arborist's view that Tree 1 is utilizing a deeper soil profile to access moisture and nutrients within the bedrock and adjacent soils.

*Figure 4. Alignment of driveway from boundary fence.*

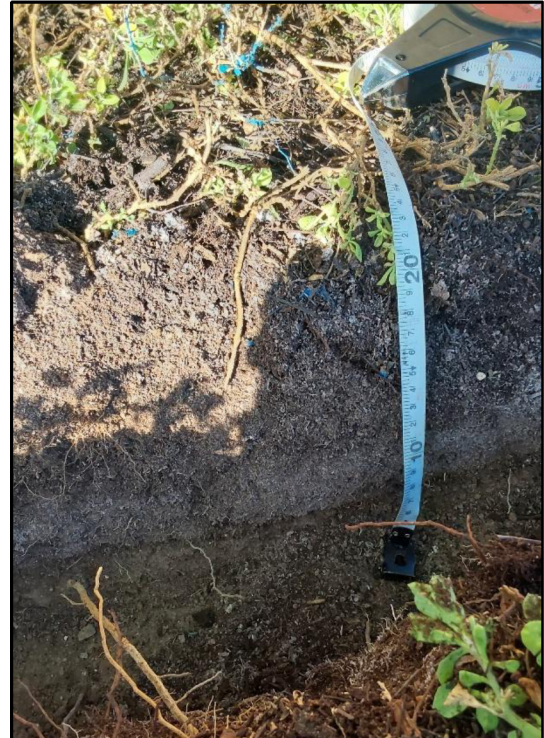
*Figure 5. 130mm deep hand dug excavation.*

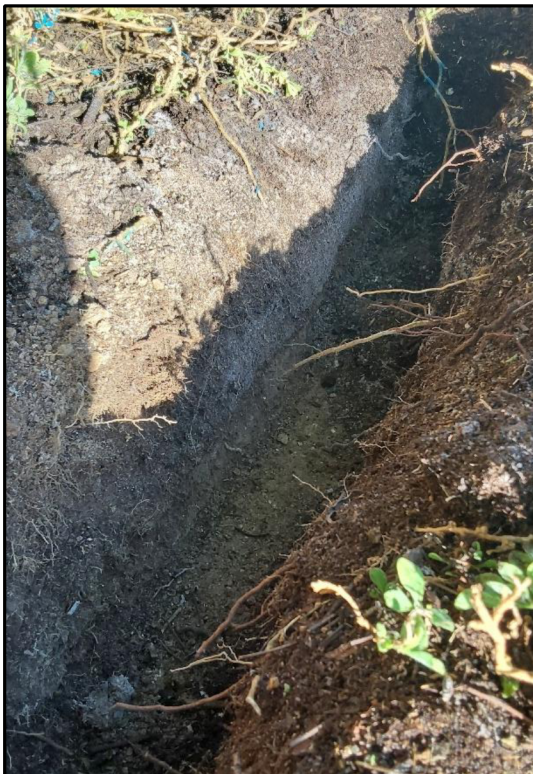
*Figure 6. Poor soil structure and no viable roots from tree 1 were identified.*

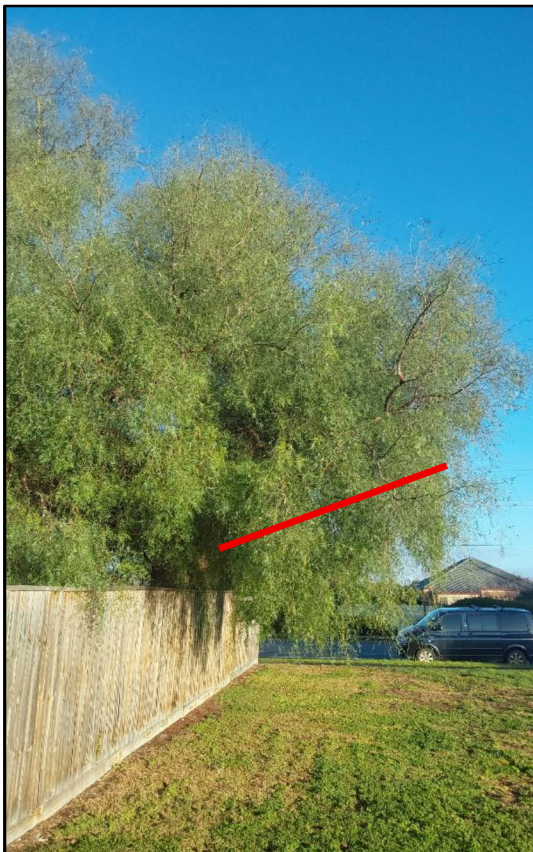
Pruning of Tree 1 will be required due to the proximity of the trees to the boundary line fences and its overhanging canopy. Several low hanging canopy branches will require clearance from proposed driveway construction.

*Figure 7. Approximate height required for car clearance above driveway being 2.5m*

The branches to be pruned should not exceed diameters of 150mm to achieve this requirement.

All pruning works shall be completed by Level 3 Arborist or above. All works shall be performed to a standard within AS4373-2007 Pruning of Amenity Trees.

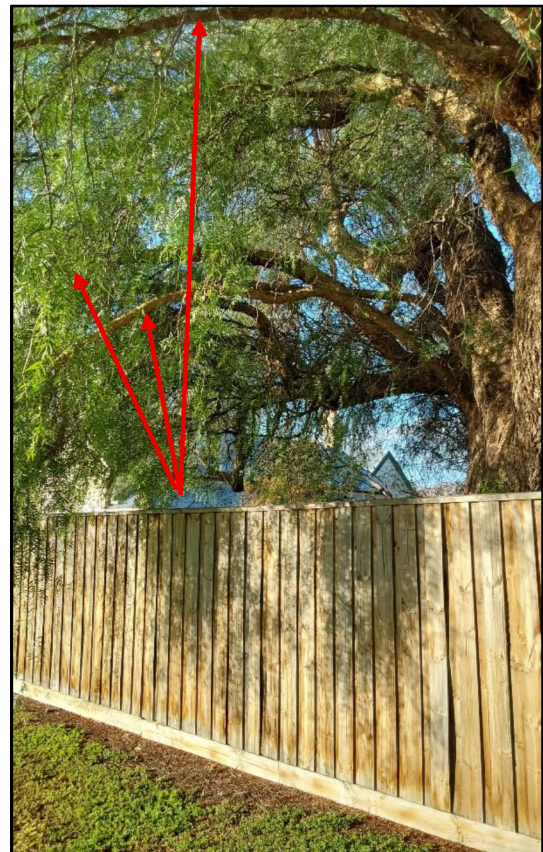
*Figure 8. Epicormic growth is prevalent within the branches overhanging the subject site and shall be pruned back to parent limb structure.*

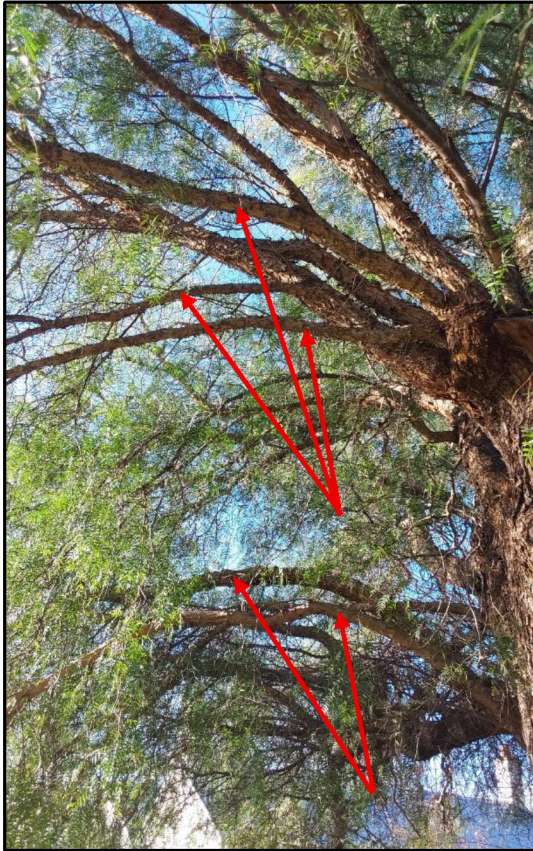
*Figure 9. Epicormic growth is prevalent within the branches overhanging the subject site and shall be pruned back to parent limb structure.*

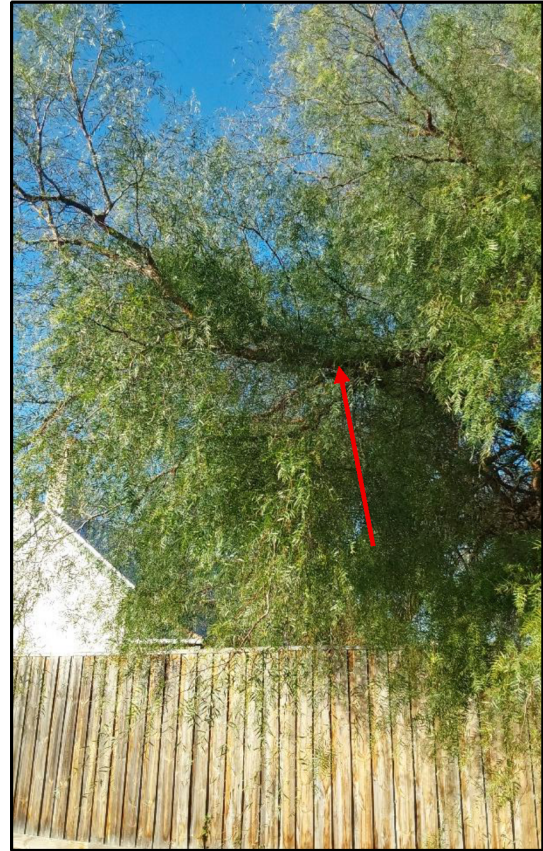
*Figure 10. Reduction of long leveraged growth from branch growing towards proposed dwelling shall be pruned to reduce likelihood of future failure. Reduction of 30% length is recommended.*
