16 STORK AVENUE BELMONT

ARBORICULTURAL REPORT

MAY 8, 2026

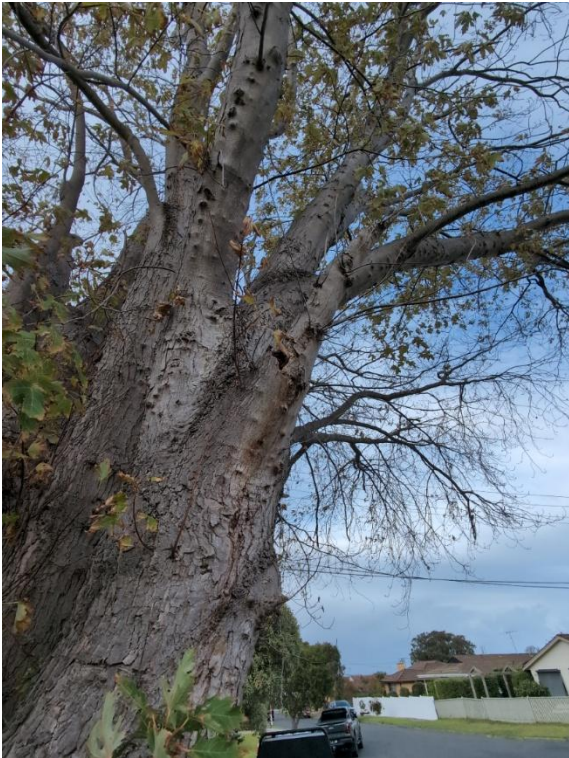
Figure 1 - Failure wound that has introduced decay into upper canopy

There is clear evidence of previous limb failure within the upper canopy. This history serves as a critical indicator of ongoing structural instability, suggesting an elevated probability of future branch failures as the tree continues to age.

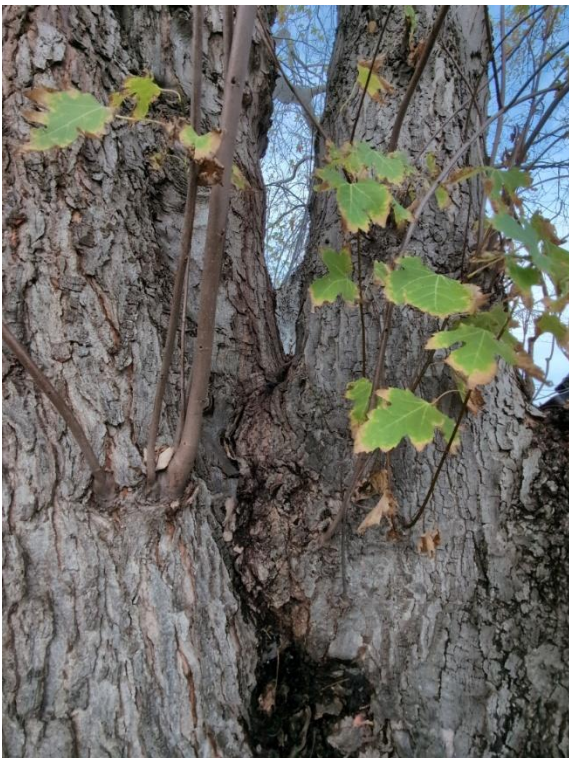
The tree exhibits extensive decay within the main trunk, which has compromised its primary structural support. This internal degradation results in a significant reduction in structural integrity, greatly increasing the likelihood of total stem failure, especially when the tree is subjected to wind or weight loading.

The structural risk in *Acer* species (Maples) is significantly amplified by their biological classification as weak compartmentalisers. Unlike species that can effectively wall off decay, Maples often struggle to contain the spread of wood-decay fungi, leading to rapid internal degradation.

Figure 2 - Large pocket of decay at main leaders point of attachment

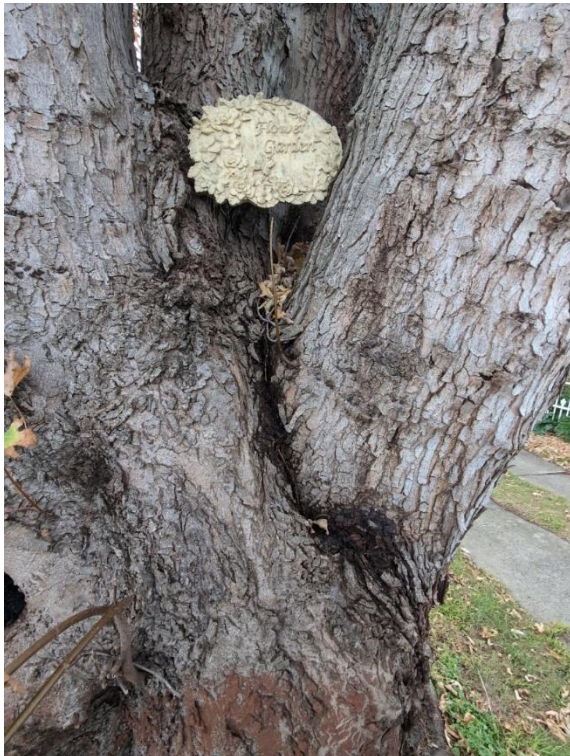
Observation of the main leaders reveals poor stem attachments characterized by weak unions. These compromised attachment points reduce the overall stability of the canopy and present a heightened risk of structural failure or branch shedding during high-wind events.

Figure 3 - Poor stem attachments

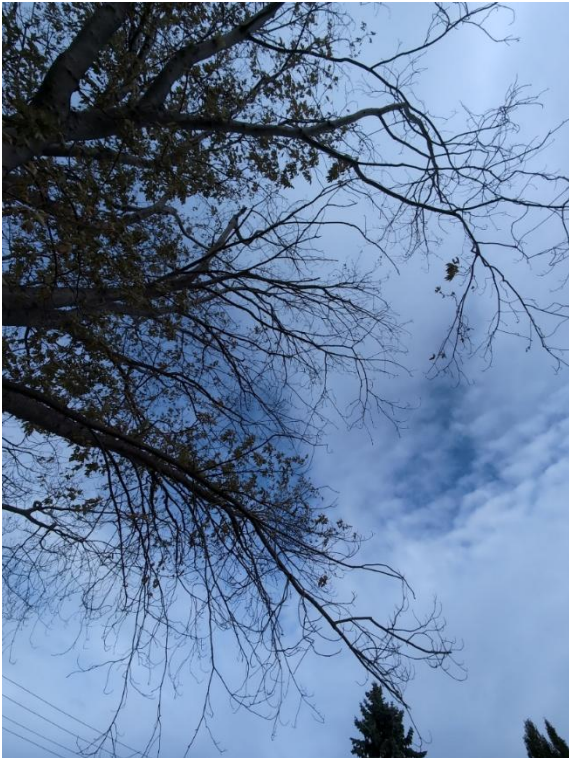
The outer canopy is currently experiencing dieback, which signals a decline in the tree's physiological condition. This loss of canopy vitality is consistent with an over-mature specimen that is no longer able to sustain its full crown.

Figure 4 - Large section of canopy dieback

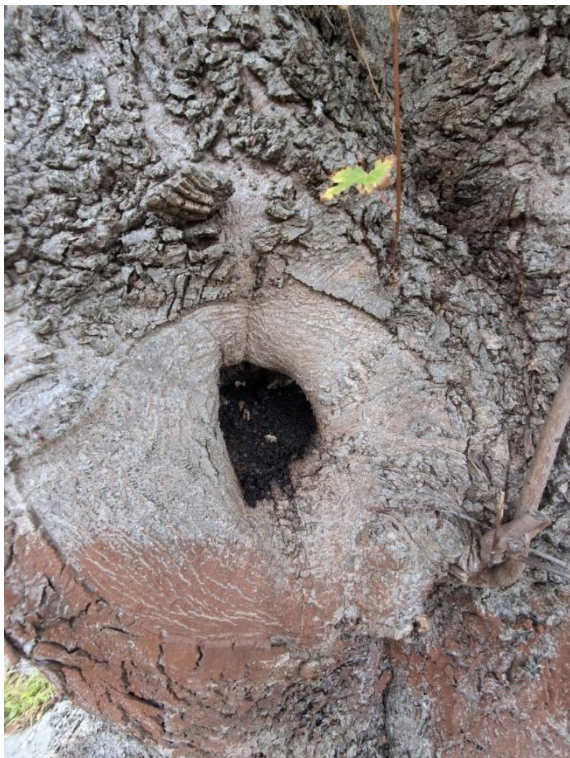
The tree exhibits heavy decay at the base of the trunk, which is the most critical load-bearing region of the specimen. This advanced structural deterioration significantly compromises the tree's anchorage and overall stability, creating a high risk of total failure as the base can no longer effectively support the weight and leverage of the upper structure.

Figure 5 - Decay pocket at the base of tree

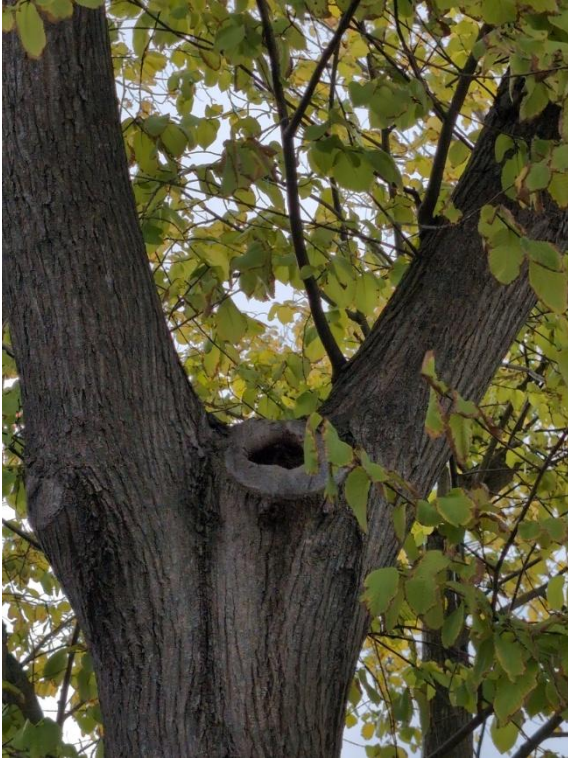
Internal decay has been identified within a primary scaffold leader, directly reducing its structural reliability. This localized weakness undermines the integrity of a major section of the tree, resulting in an increased likelihood of partial canopy failure and the shedding of large-diameter limbs.

Figure 6 - Large pocket of decay in upper canopy

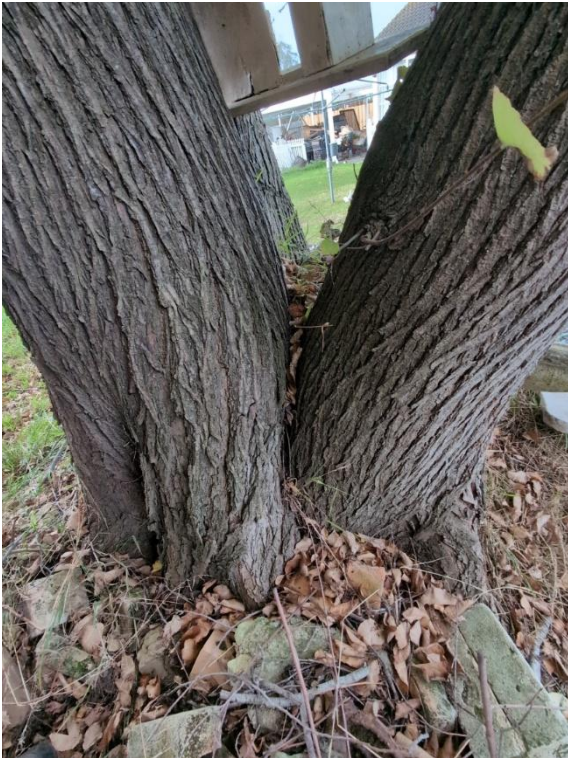
The main leaders are characterized by poor stem attachments, which lack the necessary wood-to-wood connection for long-term stability. These weak unions act as structural "fault lines," compromising the canopy's ability to withstand loading conditions and increasing the potential for significant stem failure.

Figure 7 - Poor stem attachments at base of tree
