Arboricultural Impact Assessment

Site Location: 11 Henry Street, Belmont, Victoria, 3216

Completed for: Rafferty The Wrecker

Inspection date: 20/12/2016

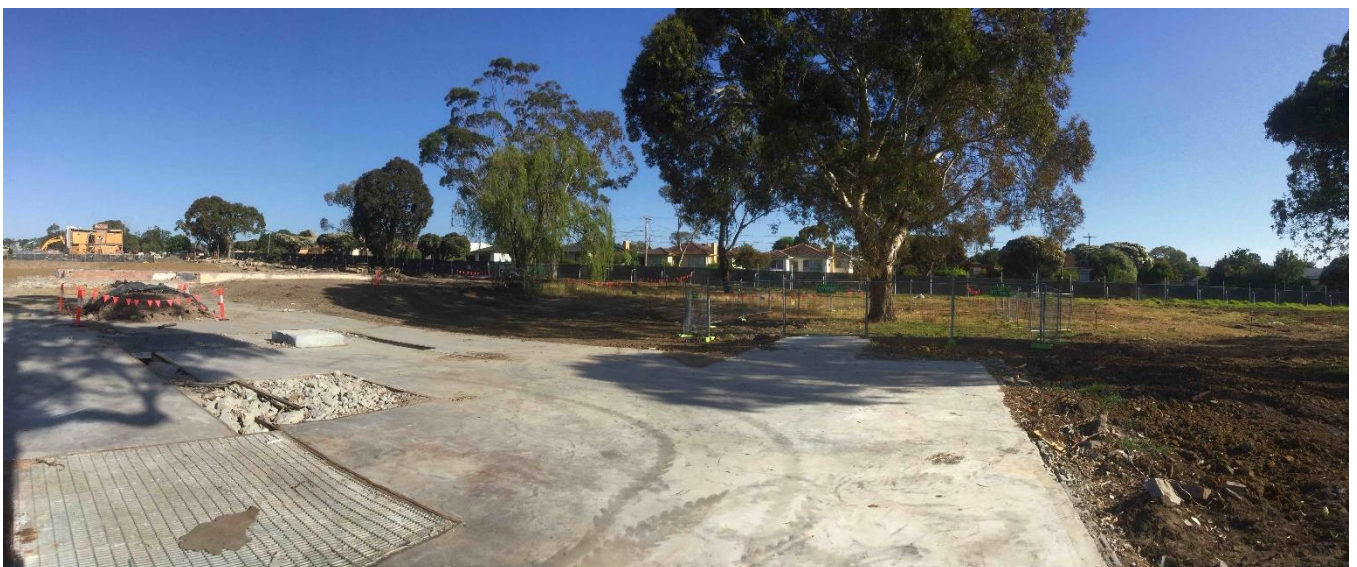
Plate 2 – Wide view of site section containing majority of trees for assessed

At the time of inspection the site demolition was almost complete. All buildings and structures appear to have been removed, including concrete carparks, fence footings, drains, etc. Debris is currently still being removed from the site. Tree Logic's reports indicate the nature of the site as being highly disturbed due to its past history as a Chemical Research Facility. Regarding the trees in question located within the site, these appear to have been planted or self-sown very close to structures recently removed (carparks, fence footings, etc.). Tree Logic specifically mention within the report dated 23/03/2016 that retention of high and moderate value trees may be difficult due to the required removal of such structures (concrete, etc., located within TPZs and SRZs).

These aforementioned reports also indicate the importance of installing Tree Protection Zones around trees to be retained in order to protect these from physical damage. The reports also dissuade any excavation within TPZ & SRZ, although acknowledge this may be necessary during demolition. On viewing the site, two trees assessed (28 & 36) had physical tree protection barriers installed, the others did not. It is also clear that trees without Tree Protection Zones have required substantial removal of material within their TPZs. This removal of material (TPZ encroachment) is considered major encroachment (more than 10% of TPZ area), however little damage has occurred despite this.

Two main structures were identified as recently removed - a line of footings/drain running West-East (within the TPZs of Tree# 31,38,40,47) and a significant amount of concrete from an old carpark located within the TPZ of Tree #28. Although excavation has taken place within the TPZs of these trees, damage observed to roots is minimal and has not visually impacted upon tree health, vitality or structure at this current time. Despite the lack of Tree Protection Zones around the trees aforementioned, no trunk or branch damage due to demolition works was observed or identified.

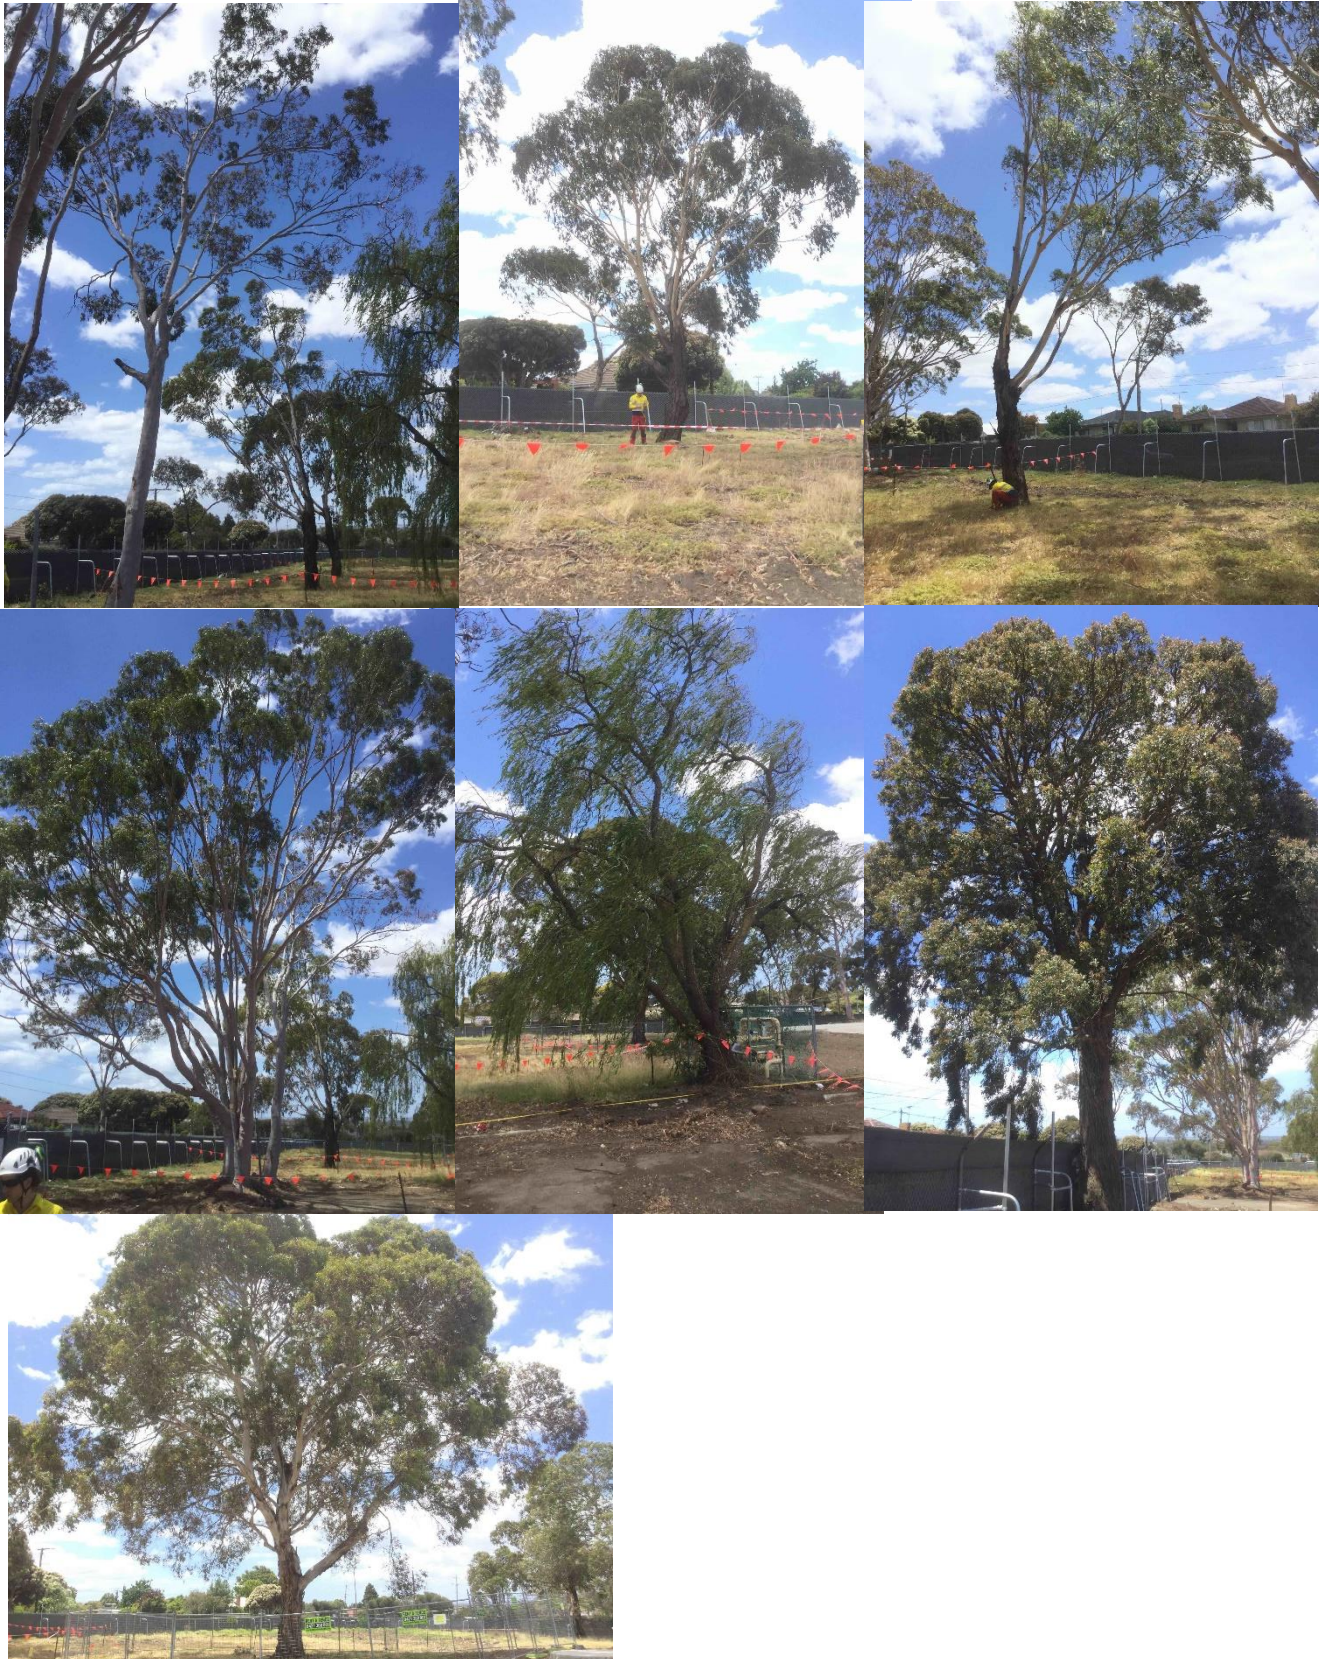
Images – Above left, Tree #38, above centre, Tree #27, above right, Tree #31, centre left, Tree #40, centre centre, Tree#36, centre right, Tree #47, below left, Tree #28

Seven trees located within the fenced area of the site were assessed. These, despite major encroachment within their TPZs in the form of soil disturbance (removal of concrete etc.), were found to be in a similar condition as originally observed (Tree Logic’s reports) with no observable impact to tree structure, condition or health as a result of incursion. The reason for this lack of observable root damage is most likely due to tree development and growth around existing structures, resulting in a lack of roots where these structures were. Concerns expressed to the author regarding browning of isolated foliage within the Northern aspect of the canopy of Tree #28 was identified as minor Psyllid damage. This damage is not considered serious at this time or related to the demolitions works.

future tree HEALTH				Detailed Tree Assessment	
DETAILS				ASSESSOR - Ryan Roche	DATE 20/12/16
				SITE - CSIRO Research	
CLIENT	Rafferty The Wrecker			TARGET/s	DESCRIPTION
PROPERTY	11 Henry St, Belmont			1	N/A
TREE LOCATION	11 Henry St, Belmont			2	
TREE#	38			3	
B/N	<i>Corymbia citriodora</i>			PRIOR WORKS	None evident
C/N	Lemon Scented Gum				
DBH (1.4m)	0.45m	TPZ	5.4m	SITE FACTORS	
DAB	0.54m	SRZ	2.55m	Suurban location within demolition site of old CSIRO Research facility	
HEIGHT	19m			Planted as one of a large number of trees	
SPREAD N/S	11.7m			PEST	None evident
SPREAD E/W	9.3m			PATHOGEN	None evident
TOTAL C/S	10.5m				
APPROX AGE	Approaching mature				
STRUCTURE				HEALTH	3
CANOPY	Sparse, asymmetrical			ARB VALUE	2
TRUNK	Ok			STR QUALIFIER	2
BRANCHES	One breakage, otherwise ok			TREE IMAGES	
LEAVES	Ok				
ROOTS	Trenching within TPZ. Minor root damage but not of structural concern				
FORM	Poor - leaning East

COMMENTS	In poor/fair health - but in same condition as originally assessed				
RECOMMENDATIONS				RISK RATING	SEE MATRIX SEE BELOW
	Retain - Average health			Low	
				RESIDUAL RISK	N/A

future tree HEALTH				Detailed Tree Assessment	
DETAILS		ASSESSOR - Ryan Roche		DATE	20/12/16
CLIENT		SITE -		CSIRO Research	
CLIENT	Rafferty The Wrecker	TARGET/s	DESCRIPTION		
PROPERTY	11 Henry St, Belmont	1	N/A		
TREE LOCATION	11 Henry St, Belmont	2			
TREE#	28	3			
B/N	<i>Eucalyptus leucoxylon</i>	PRIOR WORKS	Minor branch breakage and pruning		
C/N	Yellow Gum				
DBH (1.4m)	0.82m	TPZ	9.84m	SITE FACTORS	
DAB	1.09m	SRZ	3.43m	Suurban location within demolition site of old CSIRO Research facility	
HEIGHT	19m	Planted as one of a large number of trees			
SPREAD N/S	17.3m				
SPREAD E/W	17.5m	PEST	Minor Psyllid Damage		
TOTAL C/S	17.4m	PATHOGEN	None evident		
APPROX AGE	Maturing				
STRUCTURE		HEALTH	1		
CANOPY	Good, symmetrical	ARB VALUE	1		
TRUNK	Intact	STR QUALIFIER	2		
BRANCHES	Intact	TREE IMAGES			
LEAVES	Minor Psyllid damage				
ROOTS	Minor excavation within TPZ but no damage observed				
FORM	Spreading as per species

COMMENTS	Excavation appears to be car park removal (concrete) No root damage evident				
RECOMMENDATIONS	RISK RATING	SEE MATRIX SEE BELOW			
Retain - Good health	Low				
	RESIDUAL RISK	N/A

future tree HEALTH				Detailed Tree Assessment	
DETAILS		ASSESSOR - Ryan Roche		DATE	20/12/16
CLIENT		SITE -		CSIRO Research	
PROPERTY	11 Henry St, Belmont	TARGET/s	DESCRIPTION		
TREE LOCATION	11 Henry St, Belmont	1	N/A		
TREE#	31	2			
B/N	<i>Eucalyptus viminalis</i>	3			
C/N	Manna Gum	PRIOR WORKS	None evident		
DBH (1.4m)	0.56m	TPZ	6.72m	SITE FACTORS	
DAB	0.70m	SRZ	2.85m	Suurban location within demolition site of old CSIRO Research facility	
HEIGHT	16m	Planted as one of a large number of trees			
SPREAD N/S	8m				
SPREAD E/W	5.5m	PEST	None evident		
TOTAL C/S	6.75m	PATHOGEN	Wood borer damage		
APPROX AGE	Maturing				
STRUCTURE		HEALTH	2		
CANOPY	Sparse, asymmetrical	ARB VALUE	2		
TRUNK	Poor - borer damage	STR QUALIFIER	3		
BRANCHES	Intact - poor unions	TREE IMAGES			
LEAVES	Ok				
ROOTS	Trenching within TPZ. Minor root damage				
FORM	Poor - leaning North				
COMMENTS					
Trenching does not appear to have impacted on health of tree

future tree HEALTH				Detailed Tree Assessment	
DETAILS				ASSESSOR - Ryan Roche	
CLIENT		Rafferty The Wrecker		DATE 20/12/16	
PROPERTY		11 Henry St, Belmont		SITE - CSIRO Research	
TREE LOCATION		11 Henry St, Belmont			
TREE#		36			
B/N		<i>Salix babylonica</i>		PRIOR WORKS Poor pruning practices	
C/N		Weeping Willow			
DBH (1.4m)		0.64m		SITE FACTORS	
DAB		0.70m		Suurban location within demolition site of old CSIRO Research facility	
HEIGHT		14m		Planted as one of a large number of trees	
SPREAD N/S		15.9m			
SPREAD E/W		10.8m		PEST None evident	
TOTAL C/S		13.35m		PATHOGEN None evident	
APPROX AGE		Maturing			
STRUCTURE				HEALTH 3	
CANOPY		Sparse, asymmetrical		ARB VALUE 3	
TRUNK		Minor hollows - ok		STR QUALIFIER 3	
BRANCHES		Moderate deadwood - poor vitality		TREE IMAGES	
LEAVES		Ok			
ROOTS		Trenching within TPZ. Minor root damage			
FORM		Poor - leaning North			
COMMENTS		In poor health - but in same condition as originally assessed TPZ intact - no serious breach resulting in any damage

future tree HEALTH				Detailed Tree Assessment	
DETAILS		ASSESSOR - Ryan Roche		DATE	20/12/16
		SITE -		CSIRO Research	
CLIENT	Rafferty The Wrecker		TARGET/s	DESCRIPTION	
PROPERTY	11 Henry St, Belmont		1	N/A	
TREE LOCATION	11 Henry St, Belmont		2		
TREE#	40		3		
B/N	Corymbia citriodora		PRIOR WORKS	None evident	
C/N	Lemon Scented Gum				
DBH (1.4m)	0.80m	TPZ	9.6m	SITE FACTORS	
DAB	0.86m	SRZ	3.11m	Suurban location within demolition site of old CSIRO Research facility	
HEIGHT	22m		Planted as one of a large number of trees		
SPREAD N/S	18.5m				
SPREAD E/W	12.8m		PEST	None evident	
TOTAL C/S	15.65m		PATHOGEN	None evident	
APPROX AGE	Maturing				
STRUCTURE			HEALTH	2	
CANOPY	Sparse, asymmetrical		ARB VALUE	2	
TRUNK	Ok - tight unions from 1.4m		STR QUALIFIER	2	
BRANCHES	Thin but ok		TREE IMAGES		
LEAVES	Ok				
ROOTS	Trenching within TPZ. Minor root damage but not of structural concern				
FORM	Poor - cramped unions

COMMENTS					
In fair health - but in same condition as originally assessed					
No evident decline or damage due to trenching					
RECOMMENDATIONS			RISK RATING	SEE MATRIX SEE BELOW	
Retain - Average health			Low		
			RESIDUAL RISK	N/A

future tree HEALTH				Detailed Tree Assessment	
DETAILS				ASSESSOR - Ryan Roche	
CLIENT Rafferty The Wrecker				DATE 20/12/16	
PROPERTY 11 Henry St, Belmont				SITE - CSIRO Research	
TREE LOCATION 11 Henry St, Belmont					
TREE# 27					
B/N <i>Eucalyptus viminalis</i>				PRIOR WORKS Lopping	
C/N Manna Gum					
DBH (1.4m) 0.62m TPZ 7m				SITE FACTORS	
DAB 0.71m SRZ 2.7m				Suurban location within demolition site of old CSIRO Research facility	
HEIGHT 12m				Planted as one of a large number of trees	
SPREAD N/S 11.9m					
SPREAD E/W 10.6m				PEST None evident	
TOTAL C/S 11.25m				PATHOGEN None evident	
APPROX AGE Maturing					
STRUCTURE				HEALTH 1	
CANOPY Good, asymmetrical				ARB VALUE 2	
TRUNK Intact - lopped at 5m				STR QUALIFIER 2	
BRANCHES Intact				TREE IMAGES	
LEAVES Ok					
ROOTS Trenching within TPZ. Minor root damage					
FORM Lopped, reestablished					
COMMENTS					
Trenching does not appear to have impacted on health of tree

TRUNK	Ok - tight unions from 1.4m				
BRANCHES	Thin but ok				
LEAVES	Ok				
ROOTS	Soil disturbance with some root damage - no decline evident				
FORM	Poor - leaning East				
COMMENTS					
No evident decline or damage due to minor soil disturbance within root zone

In conclusion, trees were of acceptable condition for continued retention despite major encroachment via soil disturbance and excavation within the Tree Protection Zones of seven of the eleven trees assessed. As stated within Tree Logic's report, retention of these trees would have been difficult due to aspects of the site (carparks, etc.) requiring demolition and removal. Despite these constraints on tree retention, in the authors' opinion, site management and contractors throughout the demolition process have so far tried where possible to limit damage to trees marked for retention. Removal of material within Tree Protection Zones was clearly necessary, yet has resulted in limited observable damage and/or impact on tree health and condition. All trees assessed presented as originally assessed within Tree Logic's reports. The author recommends continued tree protection efforts and reassessment as required as the demolition process continues.

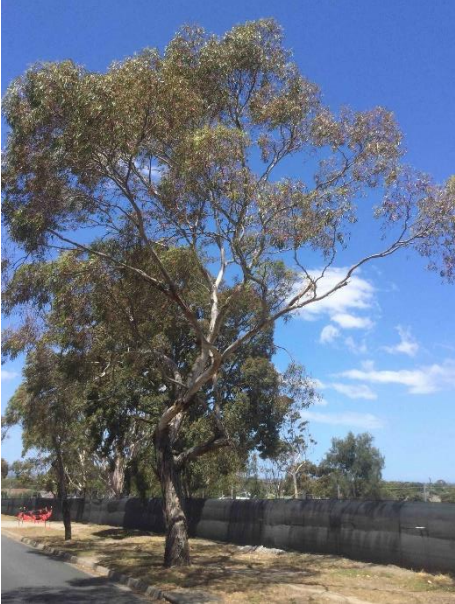
Images – Above left, Tree #51, above centre, Tree #34, above right, Tree #24, below left, Tree #49

future tree HEALTH				Detailed Tree Assessment	
DETAILS		ASSESSOR - Ryan Roche		DATE	20/12/16
		SITE -		CSIRO Research	
CLIENT	Rafferty The Wrecker		TARGET/s	DESCRIPTION	
PROPERTY	11 Henry St, Belmont		1	N/A	
TREE LOCATION	11 Henry St, Belmont		2		
TREE#	51		3		
B/N	<i>Eucalyptus leucoxydon</i>		PRIOR WORKS	Moderate pruning - wounds sealing	
C/N	Yellow Gum				
DBH (1.4m)	0.55m	TPZ	6.6m	SITE FACTORS	
DAB	0.65m	SRZ	2.76m	Suurban location within demolition site of old CSIRO Research facility	
HEIGHT	15m		Planted as one of a large number of trees		
SPREAD N/S	11m				
SPREAD E/W	19m		PEST	None evident	
TOTAL C/S	15m		PATHOGEN	None evident	
APPROX AGE	Maturing				
STRUCTURE			HEALTH	1	
CANOPY	Full		ARB VALUE	1	
TRUNK	Ok - twisted as per species		STR QUALIFIER	1	
BRANCHES	Good		TREE IMAGES		
LEAVES	Ok				
ROOTS	No issues identified				
FORM	As per species - good				
COMMENTS					
Healthy Yellow Gum on naturestrip					
RECOMMENDATIONS			RISK RATING	SEE MATRIX SEE BELOW

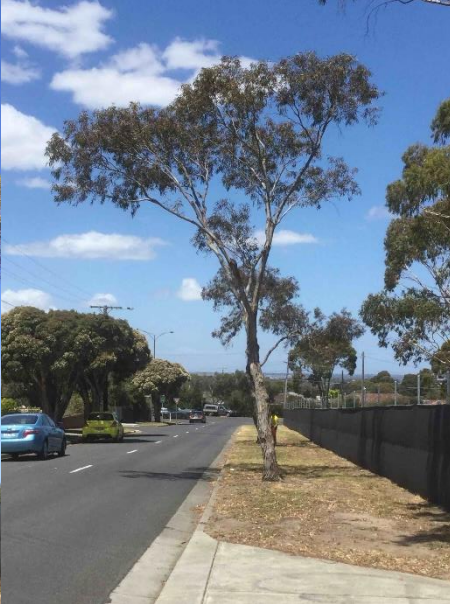
future tree HEALTH				Detailed Tree Assessment	
DETAILS		ASSESSOR - Ryan Roche		DATE	20/12/16
		SITE -		CSIRO Research	
CLIENT	Rafferty The Wrecker		TARGET/s	DESCRIPTION	
PROPERTY	11 Henry St, Belmont		1	N/A	
TREE LOCATION	11 Henry St, Belmont Naturestrip		2		
TREE#	34		3		
B/N	<i>Eucalyptus leucoxylon</i>		PRIOR WORKS	None evident	
C/N	Yellow Gum				
DBH (1.4m)	0.30m	TPZ	3.6m	SITE FACTORS	
DAB	0.37m	SRZ	2.18m	Suurban location within demolition site of old CSIRO Research facility	
HEIGHT	11m		Planted as one of a large number of trees		
SPREAD N/S	6.4m				
SPREAD E/W	7.6m		PEST	None evident	
TOTAL C/S	7m		PATHOGEN	None evident	
APPROX AGE	Early maturity				
STRUCTURE			HEALTH	1	
CANOPY	Full, symmetrical		ARB VALUE	1	
TRUNK	Ok		STR QUALIFIER	1	
BRANCHES	Ok		TREE IMAGES		
LEAVES	Ok				
ROOTS	No issues identified				
FORM	As per species - good				
COMMENTS	Healthy Yellow Gum on naturestrip				
RECCOMENDATIONS			RISK RATING	SEE MATRIX SEE BELOW

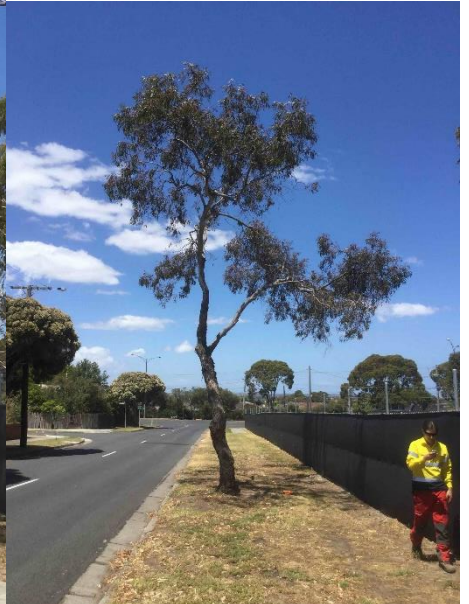
future tree HEALTH				Detailed Tree Assessment	
DETAILS		ASSESSOR - Ryan Roche		DATE 20/12/16	
		SITE -		CSIRO Research	
CLIENT	Rafferty The Wrecker		TARGET/s	DESCRIPTION	
PROPERTY	11 Henry St, Belmont		1	N/A	
TREE LOCATION	11 Henry St, Belmont Naturestrip		2		
TREE#	24		3		
B/N	<i>Eucalyptus leucoxydon</i>		PRIOR WORKS	None evident	
C/N	Yellow Gum				
DBH (1.4m)	0.33m	TPZ	3.96m	SITE FACTORS	
DAB	0.39m	SRZ	2.23m	Suurban location within demolition site of old CSIRO Research facility	
HEIGHT	9m		Planted as one of a large number of trees		
SPREAD N/S	10.10m				
SPREAD E/W	9m		PEST	None evident	
TOTAL C/S	9.55m		PATHOGEN	None evident	
APPROX AGE	Early maturity				
STRUCTURE			HEALTH	1	
CANOPY	Full, asymmetrical		ARB VALUE	1	
TRUNK	Ok		STR QUALIFIER	1	
BRANCHES	Ok		TREE IMAGES		
LEAVES	Ok

ROOTS	No issues identified				
FORM	As per species - good				
COMMENTS					
Healthy Yellow Gum on naturestrip					
RECCOMENDATIONS			RISK RATING	SEE MATRIX SEE BELOW

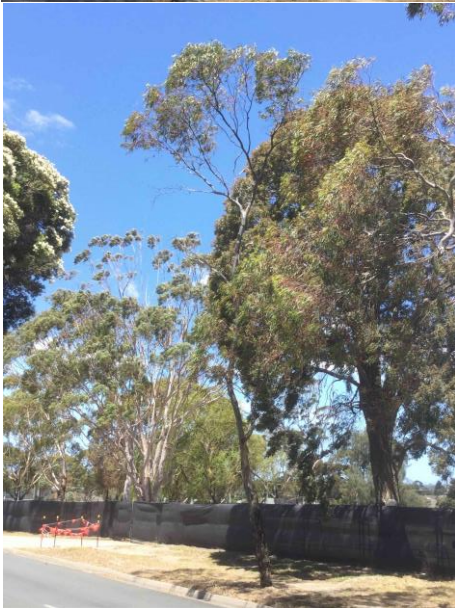
future tree HEALTH				Detailed Tree Assessment	
DETAILS				ASSESSOR - Ryan Roche	DATE 20/12/16
				SITE -	CSIRO Research
CLIENT	Rafferty The Wrecker			TARGET/s	DESCRIPTION
PROPERTY	11 Henry St, Belmont			1	N/A
TREE LOCATION	11 Henry St, Belmont Naturestrip			2	
TREE#	49			3	
B/N	<i>Eucalyptus leucoxylon</i>			PRIOR WORKS	None evident
C/N	Yellow Gum				
DBH (1.4m)	0.28m	TPZ	3.36m	SITE FACTORS	
DAB	0.27m	SRZ	1.19m	Suurban location within demolition site of old CSIRO Research facility	
HEIGHT	15m			Planted as one of a large number of trees	
SPREAD N/S	3.5m				
SPREAD E/W	4.4m			PEST	None evident
TOTAL C/S	3.95m			PATHOGEN	None evident
APPROX AGE	Early maturity				
STRUCTURE				HEALTH	1
CANOPY	Thin, symmetrical			ARB VALUE	1
TRUNK	Ok			STR QUALIFIER	1
BRANCHES	Ok			TREE IMAGES	
LEAVES	Ok				
ROOTS	No issues identified				
FORM	As per species - good				
COMMENTS	Healthy Yellow Gum on naturestrip				
RECCOMENDATIONS				RISK RATING	SEE MATRIX SEE BELOW
