Greater Geelong Planning Scheme Amendment C354

STATEMENT OF EVIDENCE
ON ARBORICULTURAL ISSUES

**9 Bridge Street,
Barwon Heads**

ROB GALBRAITH – GALBRAITH & ASSOCIATES

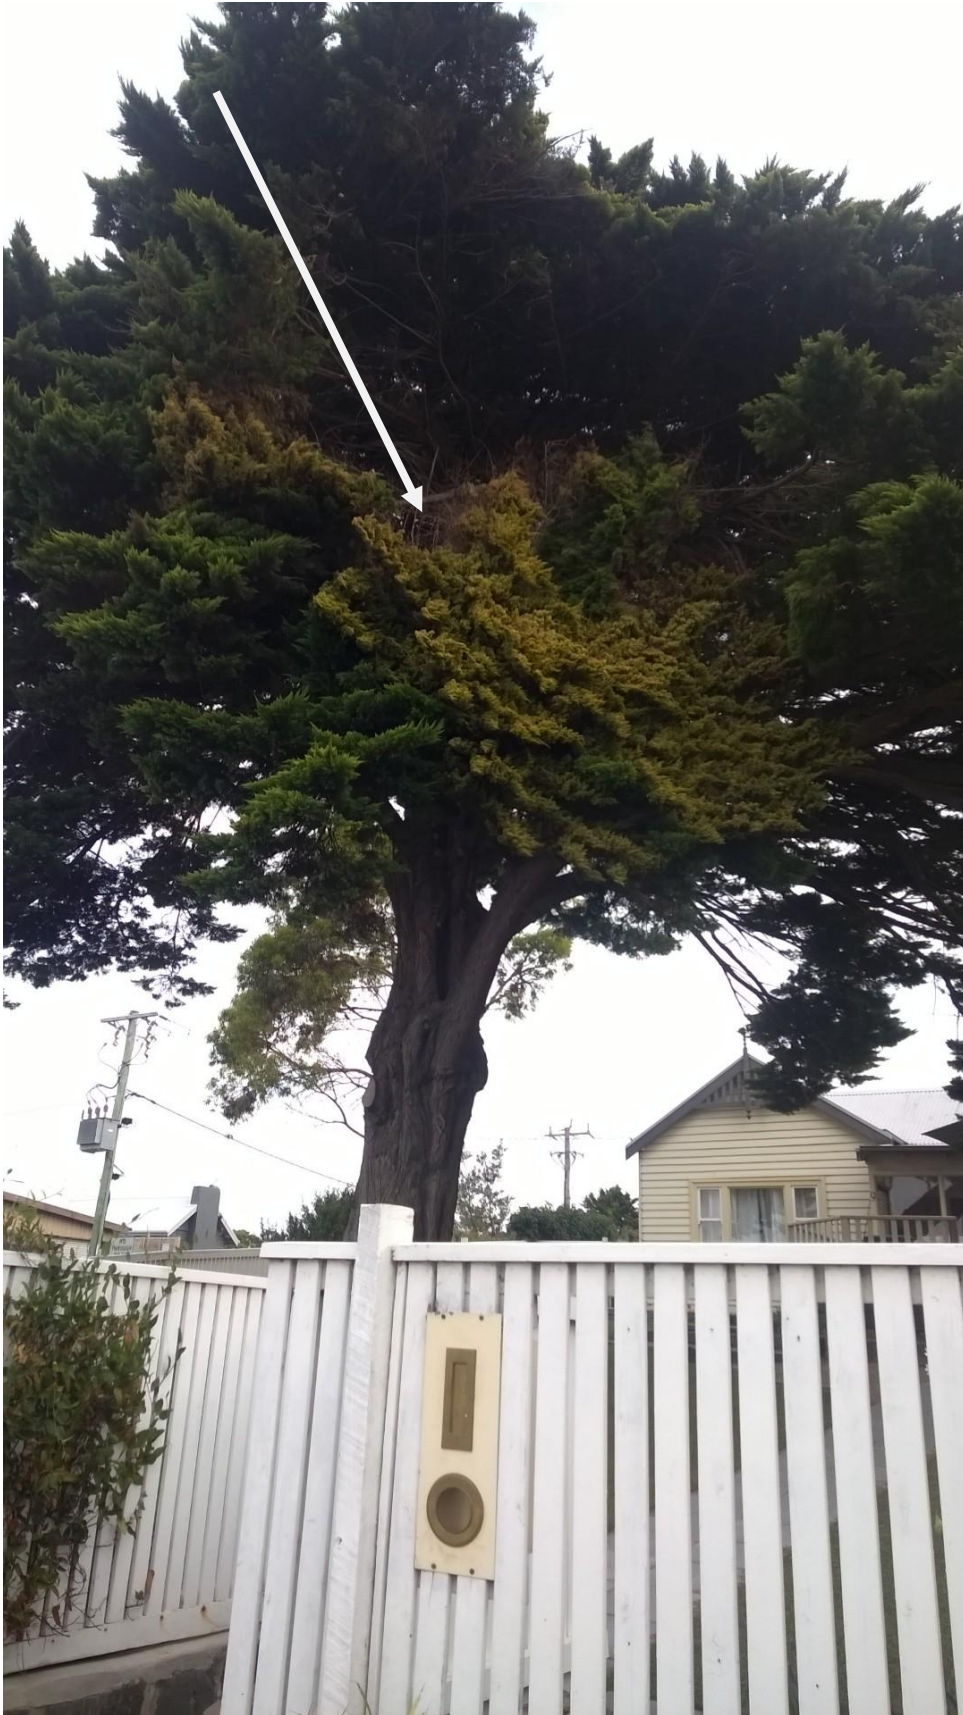
The tree is of moderate health but poor structurally as is evident from a prolific limb shed history. In fact since my initial inspection in mid October, it was apparent from the early January visit that a further large branch has fractured and is resting on branches below, putting these branches at risk of collapse.

View of the tree from Bridge Street in early January 2017. The arrowed branch with the yellow foliage has recently fractured.

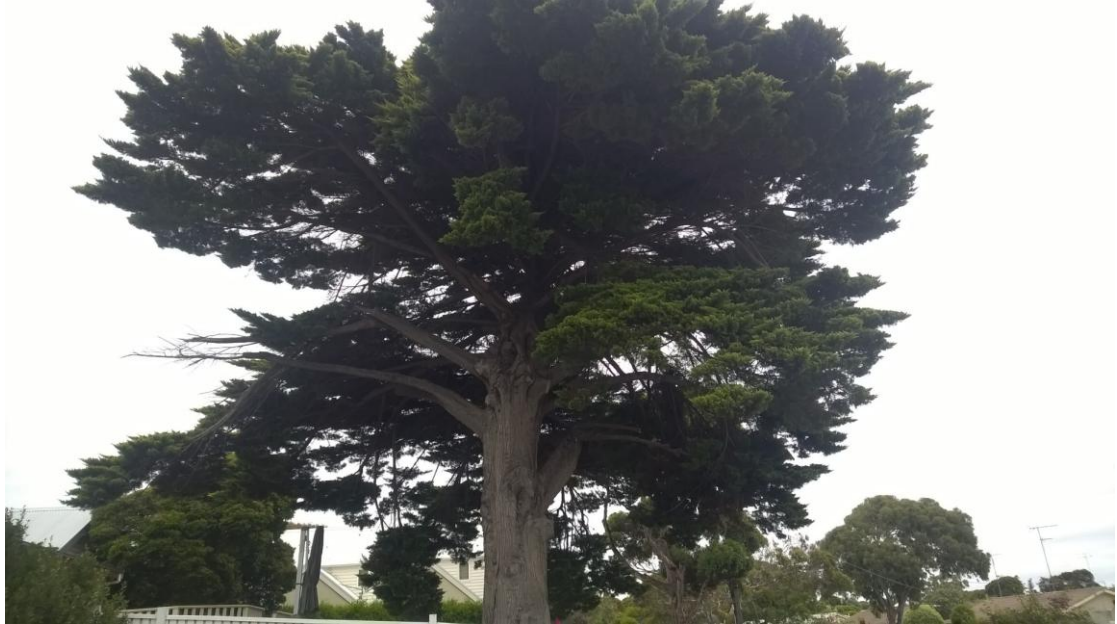
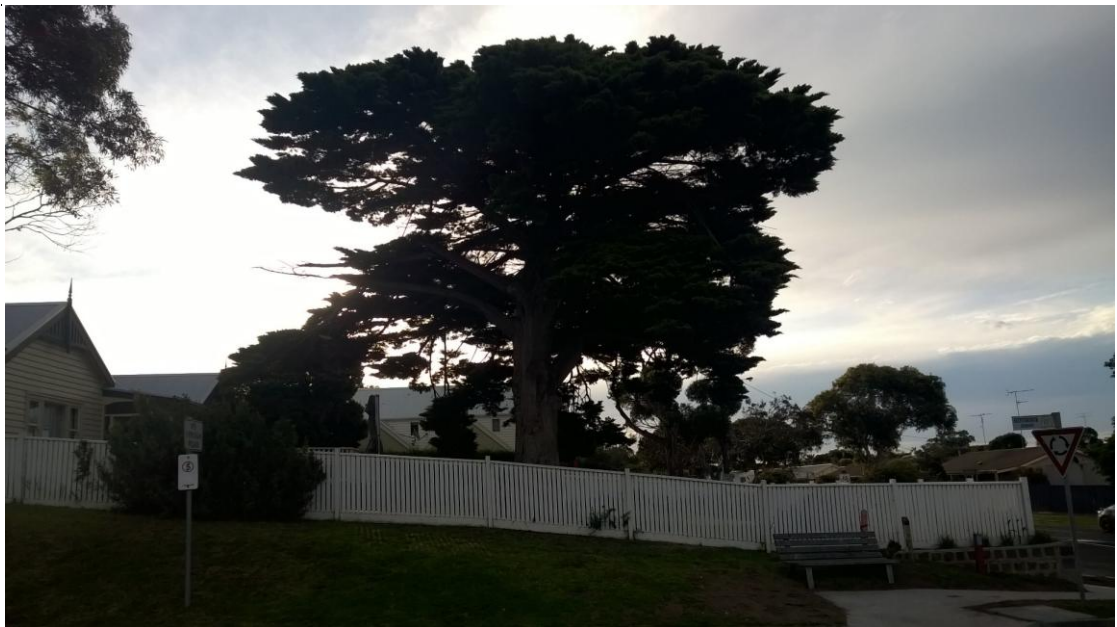
Views of the tree looking from east to west

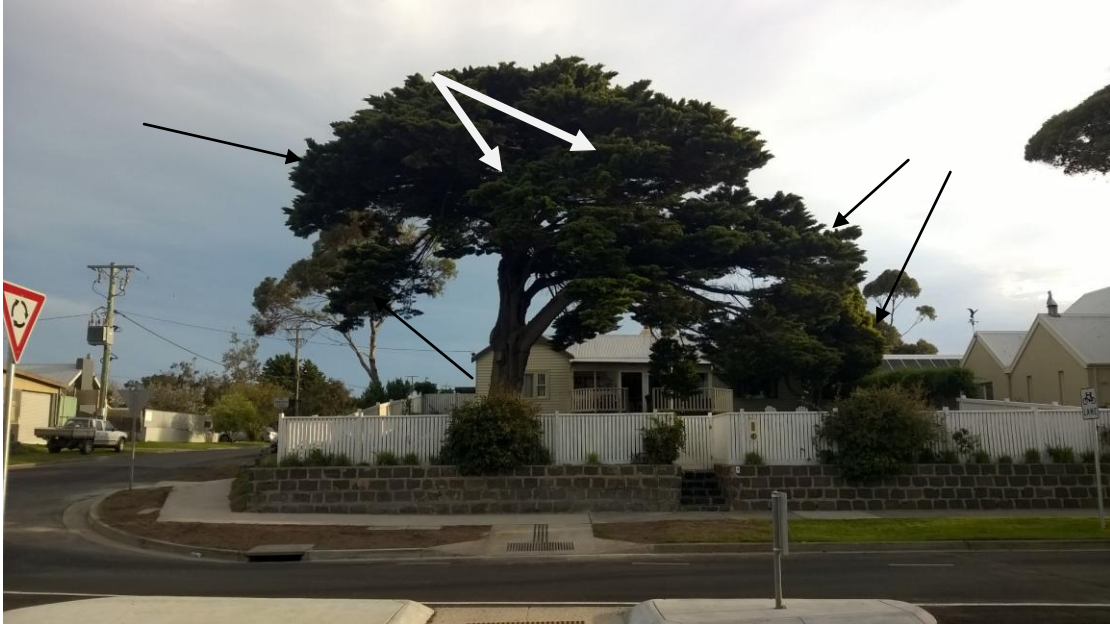
View of the tree looking south in October 2016 with the recently fracture branch arrowed in white. Other high risk boughs are arrowed in black.

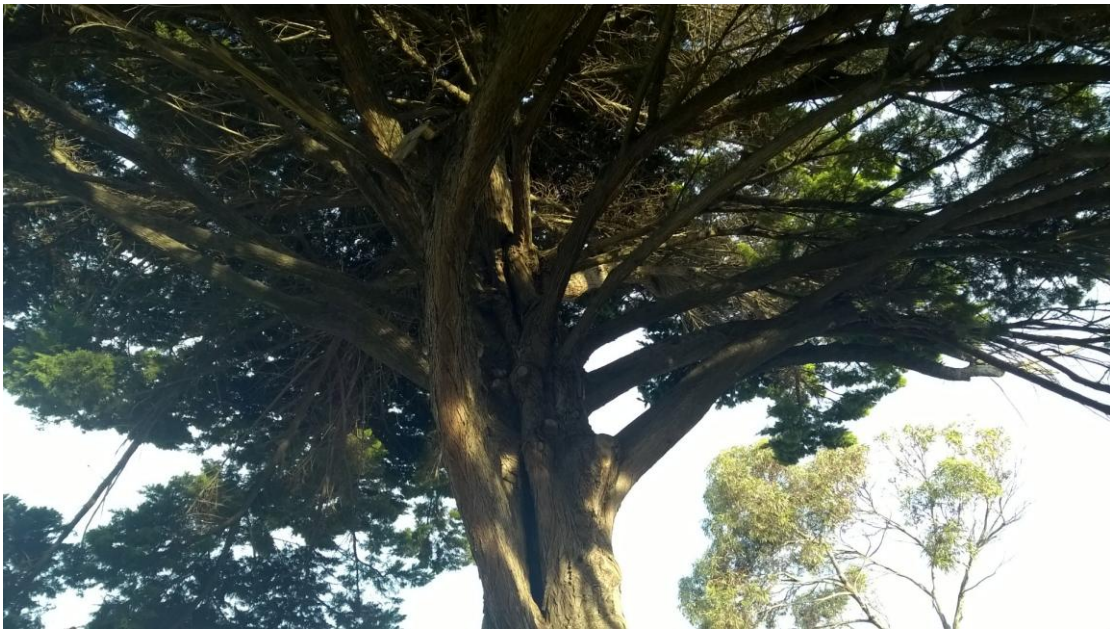
View up into the canopy showing the lack of internal foliage, except near the top of the tree. There is no facility to be able to prune back the long heavy branches to make them safe without removing all or most of the foliage clumped at the ends, thereby starving them.

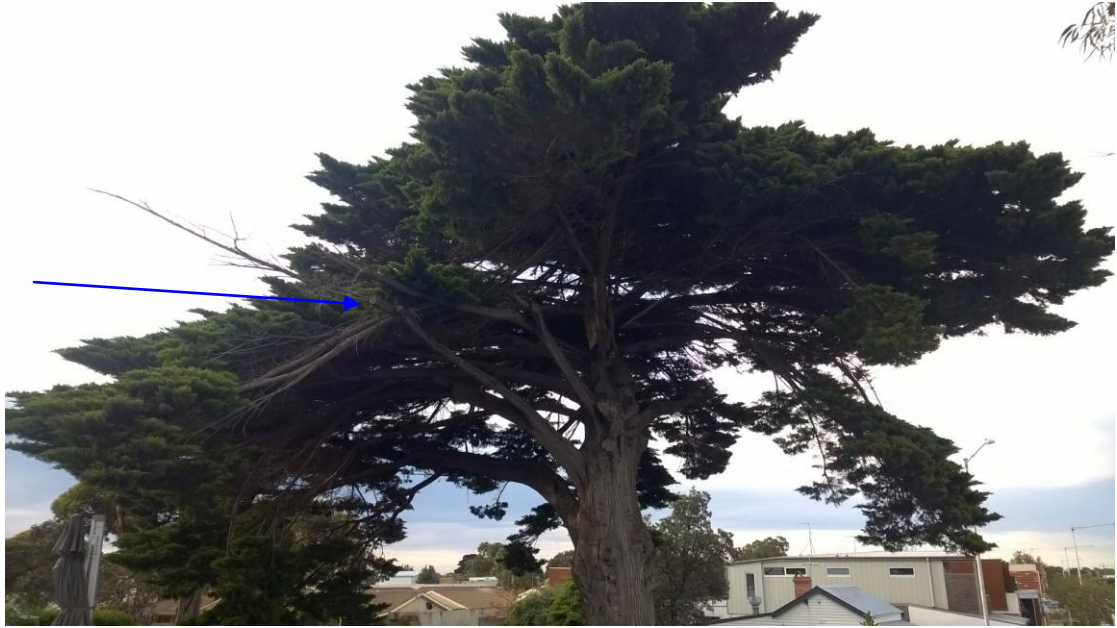
Pruning has been undertaken where arrowed within the last few years. The pruning would either have been in response to cleaning up after a branch had fractured or to take weight off long heavy branches.

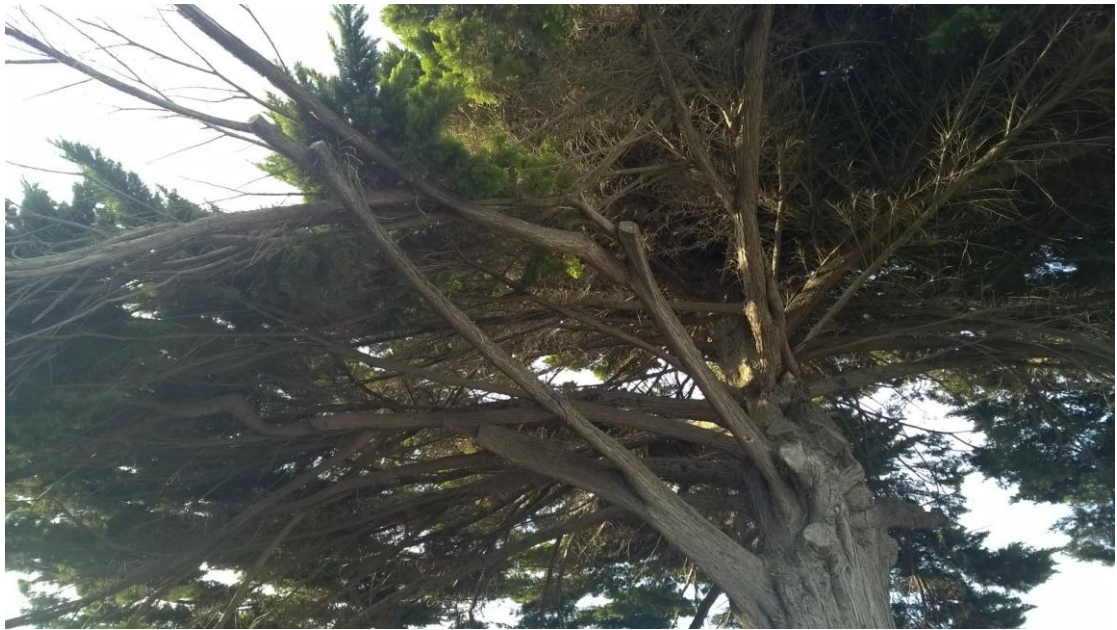
Close up of the first photos. Note that the branches have died as a result of the loss of too much foliage.

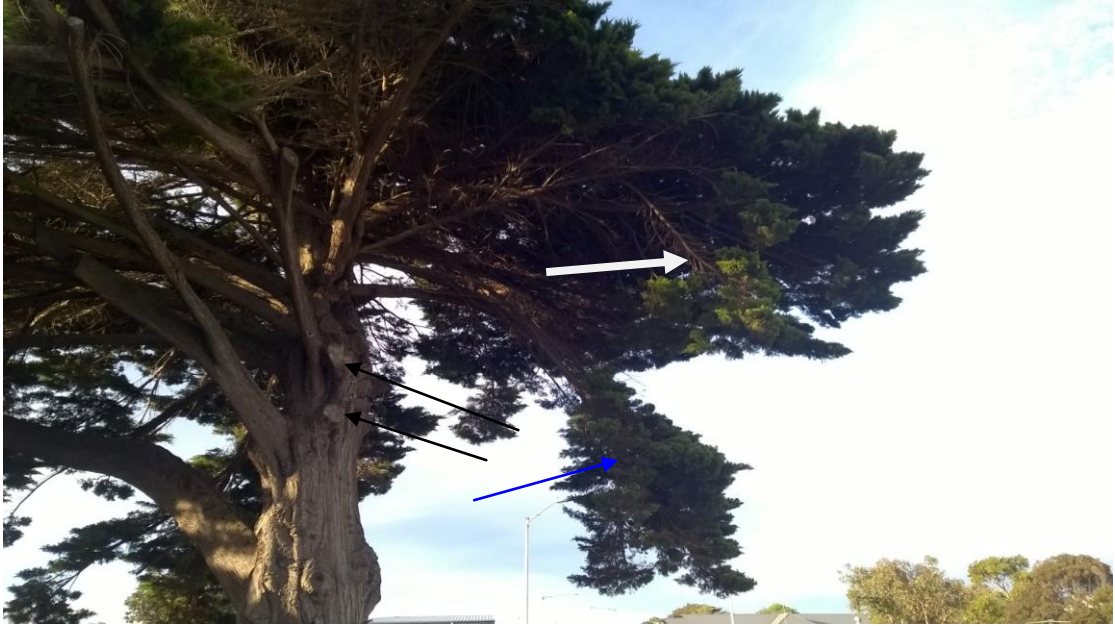
The white arrow points to a fractured drooping branch. The blue arrow points to a larger drooping branch at high risk of failure. The two black arrows point to large branch removal wounds on the trunk where presumably broken branches have been removed.

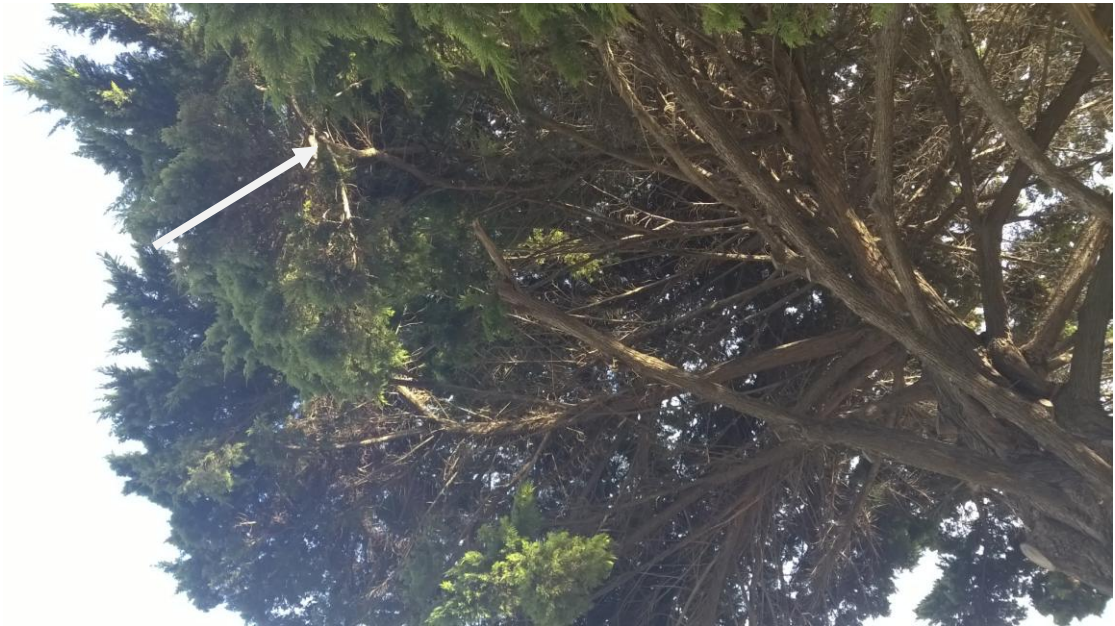
Two snapped hanging branches
