*Arboricultural Assessment for:
335 Barrabool Road
Wandana Heights, Victoria 3216*

*In reference to
Arboricultural Tree
Assessment
'Planning'*

Date: December 2014

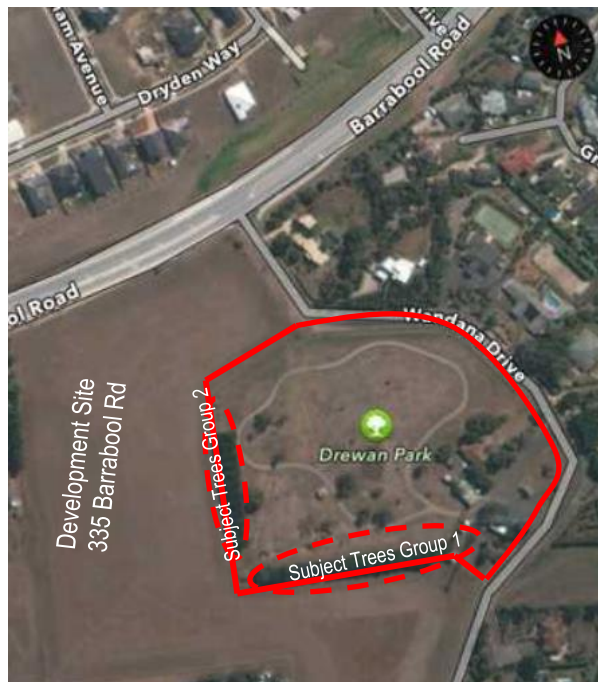
Figure 1. Site Over View

The report is based on two groups of trees located on a neighbouring allotment which is known as Drewan Park, Wandana Drive, Wandana Heights, Victoria.

The development site is a private residential allotment. The trees are located on a public open space managed by the City of Greater Geelong.

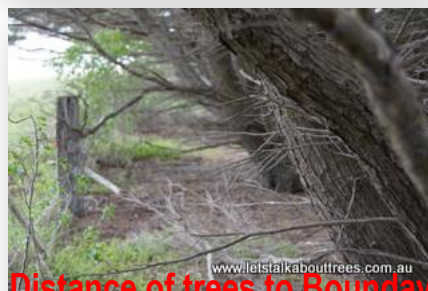
13

The Tree Protection Zone of both stands extends beyond 10 meters into the development site. Even allowing for encroachment using AS4970 – 2009 Protection of Trees on Development Sites, both stands will be affected structurally post site development. The canopies of both stands also encroach over the boundary by some 6 – 10 metres.

Distance of trees to Boundary
