Arboricultural Assessment and Report for:

120 Russells Road, Mount Duneed

August 2018

PRE-DEVELOPMENT TREE ASSESSMENT AND REPORT

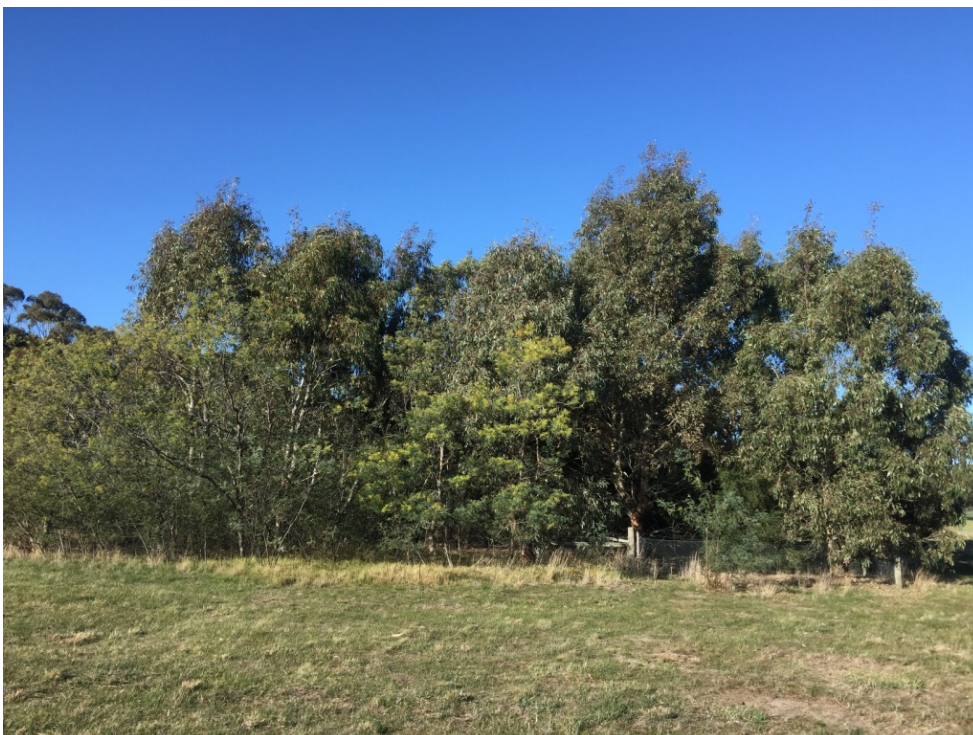
Fig. 1 Tree plantation lying across the property (50%) and the adjacent recreational reserve (50%)

The ownership of the tree plantation may need to be determined, in terms of rights and responsibilities given the property boundary runs through the plantation in close proximity to trees, if not through actual trunks. Irrespective of tree ownership status, any fencing of the boundary will require protection of trees on crown land during construction works. Trees within this plantation are yet to be included in the assessment of trees on site. This may proceed upon determination of the property boundary, the trees' status and accessibility.

It is unclear why a tree plantation was located on private property other than it was assumed to be part of the public recreational reserve. Within the plantation, the trees are generally in fair to good condition however the dense planting may compromise access to sunlight and ultimately growth potential over the longer term. The design concept for the site indicates a boundary fence will extend through the plantation necessitating removal of trees. Should trees require removal to accommodate fencing, it is strongly recommended the boundary be surveyed and marked to enable protection of trees outside the property (on public land). The trees will require protection from construction in accordance with *AS 4970-2009 - Protection of Trees During Construction*. The existing tree plantation fence may be utilised as part of the tree protection zone.

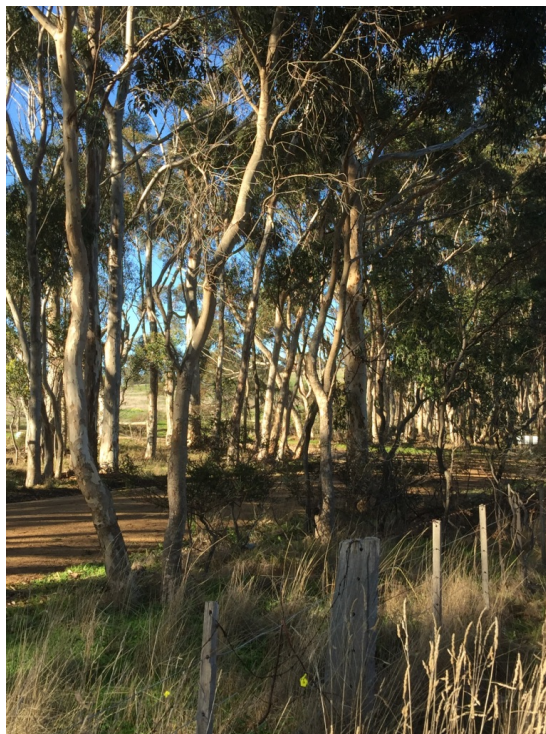
Fig.2 Self-sown Sugar Gums lining the road reserve.

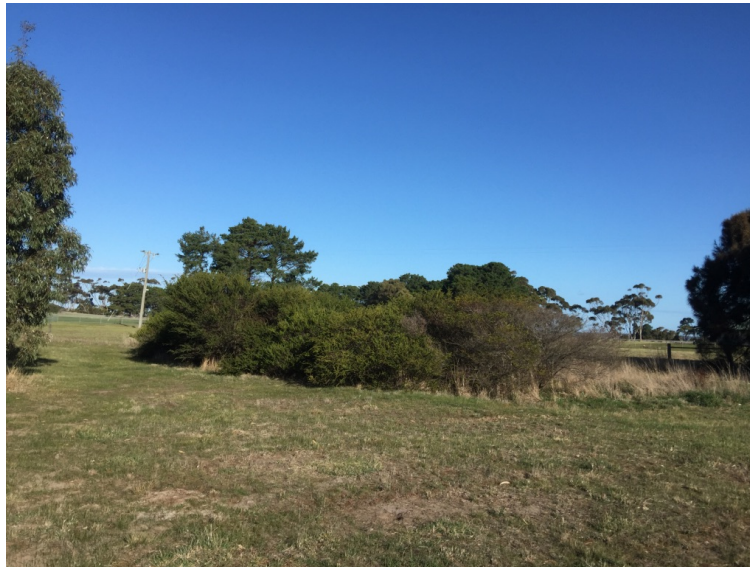
Within the site there are dense thickets of Kangaroo Thorn (*Acacia paradoxa*). This has served as a haven for rabbits as evidenced by the widespread trails, scratchings and droppings. The rabbit infestation is extensive. Removal of the thickets would facilitate control or eradication of the rabbits. While these shrubs are indigenous to the area, planting at these densities is not recommended where rabbits are present.

Fig. 3. Kangaroo Thorn (*Acacia paradoxa*) thicket providing protection for rabbit burrows

The Kangaroo Thorn thickets are recommended for removal to address the substantial rabbit infestation. The indigenous species (*Acacia paradoxa*) can be successfully incorporated within a landscape design or theme, but is not recommended as as a single species or dense planting.

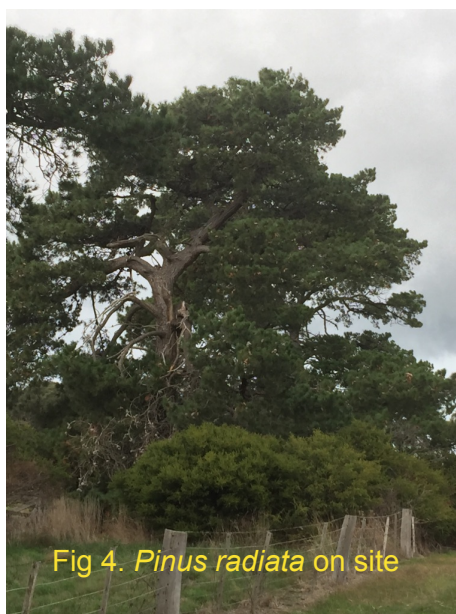
Two of the four property boundaries are lined with large, declining Monterey pines. These trees (*Pinus radiata*) have little or no retention value. They are mostly over-mature with a history of large branch shedding. The species is listed on the Greater Geelong Council's Environmental Weed List (2008), so their removal will not require a permit. All pines, including self-sown saplings are recommended for removal. Should the property owner wish to retain any, I would strongly recommend individual assessment as most have clear structural faults and are likely to be further compromised by construction.

Fig 4. *Pinus radiata* on site

All declining Monterey pines are recommended for removal. Most, if not all, are beyond their Safe, Useful Life Expectancy (SULE) and are unlikely to tolerate excavation and construction.

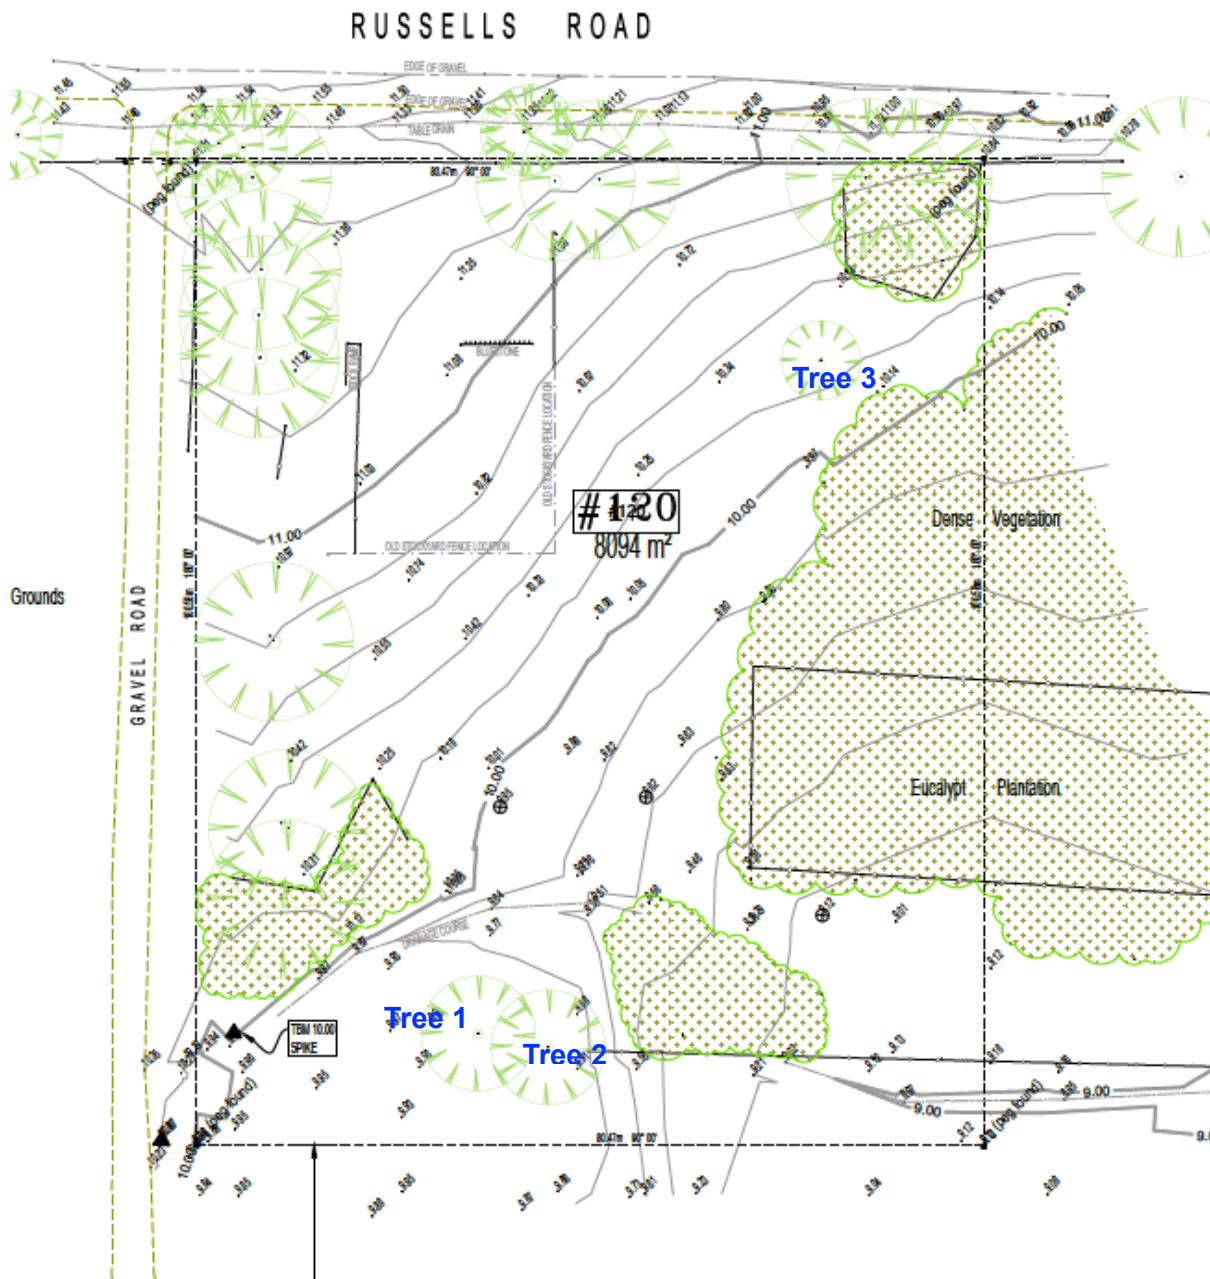
Trees nominated for retention and protection on site include the two Drooping She-oaks (*Allocasuarina verticillata*) The trees are marked on the site plan below (Tree 1 & 2) and their data recorded. The trees are indigenous to the area and are in fair-good condition and health. There is additionally, a self-sown Sugar Gum (*Eucalyptus cladocalyx*). The tree (Tree 3 on the site plan) is native but not indigenous to the area. It is in good condition, however, the number of self-sown Sugar Gums on the property and the road reserve is indicative of the species potential (environmental) weediness. The tree can be retained if desired but there is potential for weediness from this tree and others in the road reserve.

Fig. 6. Site Plan for 220 Russells Road showing trees assessed. All other trees on site (unmarked) are Monterey Pines (*Pinus radiata*)

It is recommended the two indigenous She-oaks (Tree 1 and 2) be retained and accommodated for within the property development. The trees will require protection, maintenance and monitoring in accordance with *Australian Standard 4970-2009 – Protection of Trees During Construction* as outlined above.

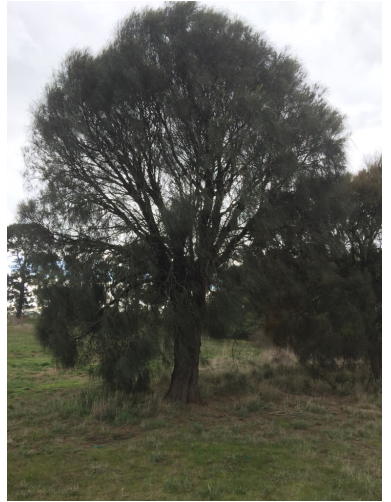
Tree No. 1		
Botanical Name	<i>Casuarina verticilata</i>

Common Name	Drooping She-oak	
Tree Origin	Native (indigenous)	
Height (m)	6.8	
Spread (m)	7.2	
DBH (cm)	56	
Health	Good	
Structure	Poor-Fair	
Useful Life Expectancy (ULE)	5-10 years	
Tree Significance	Moderate	
Tree Retention Value		
TPZ (m)	6.7	
SRZ (m)	2.7	
Comments	Bifurcated at 1.6m with included bark, mistletoe, asphalt around base. Light deadwood and crown lift. Remove asphalt.

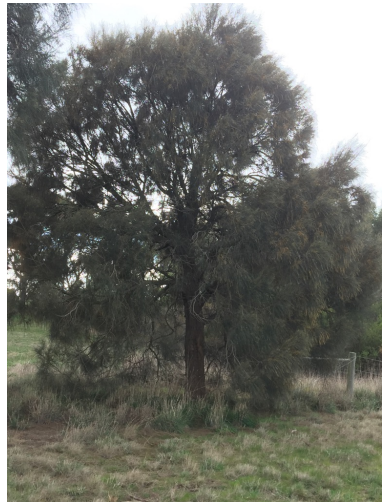
Tree No. 2		
Botanical Name	<i>Casuarina verticilata</i>

Common Name	Drooping She-oak	
Origin	Native (indigenous)	
Height (m)	6.2	
Spread (m)	7.2	
DBH (cm)	33	
Health	Good	
Structure	Good	
Useful Life Expectancy (ULE)	10-20 years	
Tree Significance	Moderate	
	Medium	
TPZ (m)	4	
SRZ (m)	2.2

Comments	Light deadwood removal and crown lift.
----------	--

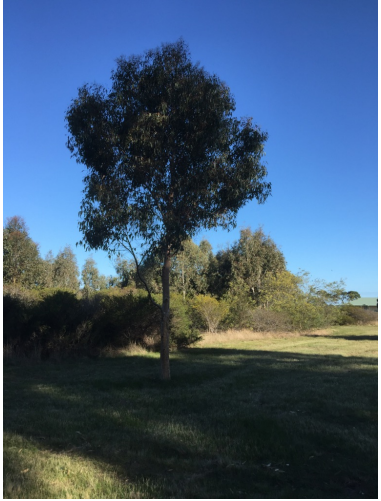
Tree No. 3

Common Name	Sugar Gum	
Origin	Native	
Height (m)	9.2	
Spread (m)	5	
DBH (cm)	22	
Health	Good	
Structure	Good	
Useful Life Expectancy (ULE)	20+ years	
Tree Significance	Low-Moderate	
Tree Retention Value	Low	
TPZ (m)	2.6	
SRZ (m)	1.9	
Comments	Healthy young self-sown specimen. Minor exudate
