CLAREMONT HOUSE

12-16 KINSMEAD STREET, VAURN PONDS VIC 3216
STRUCTURAL CONDITION ASSESSEMENT REPORT

ST_REPORT_001

RE Structural Assessment of Claremont Homestead, 8-12 Kinsmead Street, Waurnd Ponds Geelong VIC 3216

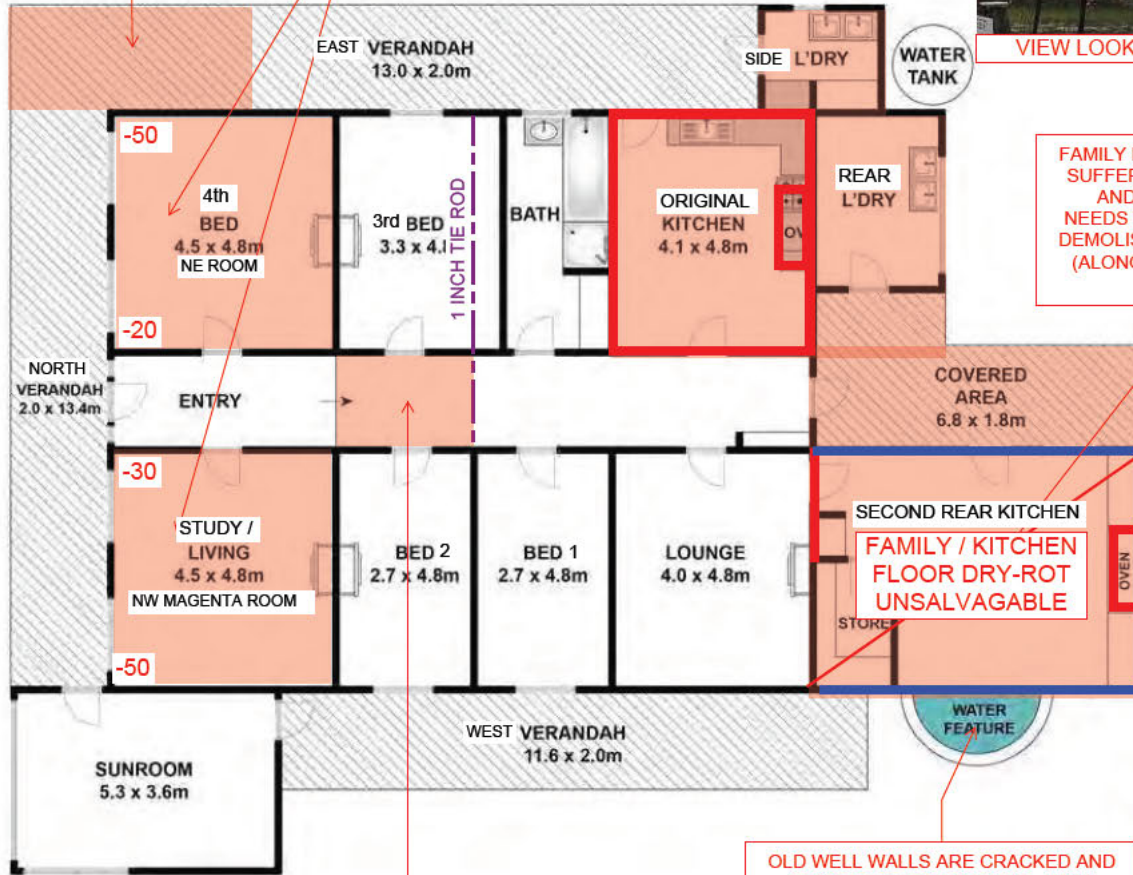
FAMILY KITCHEN FLOOR SUFFERING DRY-ROT AND IS UNSAFE. NEEDS TO BE TOTALLY DEMOLISHED & REBUILT (ALONG WITH ENTIRE ROOM)

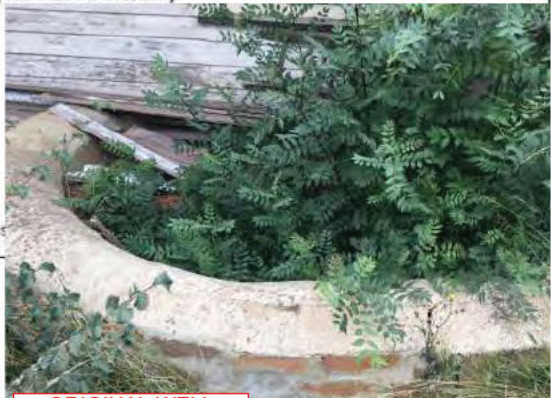
ORIGINAL WELL

OLD WELL WALLS ARE CRACKED AND NEED TO BE DEMOLISHED. WELL ITSELF NEEDS TO BE PROPERLY BACKFILLED AND SURVEYED AS IT IS A HAZARD FOR FUTURE BUILDINGS/FOUNDATIONS

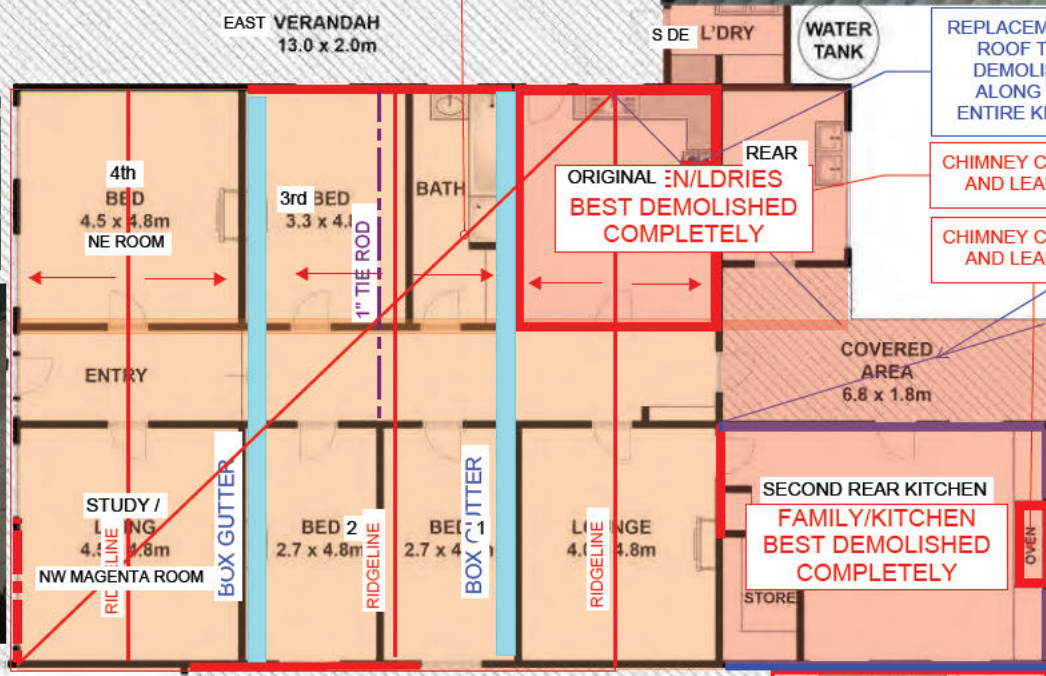
SK3 ROOF - DILAPIDATION PLAN

VERANDAH POSTS AND BEAMS HAVE DROPPED AND TIMBERS NEED 50% REPLACEMENT

TOTAL REPLACEMENT OF SLATE ROOF / BATTENS / GUTTERS REQ'D
 TOTAL DEMOLITION REQUIRED

SW AWNING ROOF HAS COLLAPSED

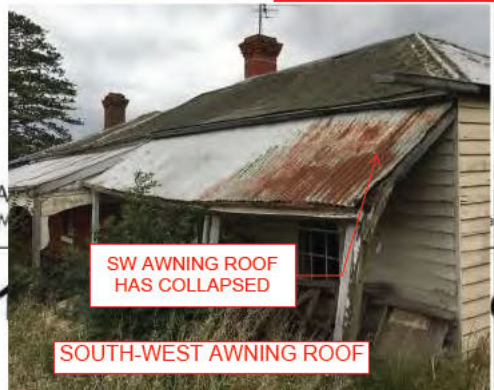
SOUTH-WEST AWNING ROOF

SW AWNING ROOF HAS COLLAPSED

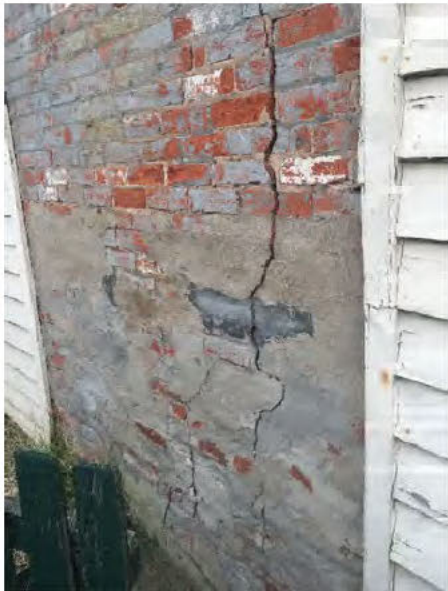
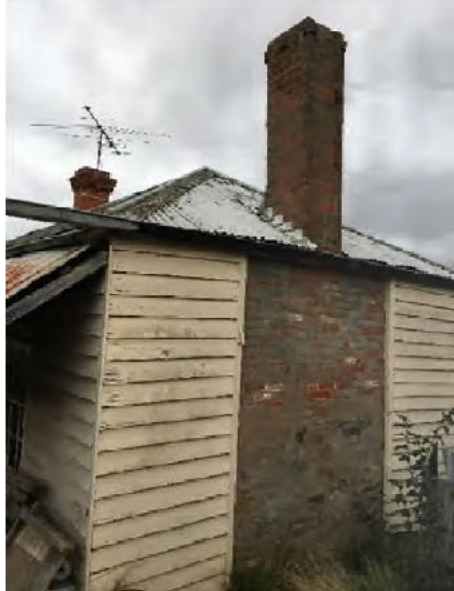
Site Inspection conducted by Block1's Ashley Willis on 22.04.2021		
	ITEM	COMMENTS
1

SOUTHERN CHIMNEY IS LEANING AND SEVERELY CRACKED
2

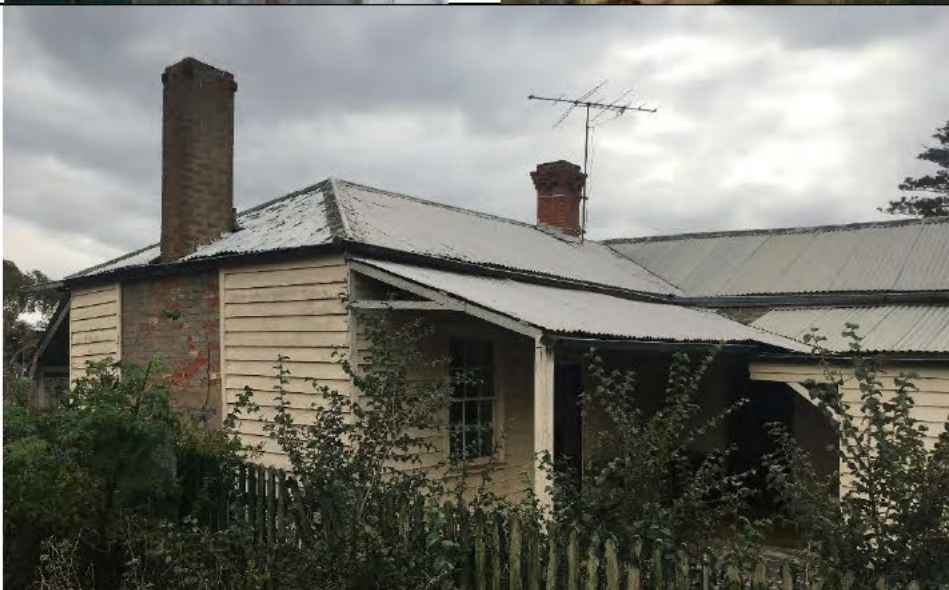
PHOTO SHOWING THIS BACK CHIMNEY LEANING NORTH

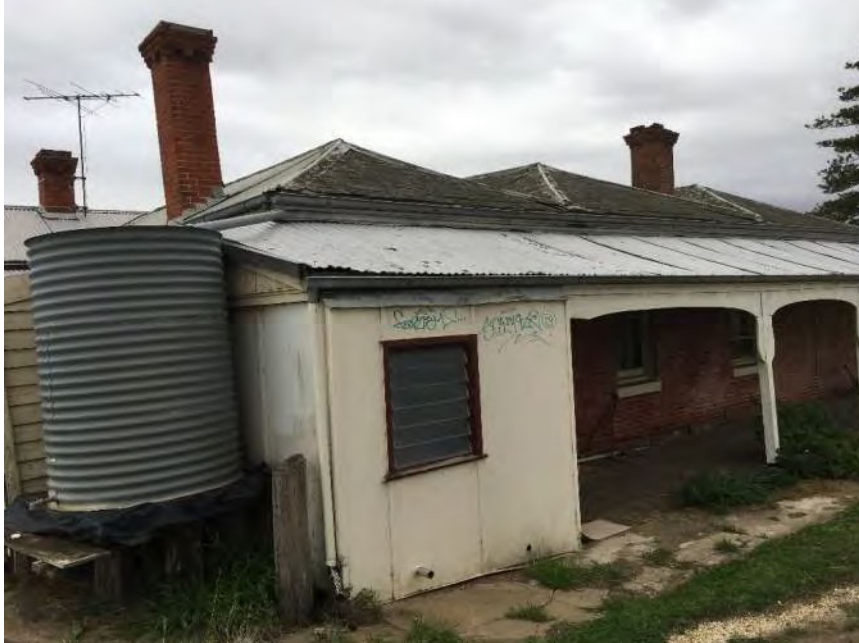
3

KITCHEN FIREPLACE IS LEANING AND IS DEEMED UNSTABLE DUE TO MASSIVE CRACKS IN MASONRY WALL TO ITS SIDE.

CRACK IN REAR LAUNDRY TO THE SIDE OF THE KITCHEN CHIMNEY. THIS ENTIRE WALL NEEDS TO BE DEMOLISHED.

GRAFFITI IS ON 'SIDE LAUNDRY' THAT IS DILAPIDATED AND REQUIRES DEMOLITION.

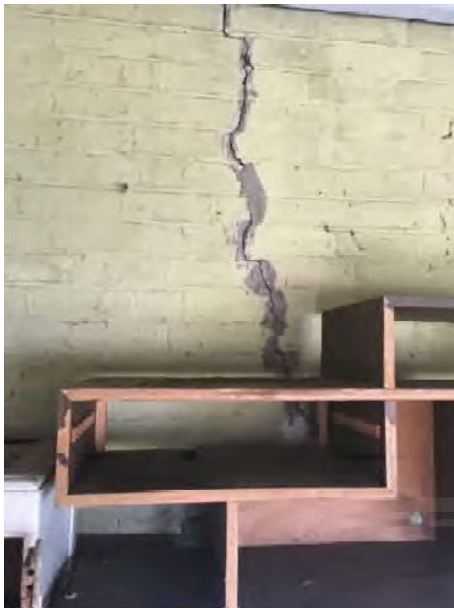
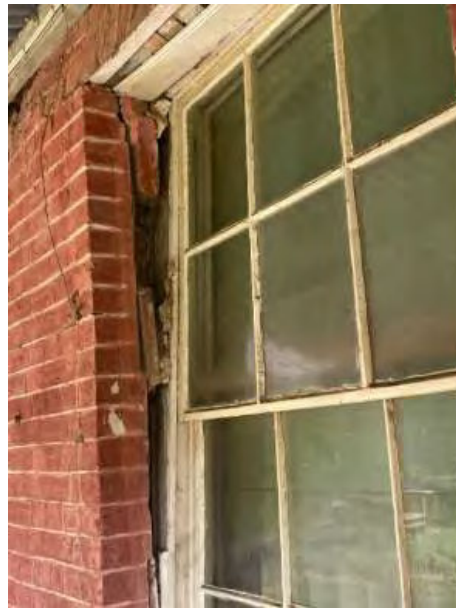
BOTTOM RIGHT – CRACK IN EXTERNAL WALL IN BATHROOM WINDOW ALONG EAST FAÇADE, (WHICH IS THE RIGHT WINDOW IN THE PHOTO ABOVE)

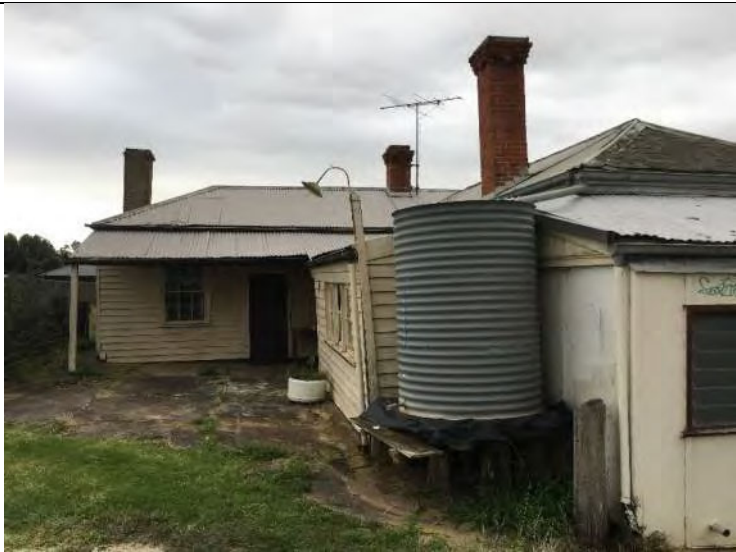
<p>4</p>

<p>VIEW OF SOUTHERN END OF HOUSE, PHOTO LOOKING WEST. SHOWS LEANING CHIMNEY TO KITCHEN IN FOREGROUND BEHIND THE WATER TANK, AND WONKY REAR LAUNDRY WALLS AND DILAPIDATED SOUTHERN AWNING ROOF. THE ENTIRE SOUTHERN END OF THE HOUSE IS UNFIXABLE AND NEEDS TO BE DEMOLISHED.</p>
<p>5</p>	 	<p>WEST EXTERNAL WALL - MASSIVE CRACK</p>

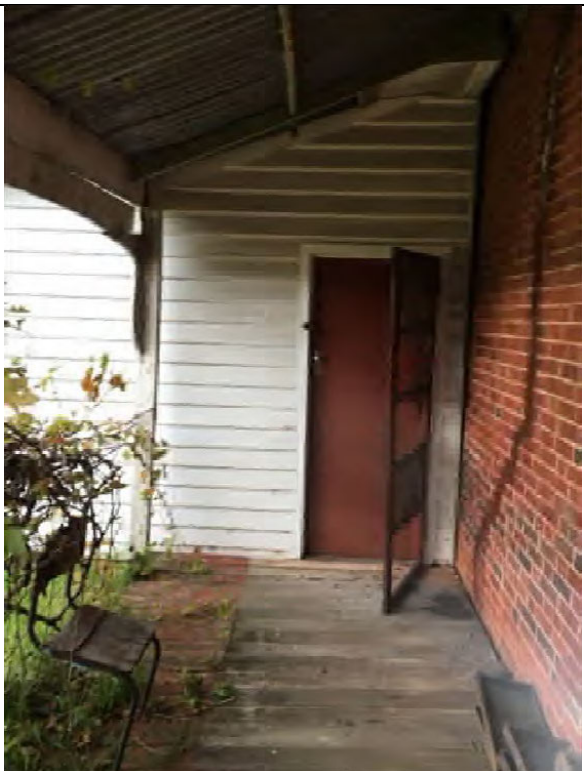
<p>6</p>

<p>WEST VERANDAH END POST AND BEAM GIVING WAY AND NEEDING REPLACEMENT, WITH BIG CRACK IN THE EXTERNAL MASONRY WALL OPPOSITE.</p>
<p>7</p>

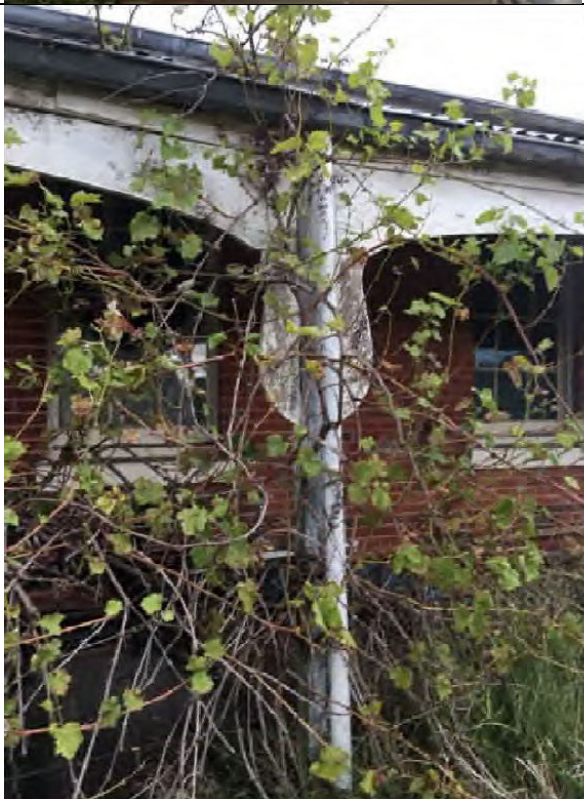
<p>WEST VERANDAH MIDDLE POST WITH CRACKED HEADER MEMBER, MOST PROBABLY REQUIRING FULL REPLACEMENT</p>

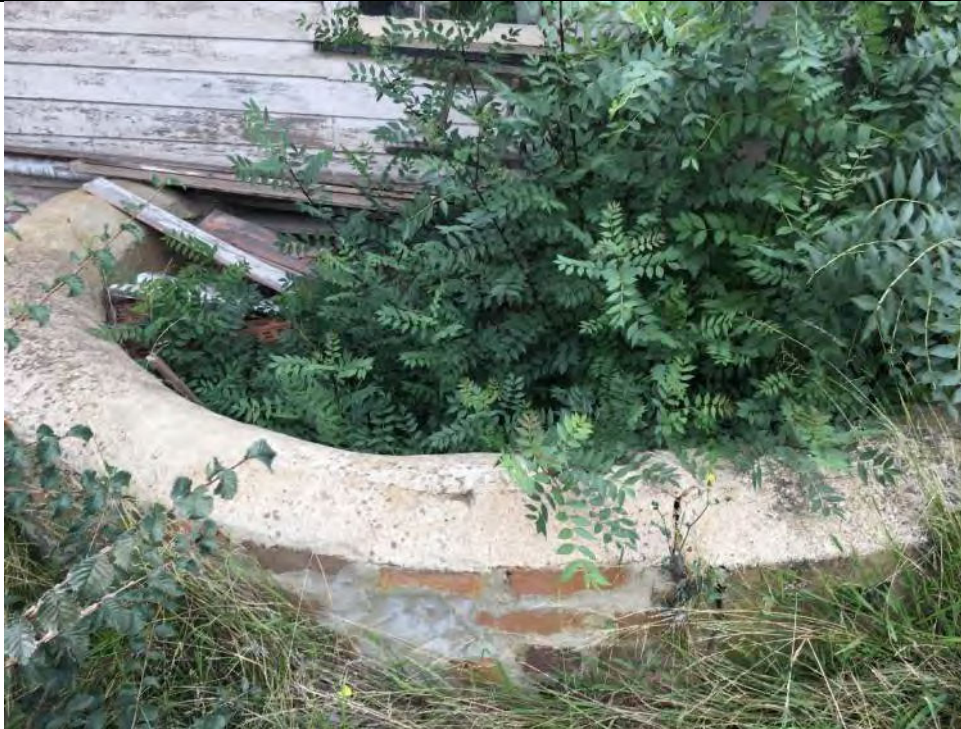
8

WELL TO WEST,
CRACKED. FILLED IN IN
THE 1960's. PROBABLY
BEST RIPPED OUT.

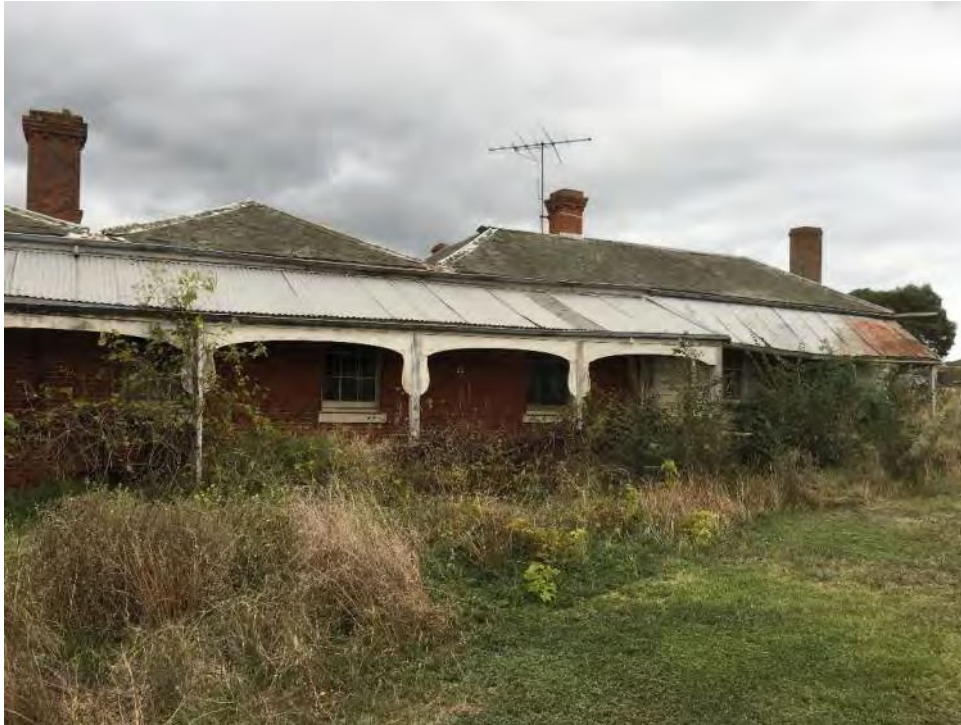
9

WEST VERANDAH –
REQUIRES REPAIR

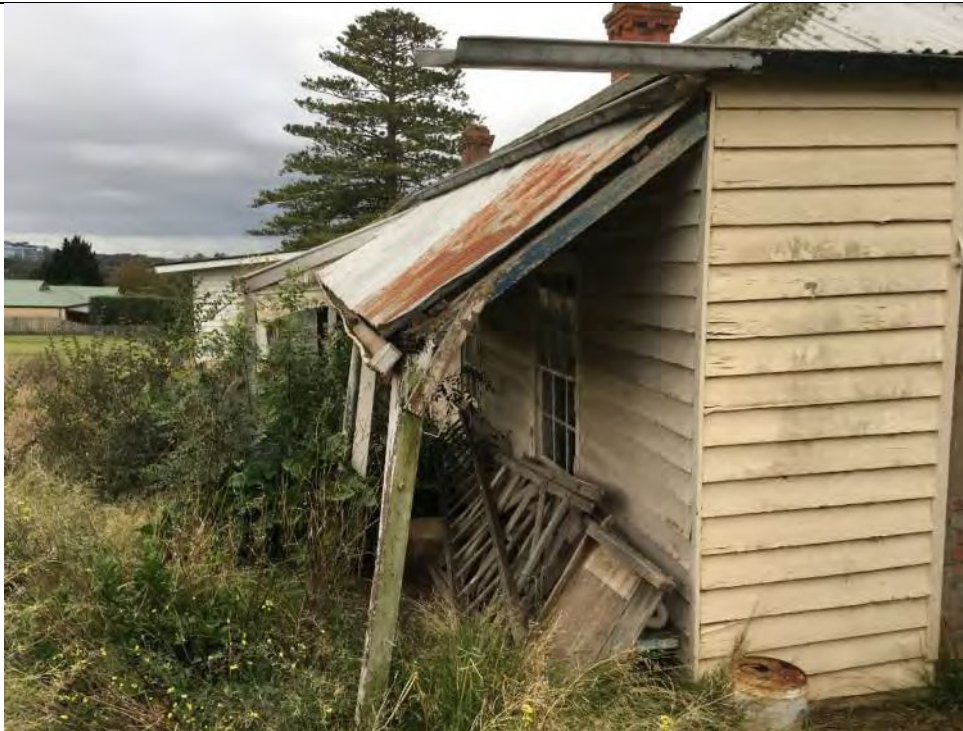
10

AWNING ROOF ALONGSIDE 'REAR KITCHEN' ON SW CORNER OF BUILDING. THIS AWNING, AND THE ENTIRE ROOM NEEDS TO BE DEMOLISHED, ALONG WITH SOUTH CHIMNEY.

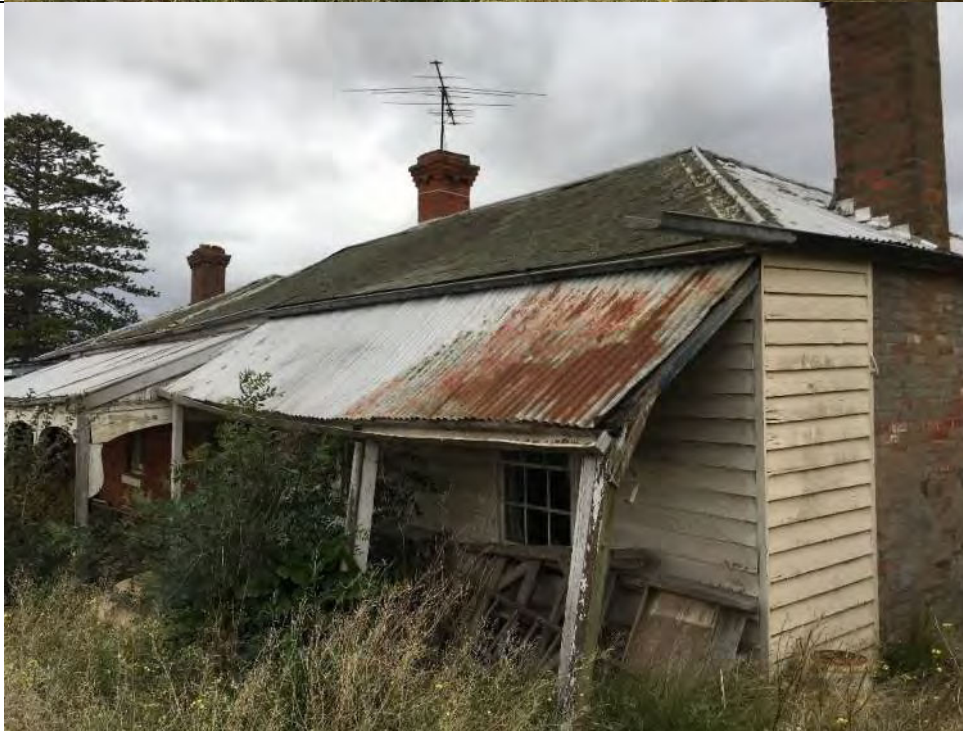
11

VIEW OF 'REAR KITCHEN' SHOWING SOUTH CHIMNEY, AWNING ROOF AND WATERBOARDS – ALL REQUIRE DEMOLITION.

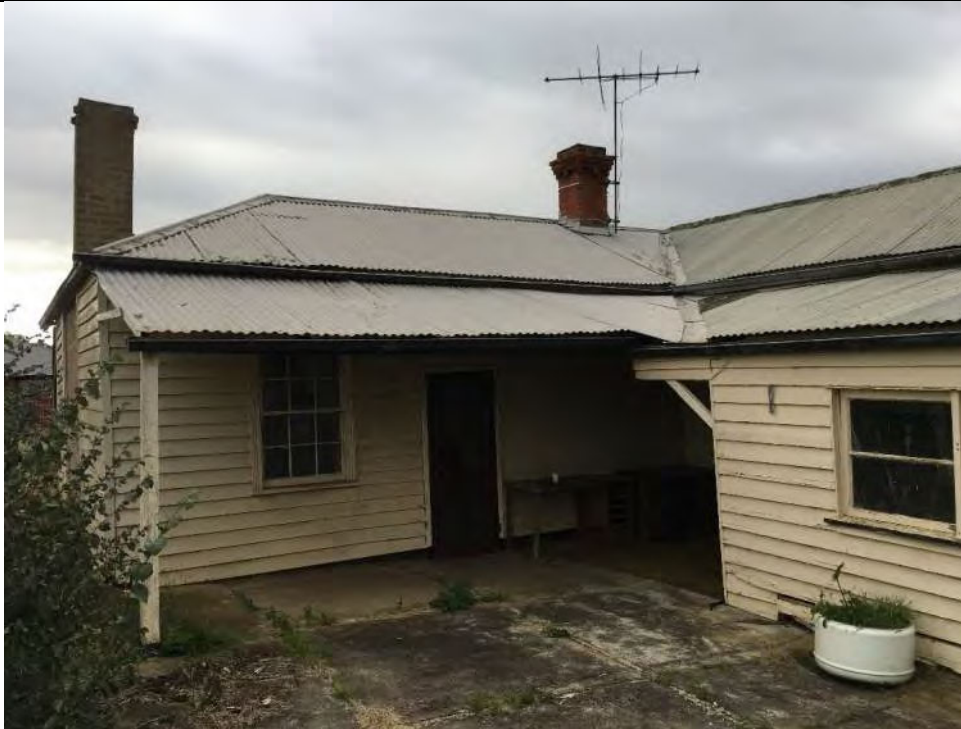
12

EAST FAÇADE OF 'REAR KITCHEN' WITH AWNING ROOF AND 'REAR LAUNDRY' TO RHS OF PHOTO. ALL ARE AT 'END-OF-LIFE' AND REQUIRE DEMOLITION, ALONG WITH ALL THE REAR CONCRETE PAVEMENT.

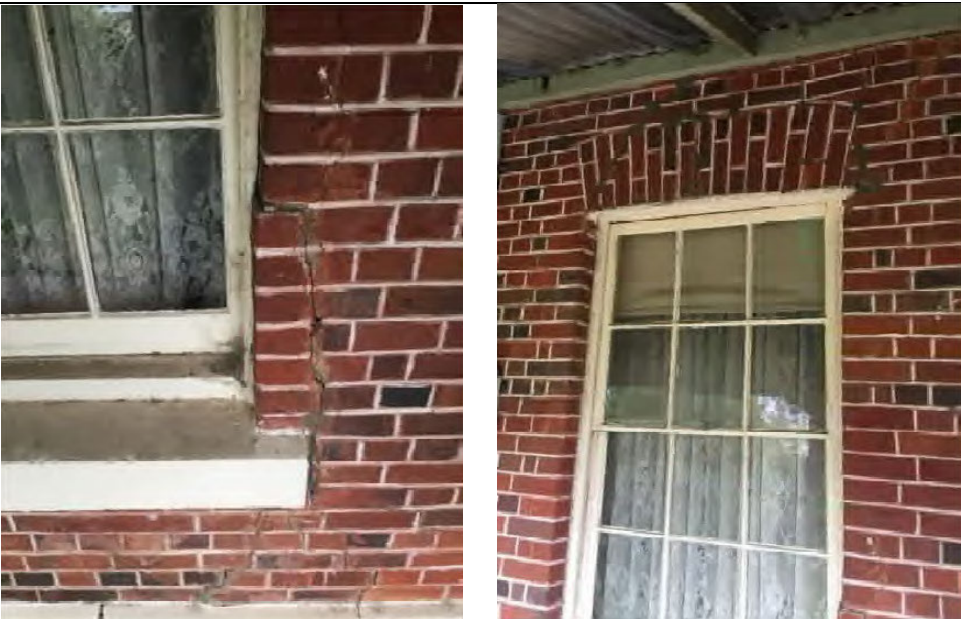
14

<p>WATER INGRESS AND ROTATING WALLS HAS CRACKED THE MASONRY THROUGH TO THE SIDE OF THIS WINDOW TO THE FRONT 'MAGENTA' ROOM (NW ROOM). THE CRACKING CONTINUES BELOW, AND THE WINDOW HEAD IS CRACKED. THIS ENTIRE SECTION OF WALLS REQUIRES REPLACEMENT.</p>
15

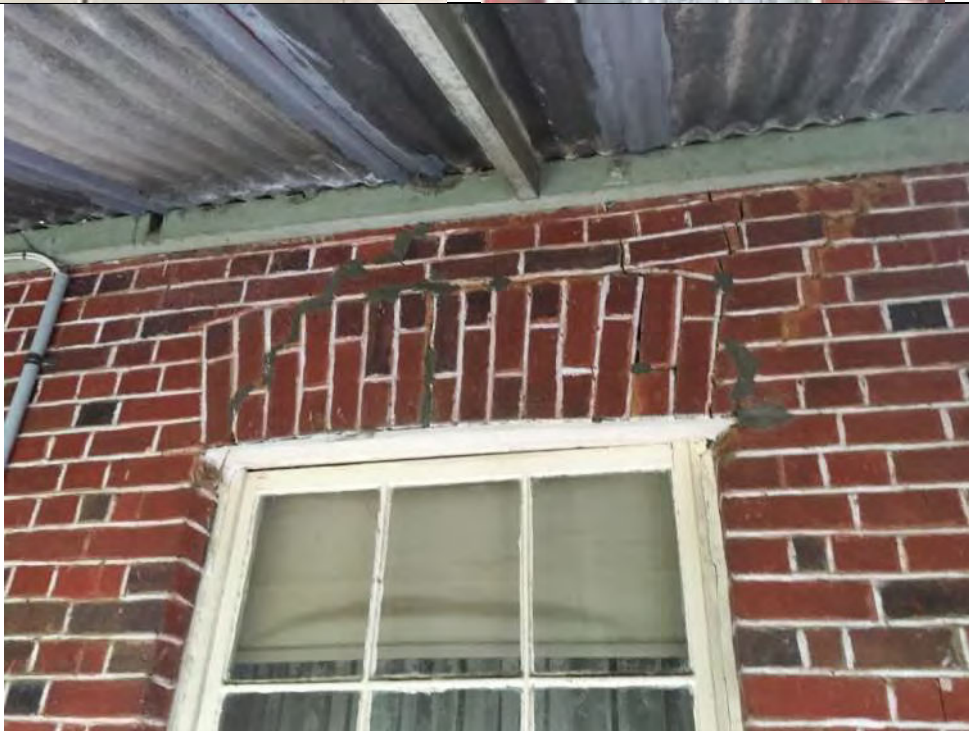
<p>WINDOW TO MAGENTA ROOM, NEXT TO CORRIDOR. MASONRY CRACKED THROUGH ABOVE WINDOW IN STATE OF COMPLETE DISREPAIR, CRACKED, BULGING AND UNFIXABLE. THE ENTIRE SECTION OF NORTH WALL, WEST OF THE CORRIDOR ENTRY DOOR NEEDS TO BE DEMOLISHED AND REPLACED.</p>

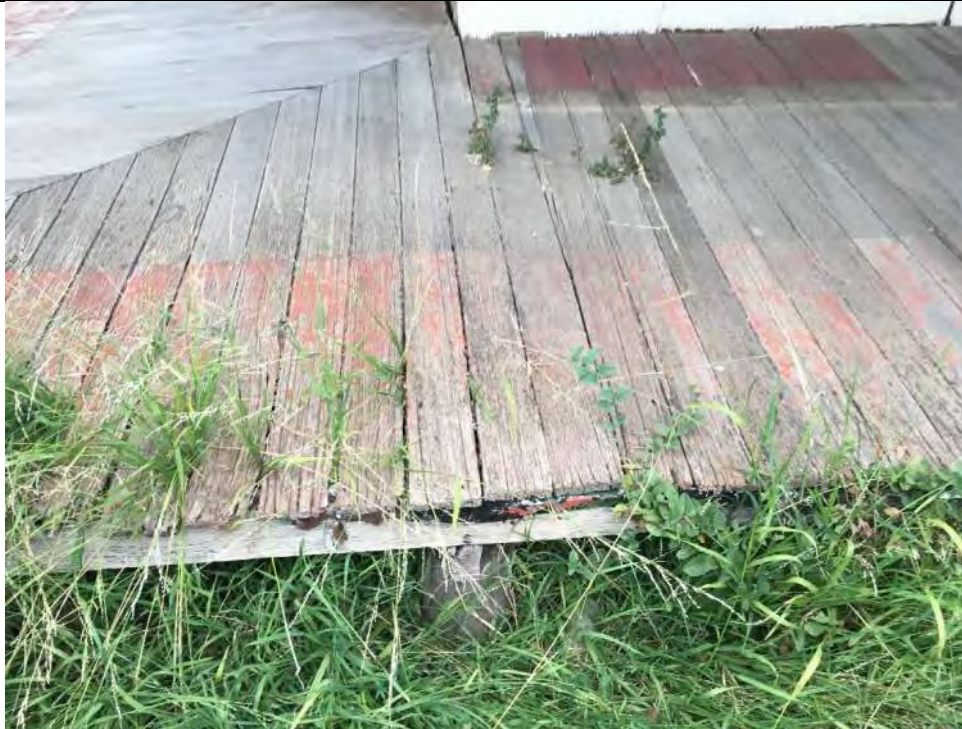
18

NE CORNER OF VERANDAH SHOWING ROTTED FLOORBOARDS AND EXTERNAL JOIST AND BEARER. THE VERANDAH REQUIRES FULL REPLACEMENT.

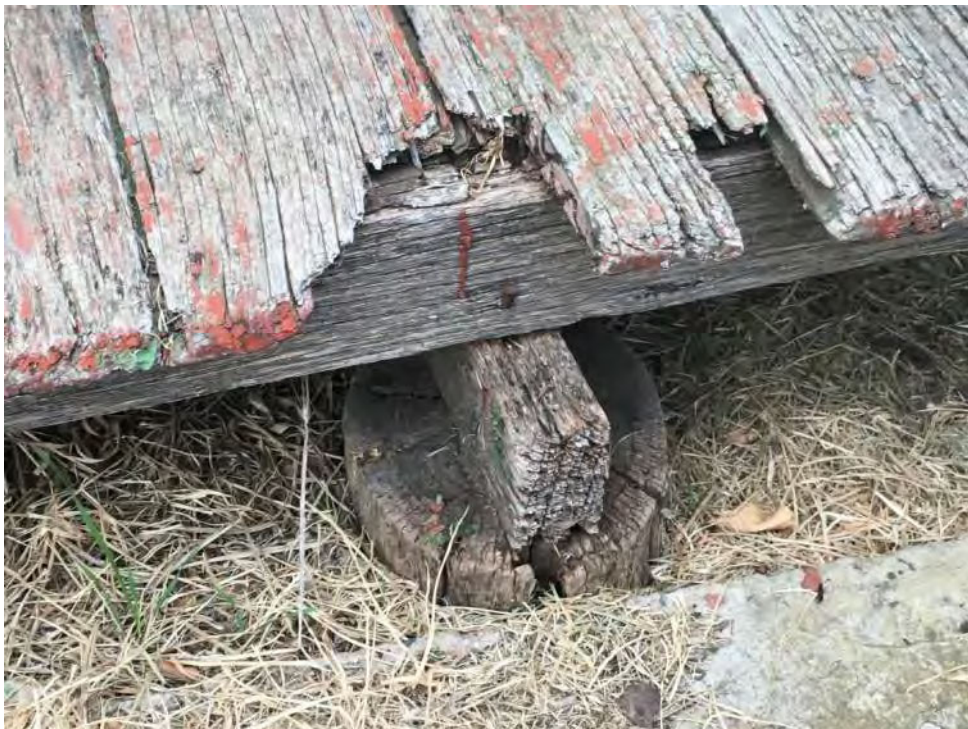
19

ANOTHER IMAGE OF THE ROTTED VERANDAH, ALSO IN THE NE CORNER OF THE HOUSE. THE BEARER IS SEATED ON A TREATED PINE STUMP EMBEDDED DIRECTLY INTO THE GROUND, PRESUMABLE WITHOUT A FOOTING, EXPLAINING WHY THE VERANDAH HAS DROPPED. IT IS BUILT TOO CLOSE TO THE GROUND EXPLAINING WHY ITS ALL ROTTED, ALSO DUE TO ITS AGE AND EXPOSURE TO WEATHER OVER 50+YRS.

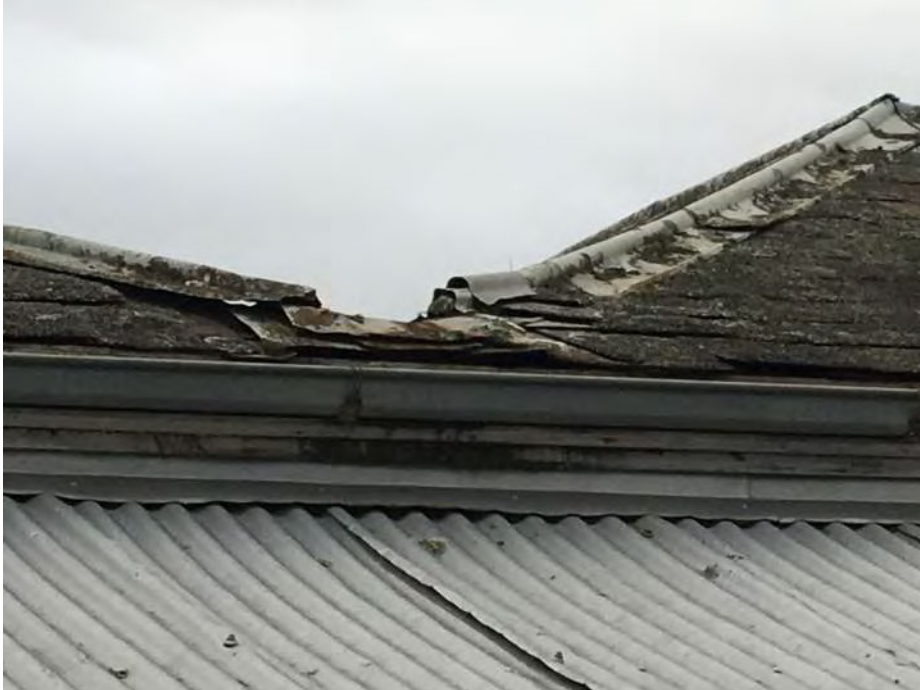
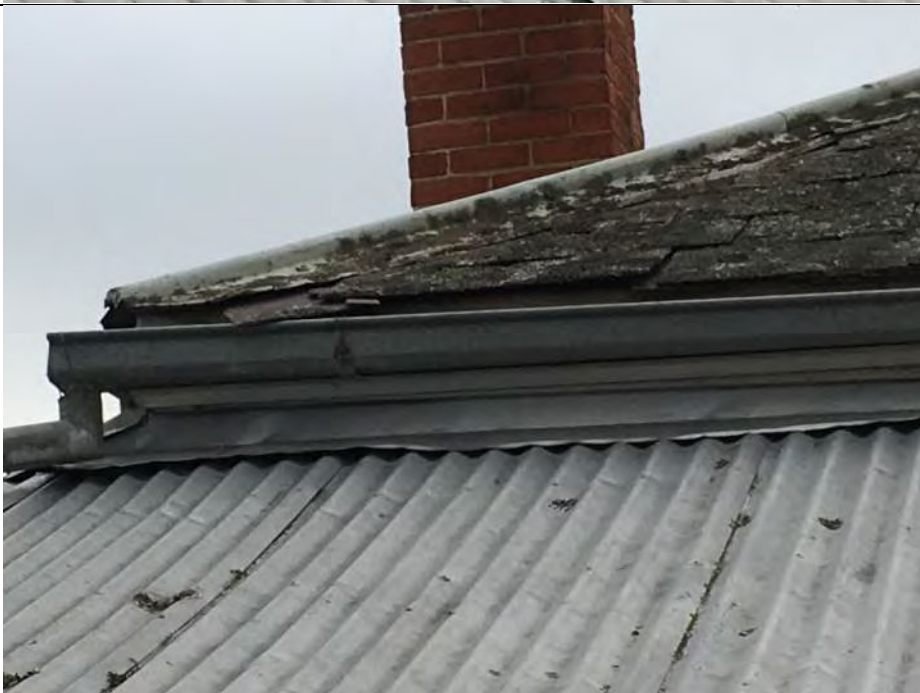
SLATE ROOF. REQUIRES FULL REPLACEMENT. ALL GUTTERS AND BOX GUTTERS ARE FAILING. THE ENTIRE ROOF NEEDS TO BE STRIPPED AND RECLAD. IT IS EXPECTED THAT THE EXSTING RAFTERS CAN LARGELY BE REUSED, BUT WILL REQUIRE OVERBATTENING WITH 140dp BATTENS TO CREATE DEPTH FOR BOX GUTTERS

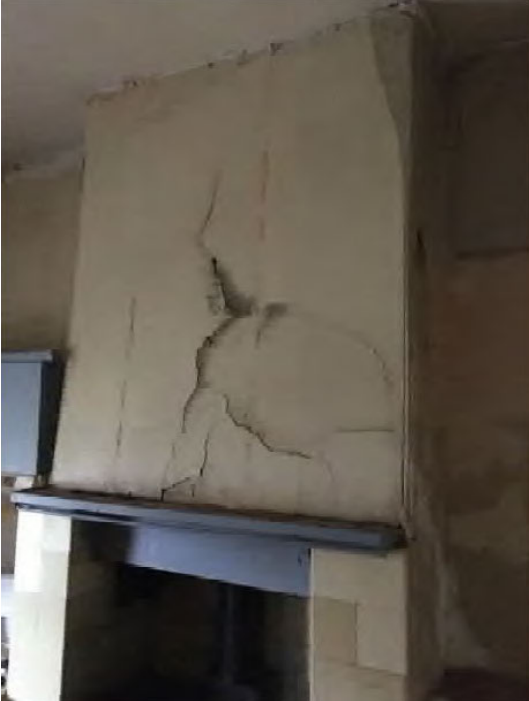
23

<p>MAIN KITCHEN CHIMNEY – CRACKS ARE TERRIBLE, CHIMNEY IS LEANING, ENTIRE WALL IS UNFIXABLE, AND CONSEQUENTLY NEEDS TO BE DEMOLISHED. ALL FOUR WALLS IN THE ORIGINAL KITCHEN ARE CONDEMNED.</p>
24

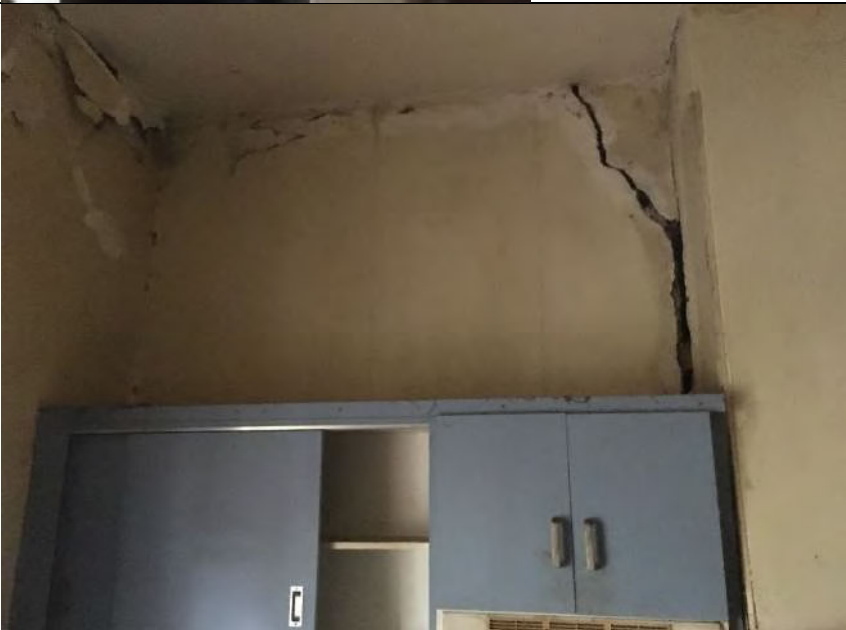
<p>THIS IS THE CRACK NEXT TO THE ORIGINAL KITCHEN FIREPLACE, WHICH ABUTS ONTO THE REAR LAUNDRY. THE ENTIRE ORIGINAL BRICK SOUTHERN WALL IS LEANING AND FAILING AND IN A STATE OF TOTAL DISREPAIR. IT IS CONDEMNED AND MUST BE DEMOLISHED FOR SAFETY'S SALES. ALL THE WALLS ARE MOULDY AND DISGUSTING.</p>

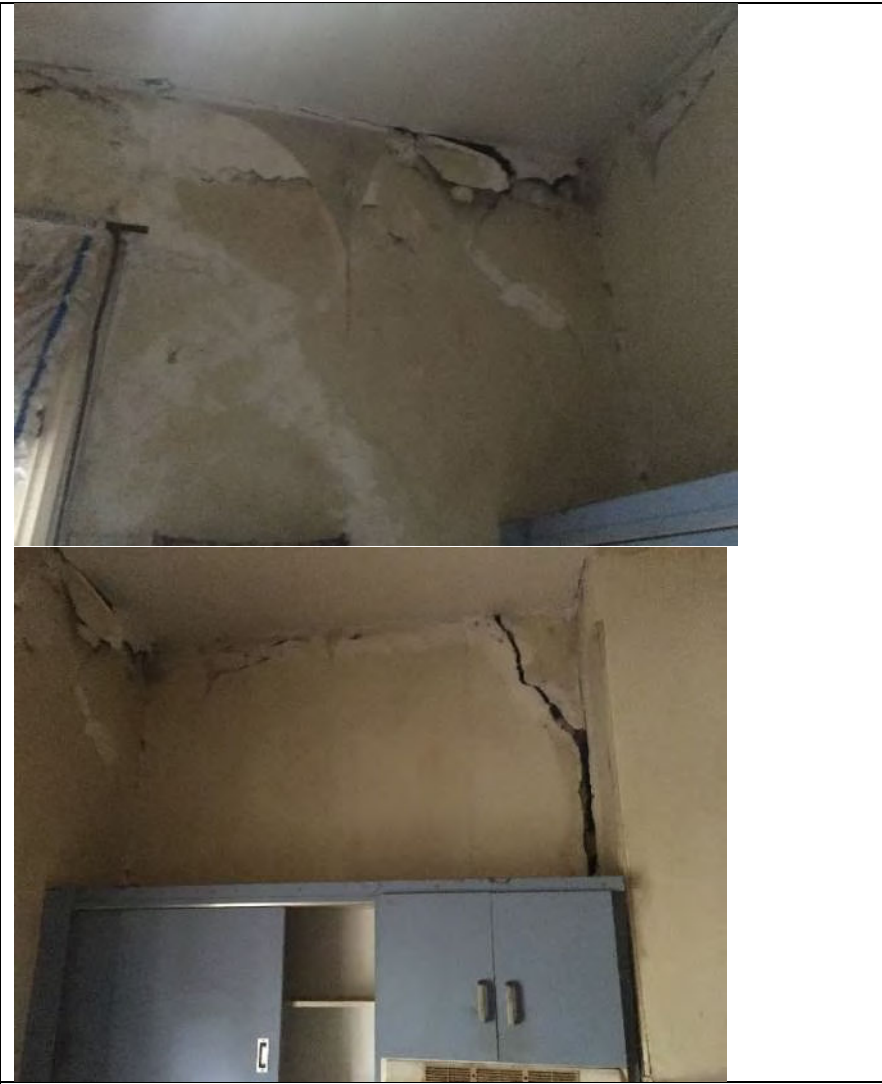
<p>25</p>

<p>TOP – SE CORNER OF KITCHEN IN ALL ITS GLORY. CLEARLY THE ENTIRE ROOM NEEDS TO BE STRIPPED OF ITS RENDER, AND DUE TO THE CRACKING IN THE WALL, THE WALLS THEMSELVES NEED TO BE PULLED DOWN.</p> <p>FOR EXAMPLE, SEE THE CRACK EAST OF KITCHEN CHIMNEY (BELOW). THIS ENTIRE WALL IS LEANING AND IN A HORRIBLE STATE. THE ENTIRE WALL AND CHIMNEY IS CONDEMNED.</p>
<p>26</p>

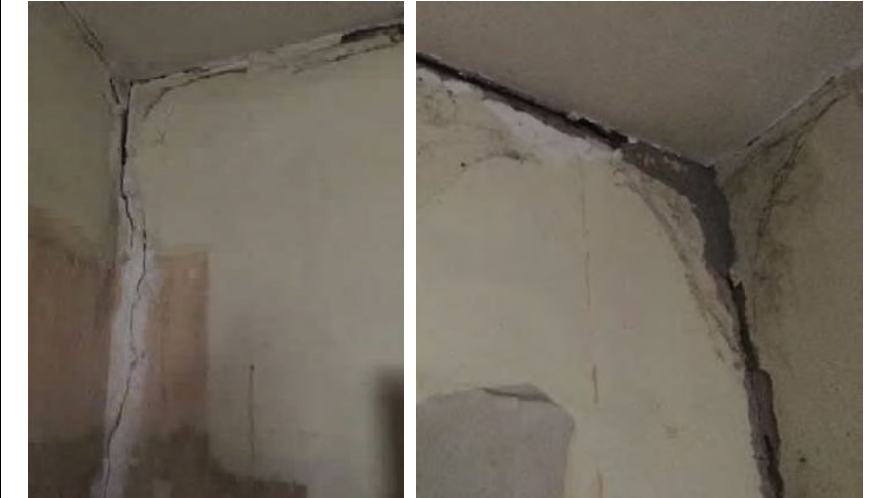
<p>LEFT - THIS IS THE SW CORNER OF THE KITCHEN. WALL IN TERRIBLE CONDITION. ALONG WITH ENTIRE ROOM, CONDEMNED</p> <p>RIGHT - THIS IS EQUALLY HORRIBLE CONDITION OF NW CORNER WALL OF THE KITCHEN. ALL FOUR WALLS IN THE KITCHEN ARE CONDEMNED. (SEE CRACK ABOVE BATH, WHICH IS THE KITCHEN NORTH WALL!)</p>

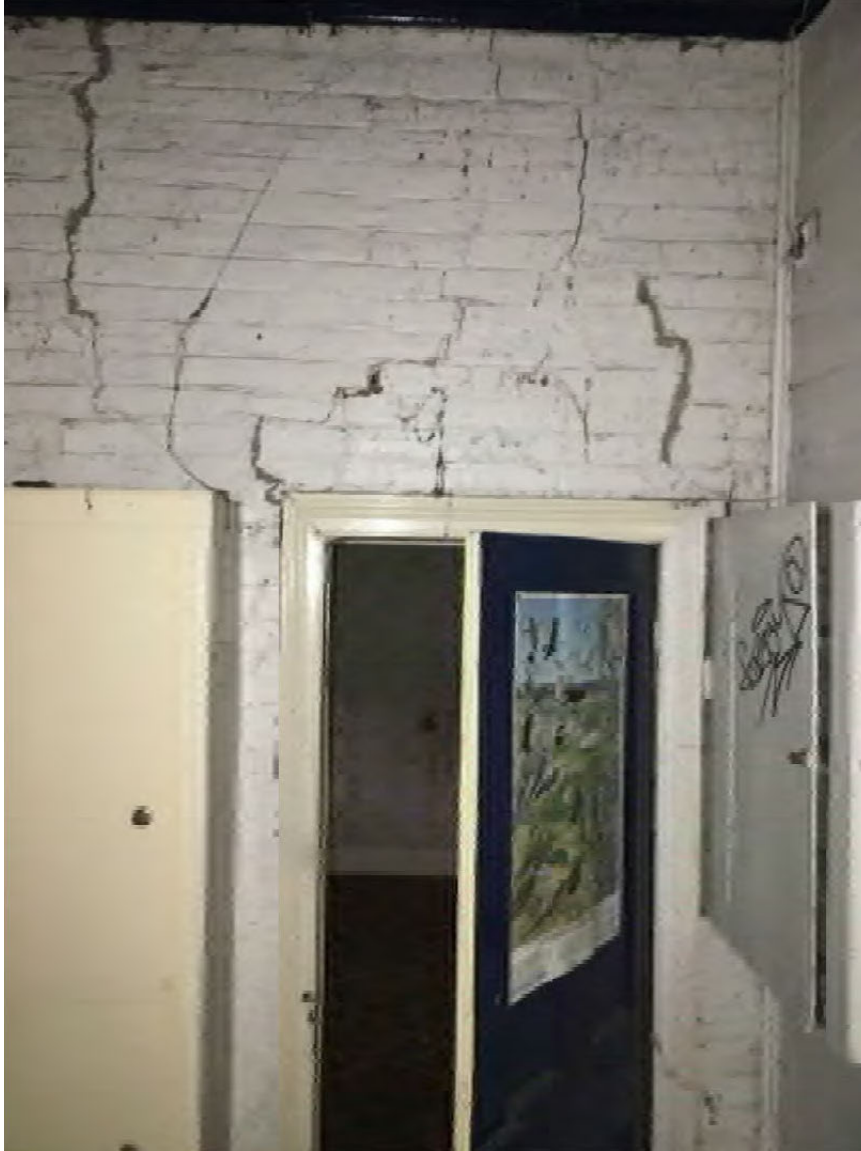
27

THIS IS THE 'NEW KITCHEN' ENTRY, WHICH IS THE ORIGINAL SOUTHERN WALL OF THE HOUSE. THE CRACKS ARE RIGHT THROUGH AND UNREPAIRABLE. THIS SOUTHERN WALL (WHICH JOINS ACROSS THE CORRIDOR TO THE SOUTHERN WALL IN THE ORIGINAL KITCHEN, IS UNFIXABLE AND MUST BE DEMOLISHED. IT IS CLEARLY UNSAFE AND IN AWFUL CONDITION.

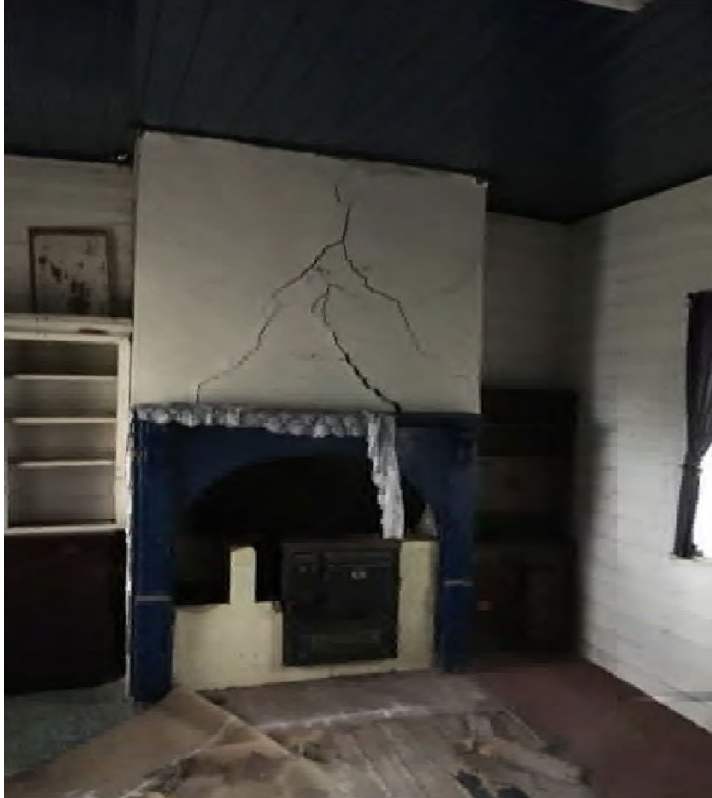
<p>28</p>

<p>THIS IS THE 'EXTENSION' SECOND KITCHEN MADE BECAUSE BACK IN THE DAY, MUM COULDN'T SHARE WITH GRANDMA AND NEEDED HER OWN.</p> <p>THE SOUTHERN CHIMNEY IS CRACKED THROUGH & LEANING. THIS CHIMNEY IS CONDEMNED. THE FLOOR HAS DRY-ROT AND NEEDS TO BE TOTALLY RIPPED UP. ALL THE STUD WALLS ARE LEANING AND IN A BACK STATE & ALSO NEED TO BE DEMOLISHED. SO THE 'SECOND KITCHEN' IS TOTALLY DILAPIDATED AND REQUIRES FULL DEMOLITION, ALONG WITH THE ADJOINING AWNING TO THE WEST WHICH HAS COLLAPSED, AND THE AWNING TO THE BACK DOOR/LANDRY WHICH IS PAST ITS END-OF-LIFE.</p>
<p>29</p>

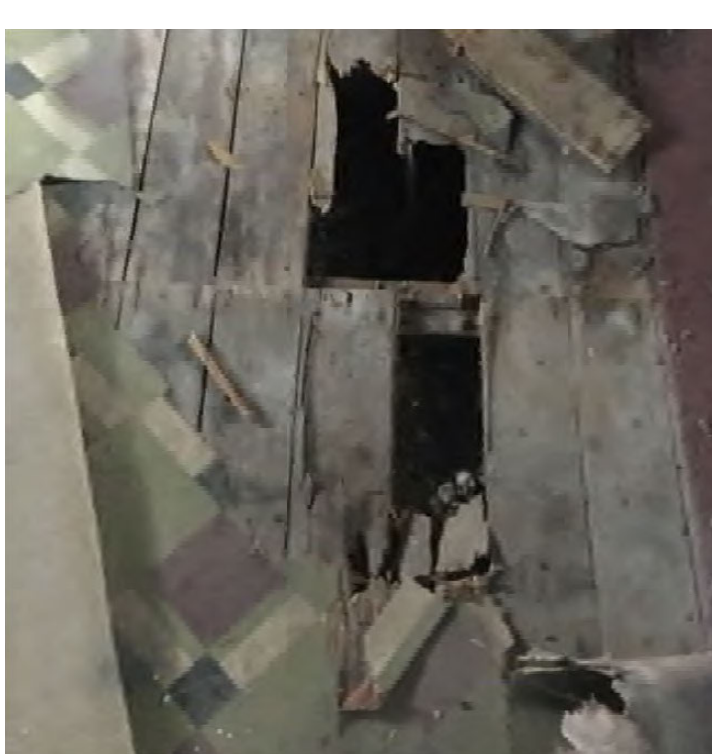
<p>THIS PHOTO SHOWS THE DRY-ROT IN THE FLOOR, THAT HAS BEARERS IN CONTACT WITH THE GROUND WITH GRAVEL BETWEEN THE BEARERS. THE FLOORBOARDS ARE TOTALLY GONE AND YOU CAN STOMP THROUGH THEM. THE ENTIRE ROOM IS A SAFETY RISK, ESPECIALLY THE CHIMNEY THAT IS FALLING OVER.</p>

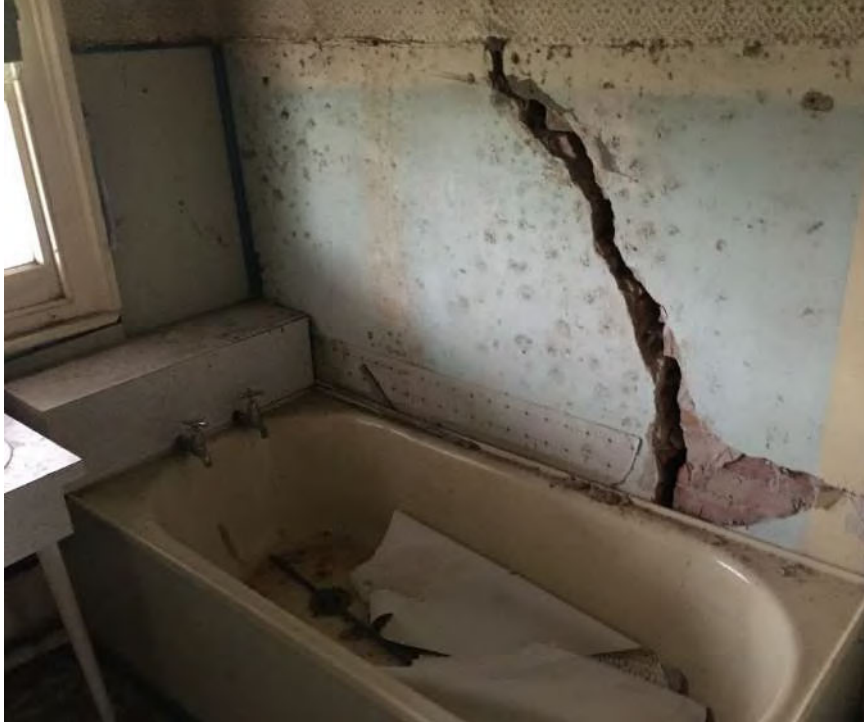
30

THIS IS THE MOST HORRIFIC CRACK IN THE HOUSE – DIRECTLY ABOVE THE BATH!! BACKING ONTO THE KITCHEN (EG THE KITCHEN NORTH WALL). THIS IS DISASTEROUS. THIS ENTIRE WALL IS CONDEMNED AND MUST BE DEMOLISHED. IT IS UNBELIEVABLE!

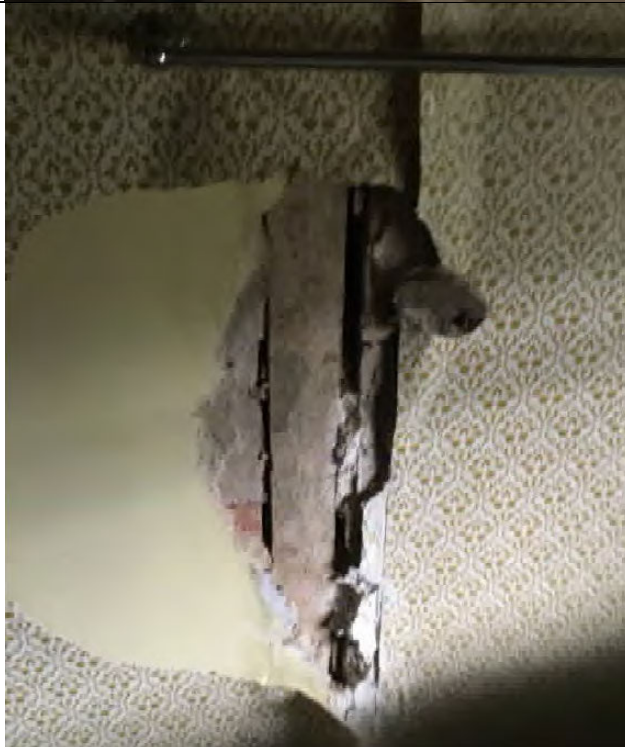
31

THIS IS VERTICAL CRACKING IN THE WALL OPPOSITE THE BATH, CAUSED BY A TIMBER POST EMBEDDED IN THE MASONRY WALL. THIS IS AN EXAMPLE OF AN INTERNAL MASONRY WALL THAT REALLY SHOULD BE REMOVED AND REPLACED WITH A NEW INTERNAL STUD WALL, WITH THE ROOF TIMBERS COMPLETELY PROPPED DURING THE WORKS.

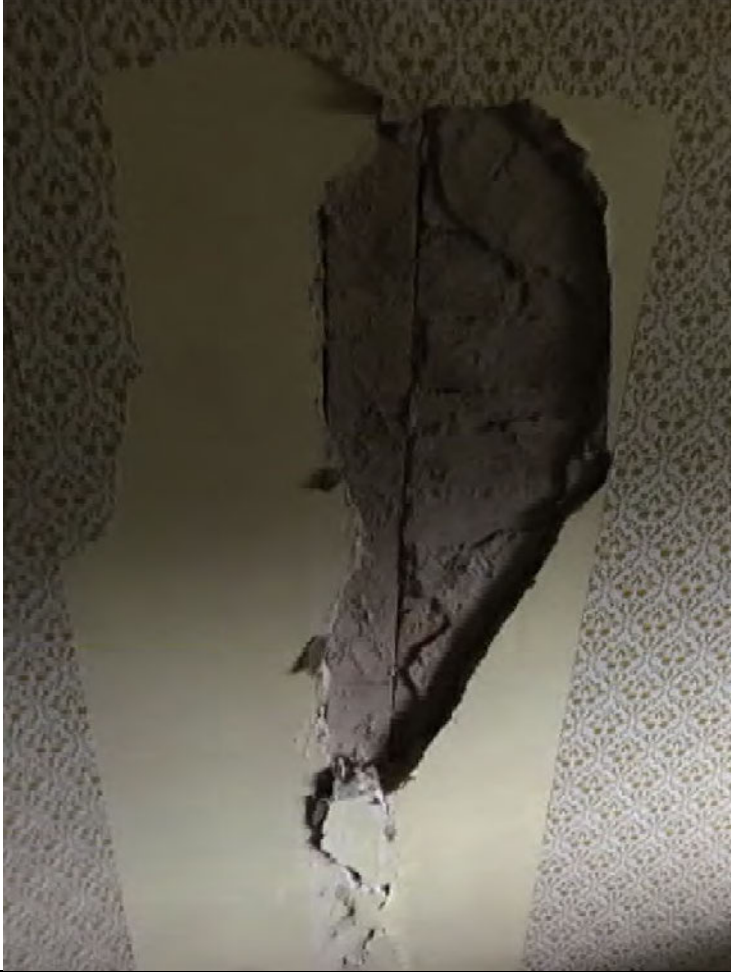
32

THIS CRACK IS ALSO IN THE BATHROOM NORTH WALL. DITTO ABOVE. THE HORRIBLE FLAKEY RENDER OVER THE BRICKS IS APPARENT.
----	--	---

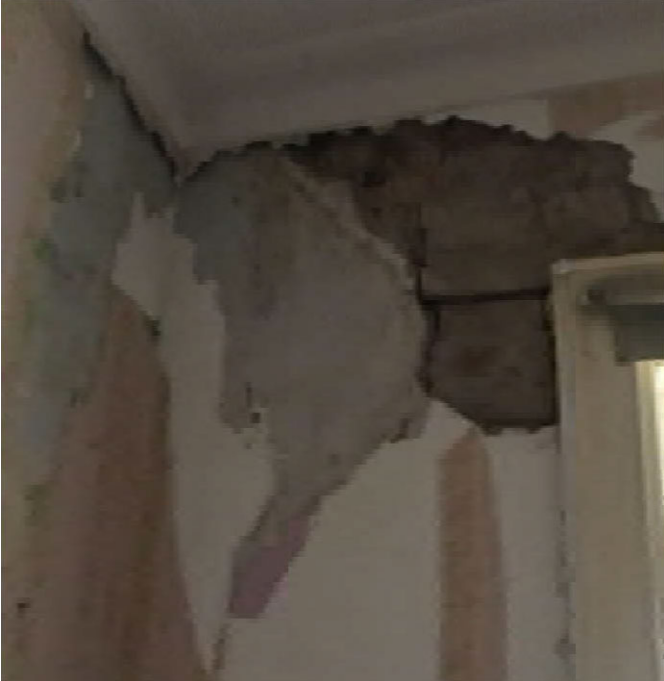
33

<p>THIS IS TYPICAL CRACK IN THE MASONRY EXTENRAL WALLS TO THE CORNERS OF WINDOWS. MOST WINDOWS SUFFER FROM SIMILAR CRACKS, WHICH SHOWCASES WHY THE EXTERNAL MASONRY WALLS REQUIRE DEMOLITION.</p>
34

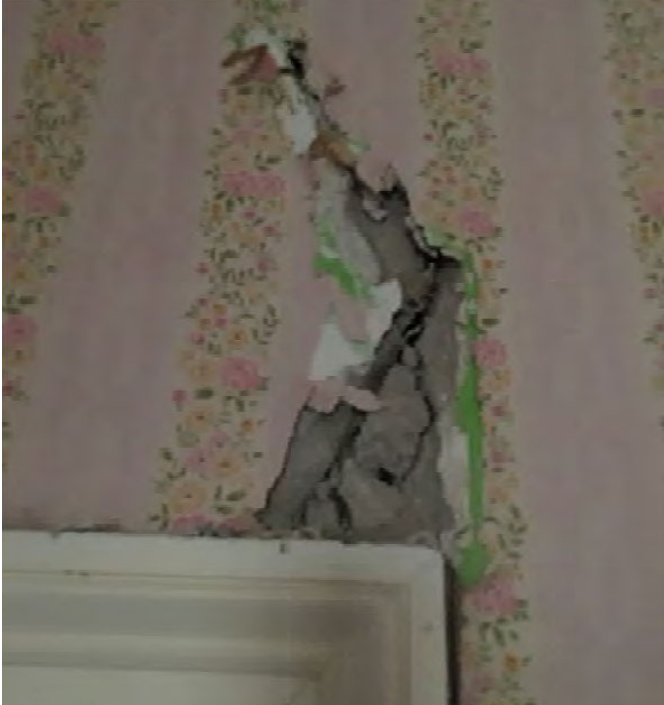
<p>THIS IS THE CRACK IN THE OTHER SIDE OF THE SAME EXTERNAL WINDOW AS ABOVE. THE DUSTY FLAKEY RENDER IS EXPOSED.</p>

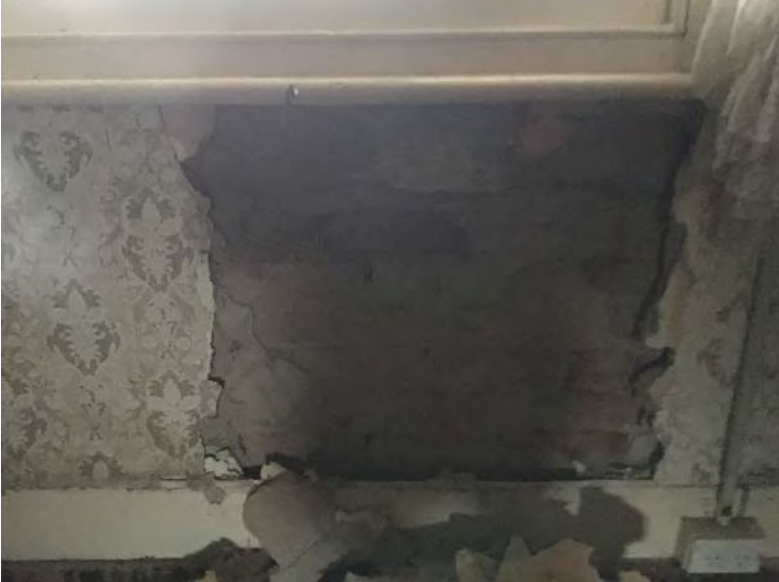
35

<p>THIS PHOTO IS A TYPICAL SILL UNDER A WINDOW, WITH CRACKS THROUGH THE BRICKS THAT HAS DIRECT SANDY RENDER OVER. THERE IS NO CAVITY TO THE EXTERNAL MASONRY, NO AIR-GAP, AND HENCE THE ENTIRE HOUSE HAS MOISTURE COMING THROUGH THE WALLS (AND ROOF) AND IS MUSTY.</p>
36	 	<p>WE ARE NOW LOOKING AT THE T-INTERSECTION OF INTERNAL 110mm BRICK WALLS, THAT ARE MADE UP AGAINST THE EXTERNAL WALLS, WITHOUT KEYING IN, SO THAT NEITHER WALL GAINS STRENGTH BY BEING INTEGRATED, ALLOWING THE EXTERNAL WALLS TO DELAMINATE AND LEAN OUTWARDS TYPICALLY 30-50mm></p>
