CLAREMONT HOUSE

12-16 KINSMEAD STREET, VAURN PONDS VIC 3216
STRUCTURAL CONDITION ASSESSEMENT REPORT

ST_REPORT_001

RE Structural Assessment of Claremont Homestead, 8-12 Kinsmead Street, Waurnd Ponds Geelong VIC 3216

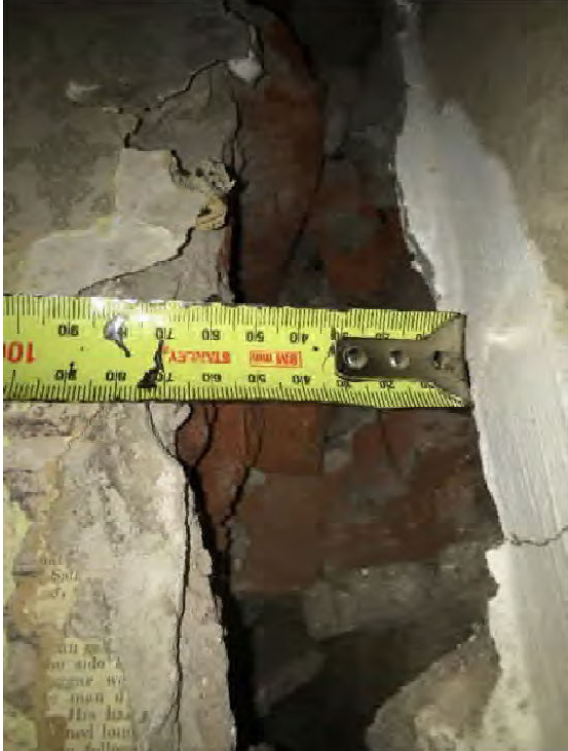
<p>37</p>

<p>EXTERNAL WALL THAT HAS MOVED 50 - 60mm OUT FROM THE INTERNAL WALL AT THEIR 'JOIN' LINE.</p>
<p>38</p>

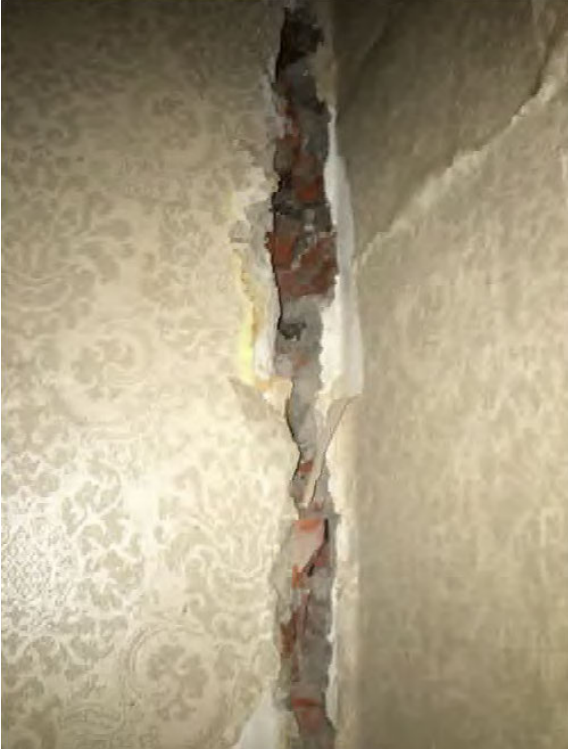
<p>THIS SAME WALL, LOOKING AT THE AMOUNT OF MOVEMENT. THE DUST THAT FALLS OUT OF THESE WALLS UPON RIPPING THROUGH THE WALLPAPER AND RENDER AND EXPOSING THESE GAPS IS ASTONISHING.</p>

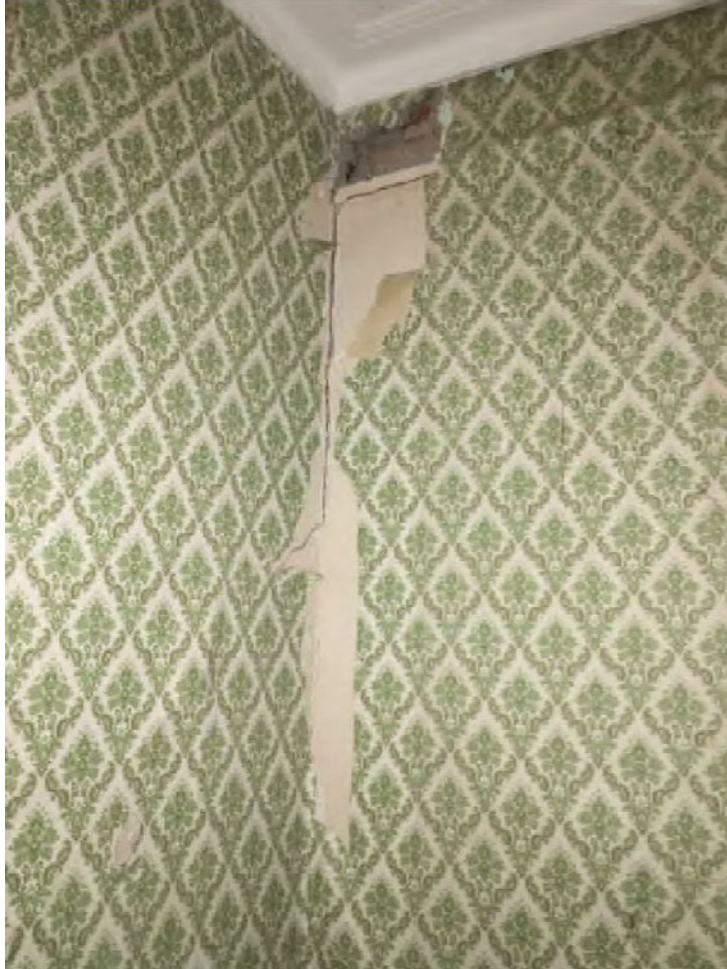
39

ANOTHER CRACK, THIS TIME IN AN INTERNAL INTERSECTION WITH THE CORRIDOR WALL. NOTE THAT ONLY A SMALL PART OF THE WALL PAPER WAS REMOVED DURING THE INSPECTOIN, HOWEVER CRACKS LIKE THIS WERE SEEN IN ALMOST EVERY INSTANCE, AND IF THE WALLS WERE FULLY EXPOSED, IT IS EXPECTED THAT THEIR WOULD BE CRACKS EVERYWHERE.

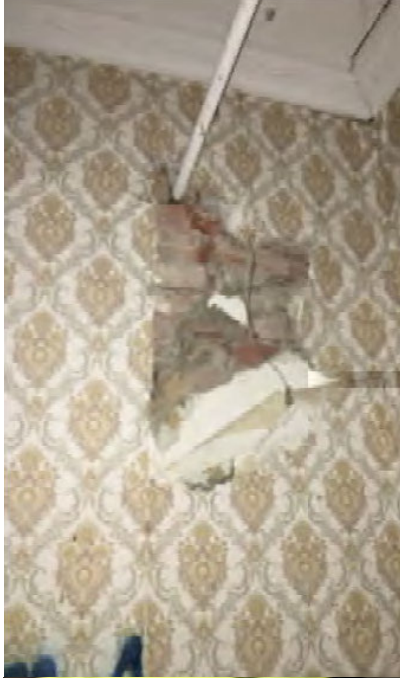
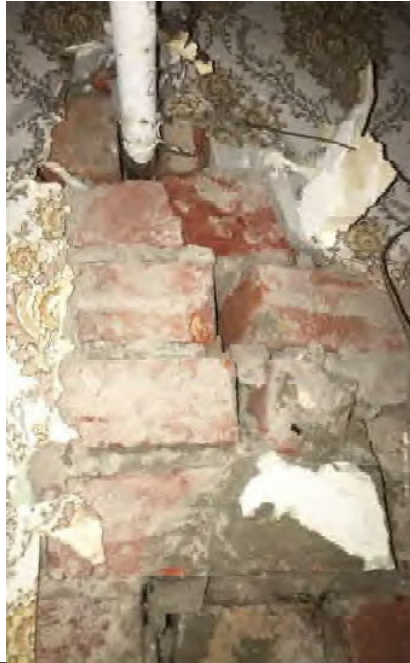
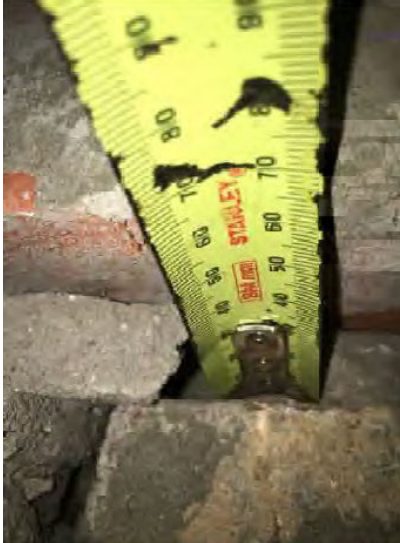
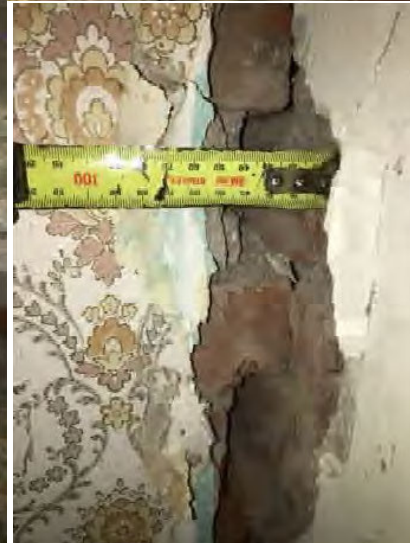
40-43

THIS IS A PARTICULARLY NOTICEABLE DEFECT. THERE IS AN INCH-DIAMETER STEEL ROD ACTING AS A LATERAL TIE ACROSS THIS BEDROOM (SECOND IN FROM NE) AS OPPOSED TO THE ROD HAVING PULLED ON THE WALL, I BELIEVE WHAT HAS ACTUALLY HAPPENED IS THAT THE ENTIRE EAST WALL HAS FALLEN OUTWARDS BY 50mm AND ONLY THE BRICKS CONNECTED TO THE ROD (AND ITS END PLATE) REMAIN IN THEIR ORIGINAL POSITION.

BOTTOM LEFT – 50mm DISLODGE­MENT. THIS IS WAS THE INCH-DIAMETER ROD CONNECTION TO THE EAST EXTERNAL WALL LOOKS LIKE BEHIND THE WALLPAPER.

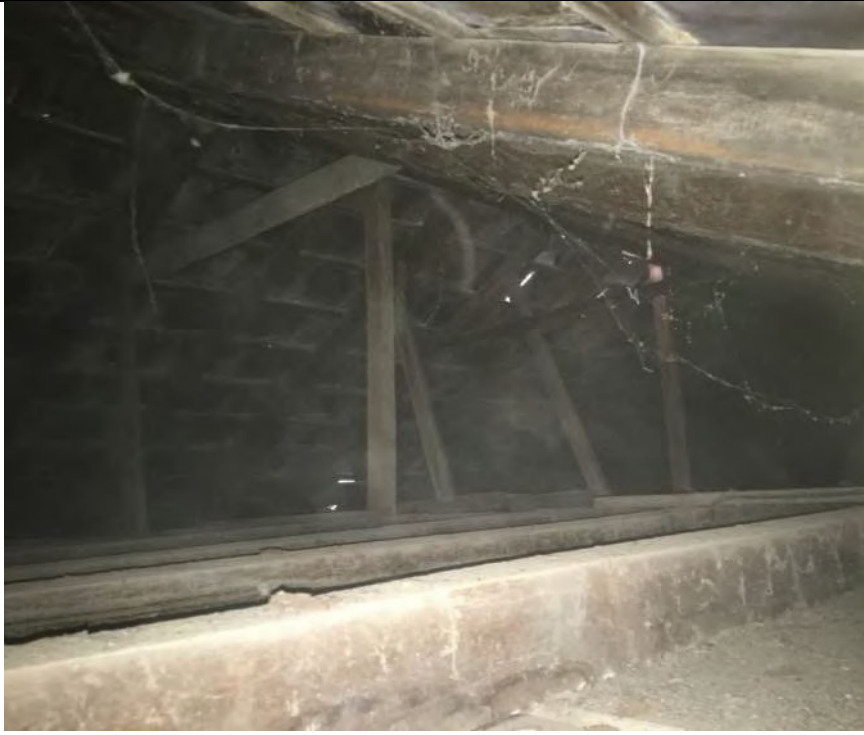
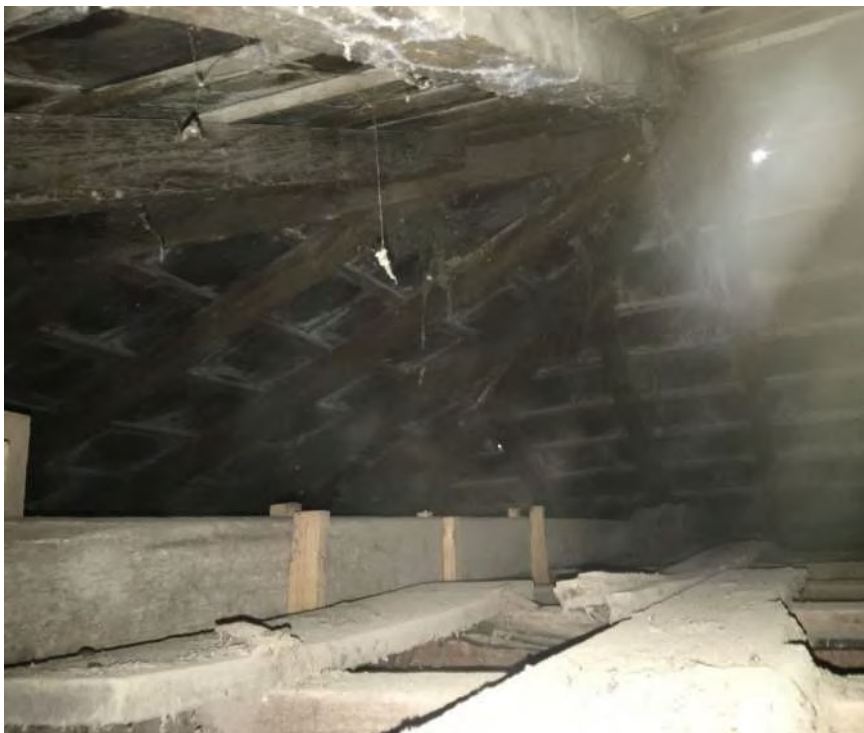
44

THE MASONITE CEILING WAS PULLED DOWN TO ALLOW FOR AN INSPECTION INTO THE ROOF CAVITY. THE TIMBERS ARE MOSTLY DRY AND REUSABLE. THERE IS 1cm OF DUST ON THE CEILINGS THAT NEEDS TO BE VACUUMED OUT. THERE IS ROTTED TIMBERS ALONGSIDE THE BOX GUTTERS.

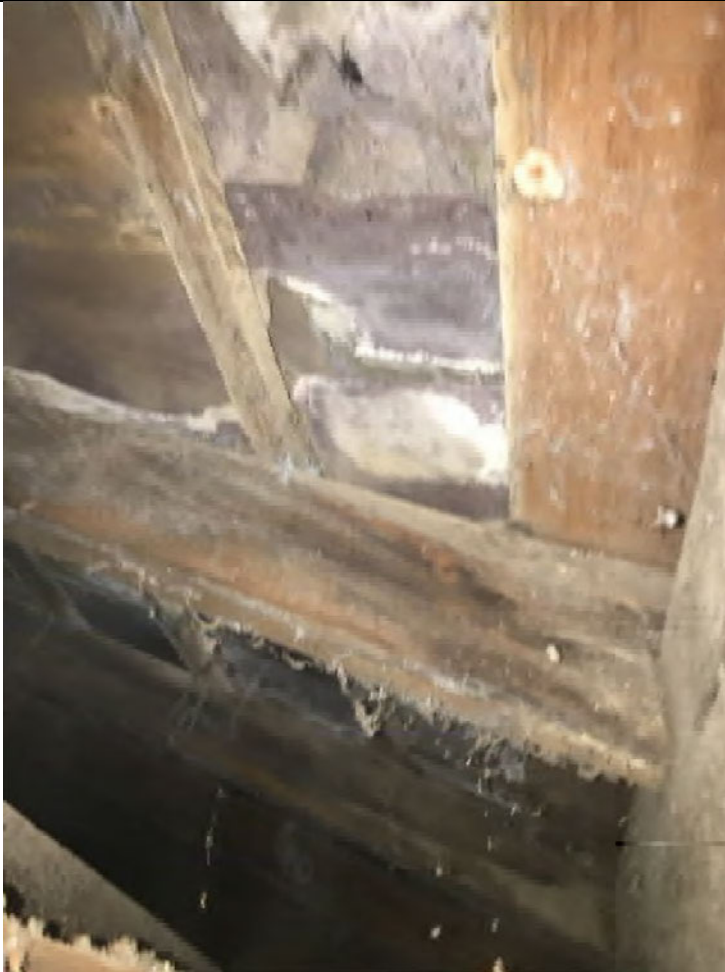
45

THIS PHOTO SHOWS 40X20
BATTENS OVER 100x##
RAFTERS AT ## CENTRES,
WITH A BARGEBOARD TO
THE GUTTER THAT IS
ROTTED.

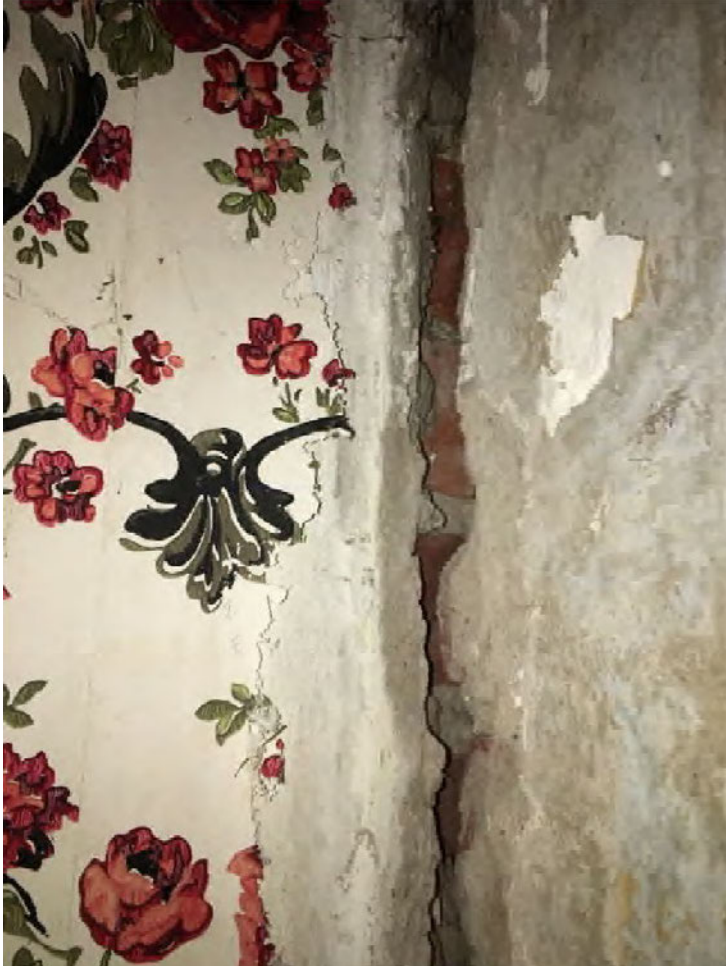
46

HERE IS ANOTHER EXAMPLE OF THE EXTERNAL WALL HAVING PULLED 30mm AWAY FROM THE INTERNAL WALLS.

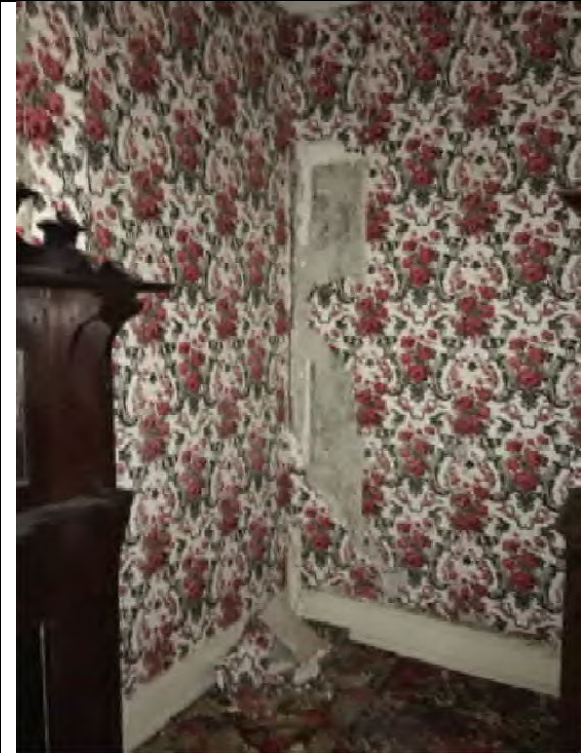
<p>47</p>

<p>AND OTHER, IN THE MAGENTA FROM NW ROOM (SET UP LIKE A STUDY).</p>
<p>48</p>

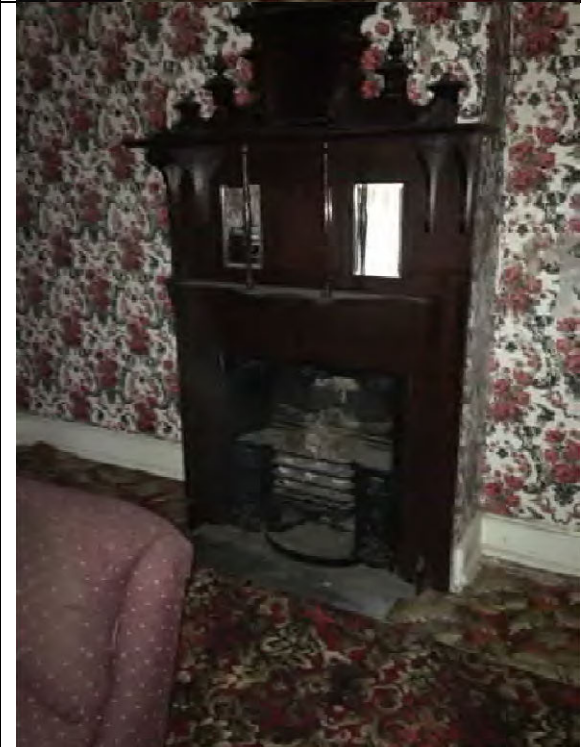
<p>FIREPLACE IN THE CRIMSON ROOM, WHICH SEEMS OKAY. (BACKS UP WITH PHOTO ABOVE)</p>

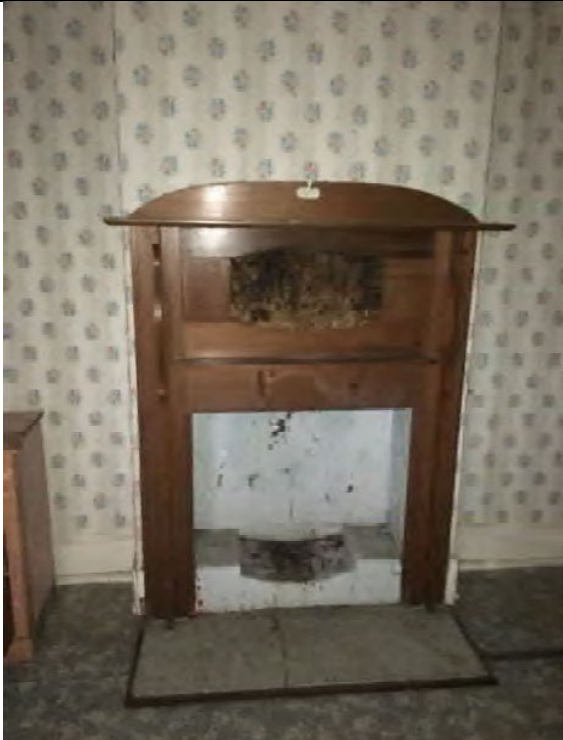
<p>49</p>

<p>BED 2 - HERE IS A HAPPY PHOTO OF ONE OF THE FRONT CHIMNEYS (THAT BACKS ONTO THE CRIMSON ROOM (FRONT NW) THAT APPEARS TO BE RELATIVELY UNCRACKED AND ABLE TO BE SALVAGED.</p>
<p>50</p>

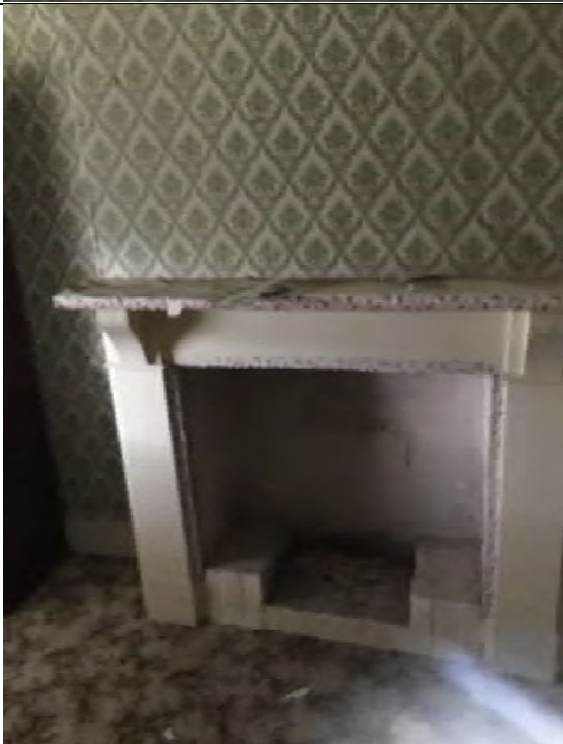
<p>BED 3 - HERE IS ANOTHER FIREPLACE (IN THE FRONT NE ROOM) THAT DOESN'T SEEM TO BE CRACKED AND IS VISIBLY STILL VERTICAL ABOVE ROOF LEVEL, AND SO CAN BE RETAINED.</p>

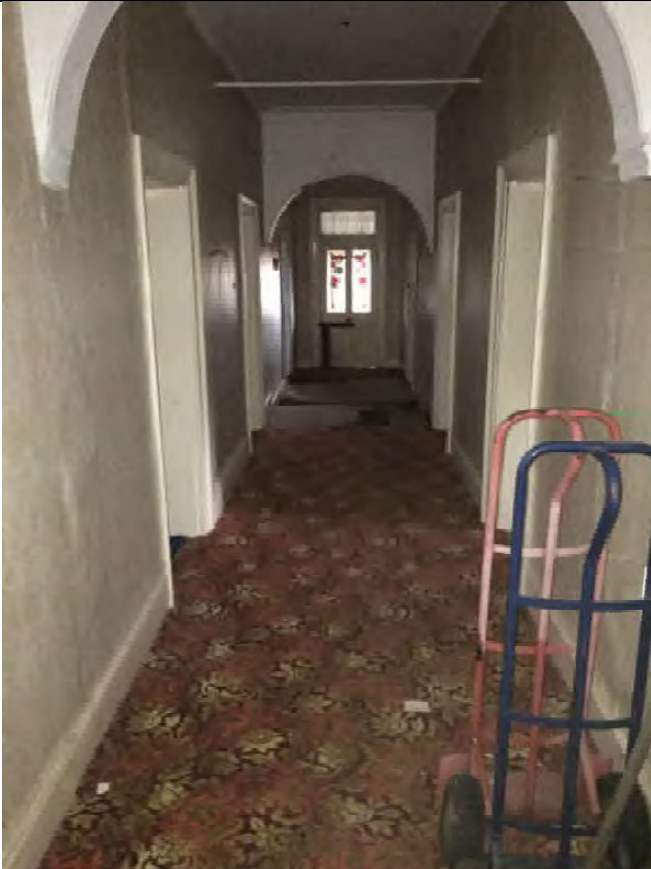
51

<p>A PHOTO LOOKING NORTH DOWN THE CORRIDOR. THE HOLE IN THE FLOOR IS MOST OF THE WAY ALONG</p>
52

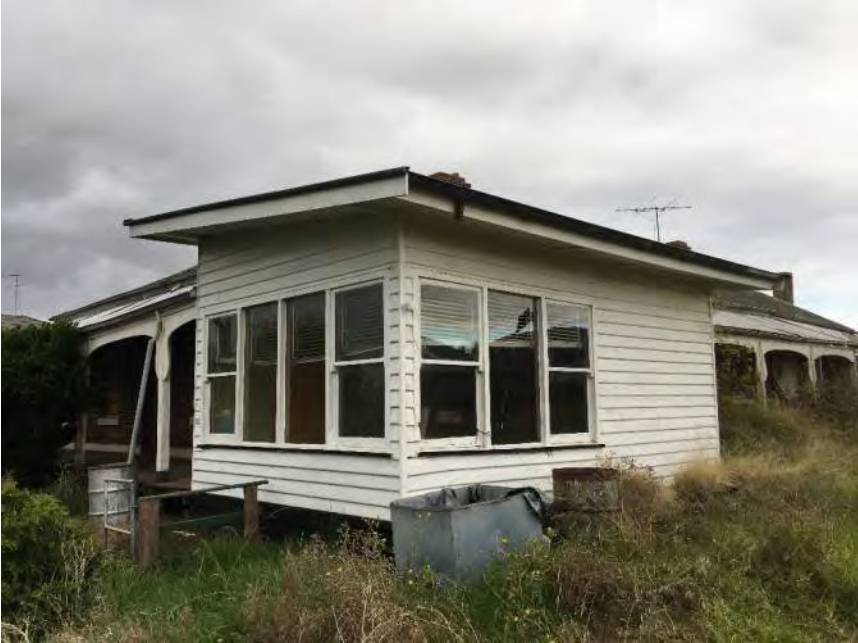
<p>THE SUNROOM, THAT IS A LATER ADDITION & PROBABLY THE ONLY ROOM IN THE HOUSE THAT COULD REMAIN INTACT, HOWEVER APPARENTLY IT HOLDS LITTLE HERITAGE VALUE.</p>
		<p>END OF PHOTO RECORD</p>
