Arboricultural Assessment for:

# Tree Identification, Heath and Retention Value

32 – 70 McDermott Road

**Pre Development Arboricultural Assessment**

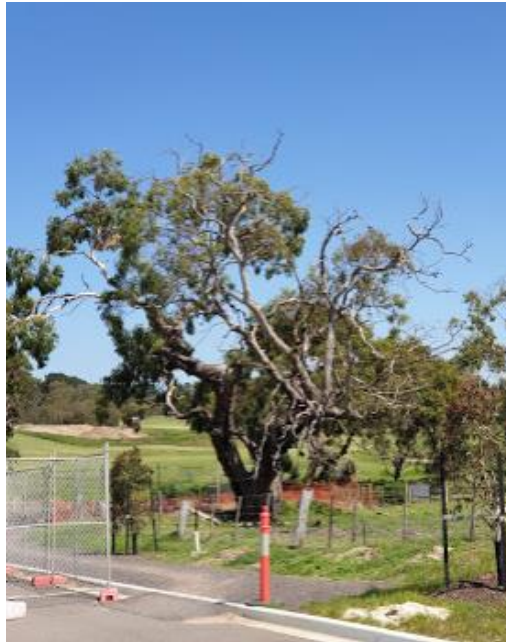
Tree 1, *E. viminalis*

No.	Identification	Est. Age Yrs	ULE	Health	Structure	Significance	Hazard	Esti. Height (m) & Spread (m)	DBH (cm) *multi stemmed	TPZ Radius (m) SRZ Radius (m)	Comment
1	<i>Eucalyptus viminalis</i> – Manna Gum	M	L	P	P	H	L	14 x 10	160	15.0 SRZ 4.0	On the rail trail corner, SE corner of the site. Sound tree with a good form however poor health and 50% dead in canopy. Remanent indigenous native tree.
2	<i>Eucalyptus camaldulensis</i> – Red Gum	M	L	G	G	L	M	16 x 8	62	7.4 SRZ 2.7	This tree is located in a garden bed in front of a dwelling on the site. Significantly younger than the other trees of this report, and growing in a formal landscape environment. This tree is a planted specimen. Retention of this specimen in development will see the specimen impacted in site clearing works, the tree is endocormic. As such the tree has a low retention value. Remanent indigenous native tree.
3	<i>Eucalyptus camaldulensis</i> – Red Gum	M	L	G	F	M	L	14	67	8.0 SRZ 2.8	Sound tree with an upright form. Presents with an endocormic canopy the result of coppicing many years ago. The tree has a biased lean to the north. Remanent indigenous native tree.

The tree is a remnant indigenous tree, and is in poor health and a greater than 50% dead canopy. The tree carries a significant ecological value to the neighbouring site, and development which avoids impact to this tree is recommended. Planned development which encroaches the tree no closer than 10.3 m eliminate an impact greater than 10% as such an acceptable development impact when guided by AS4970-2009 Protection of Trees on Development Sites.

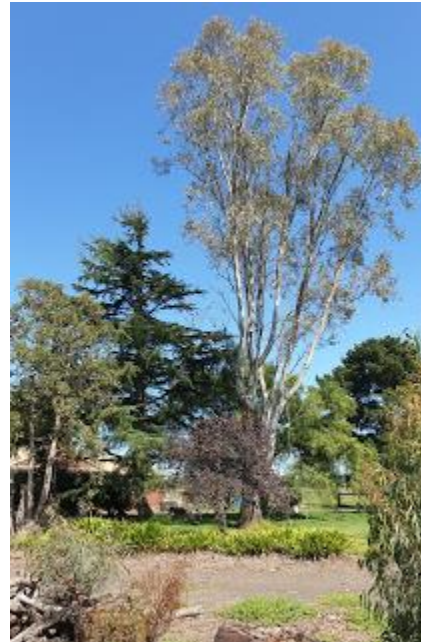
Tree 2, *E. camaldulensis*

Tree 2 grows in the formal landscape of a current site dwelling, and presents as a planted specimen. The tree has been coppiced in its earlier years, I suggest to manage its growth in the formal landscape. The tree has regrown and now presents with an endocormic canopy. As such the long term retention of the tree is greatly reduced. Long term retention of this tree is not recommended.

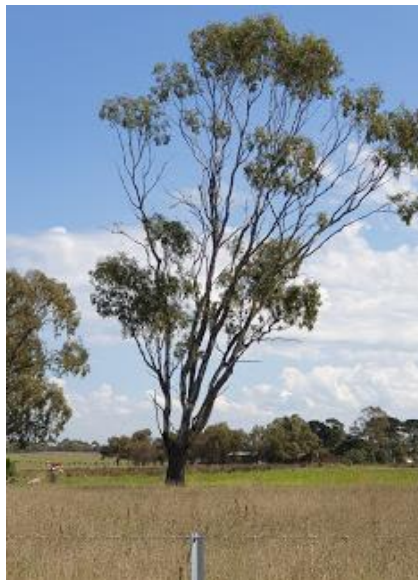
Tree 3, *E. camaldulensis*

Trees 3, 7 and 8 present as the most impacted trees. Trees 3 and 8 presenting as having had major canopy reduction earlier in their life, now presenting with a modified endocormic canopy.

Tree 3 is a managed impacted planted specimen, and holds no retention value to the site. This reports supports the loss of this tree.

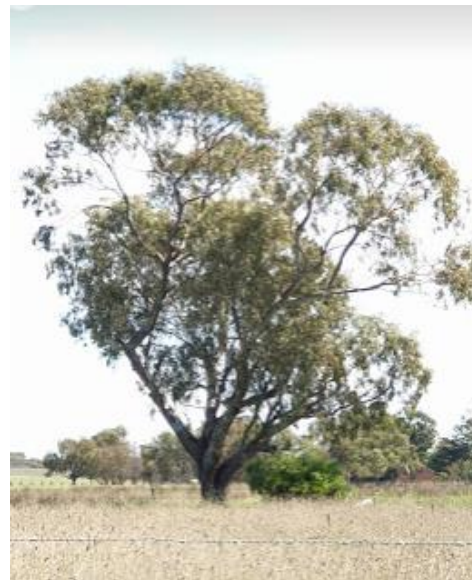
Tree 4, *E. camaldulensis*

4	<i>Eucalyptus camaldulensis</i> – Red Gum	M	L	G	G	H	L	12	91	10.9 SRZ 3.2	Tree with sound form showing typical for age past limb failings. Remanent indigenous native tree.

Trees 4, 5 and 6 present as sound and balanced in canopy.

Trees 4, 5 and 6 offer trees suitable for long term retention form a heath management and future retention value view.

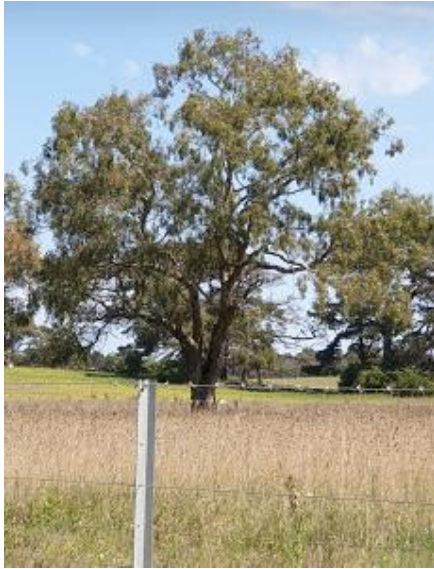
Tree 5, *E. camaldulensis*

5	<i>Eucalyptus camaldulensis</i> – Red Gum	M	L	F	F	H	L	12	88	10.6 SRZ 3.1	Sound tree with good shape and form. Remanent indigenous native tree.
6	<i>Eucalyptus camaldulensis</i> – Red Gum	M	L	F	F	H	L	11	91	10.9 SRZ 3.2	Sound tree with good shape and form. Remanent indigenous native tree.
7	<i>Eucalyptus camaldulensis</i> – Red Gum	M	L	F	P	H	M	12	77	9.2 SRZ 3.0	Structure bifurcated, the canopy has a major past limb failing evident. Sound tree. Remanent indigenous native tree.
8	<i>Eucalyptus camaldulensis</i> – Red Gum	M	L	F	F	H	L	14	65	7.8 SRZ 2.8	Sound upright form with deadwood throughout the canopy. Evident past pruning in the trees structure resulting in endocormic limbs.
9	<i>Eucalyptus viminalis</i> – Manna Gum	M	L	G	F	H	L	12	85	10.2 SRZ 3.1	Tree on neighbouring allotment – Rail Trail. Sound tree with deadwood in the upper canopy. Canopy open and spreading with past major failings. Remanent indigenous native tree.

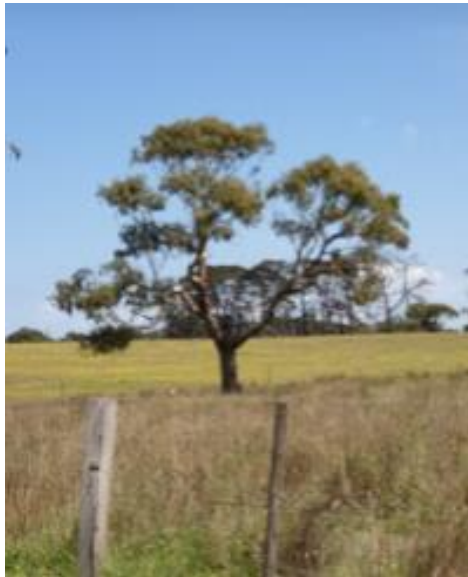
Tree 7, *E. camaldulensis*

Tree 7 shows significant past structural failings resulting in a modified canopy which is bifurcated, and will become structurally deficient as the tree continues to age.

Trees 7 and 8 present as modified in structure and form and offer a reduced life expectancy. This report supports the loss of these trees in urbanisation of the site.

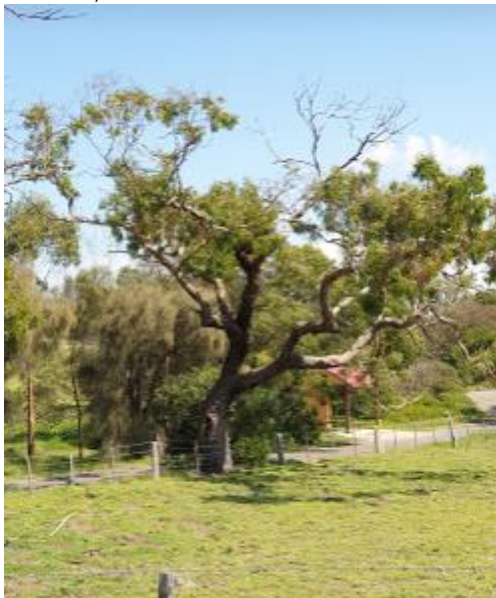
Tree 9, *E. Viminalis*

The trees on neighbouring allotments show no correlation to the trees on the site with the exception of trees 1 and 9 which both contribute to the vegetation of the neighbouring allotment.

Noting both trees to be in poor health with a reduced long term retention value may influence a decision of tree removal pre development. In urbanising this site, this report supports the loss and replacement of these trees.

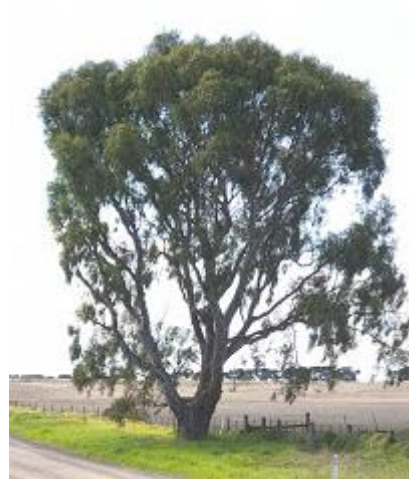
Tree 10 *E. camaldulensis*

No.	Identification	Est. Age Yrs	ULE	Health	Structure	Significance	Hazard	Esti. Height (m) & Spread (m)	DBH (cm) *multi stemmed	TPZ Radius (m) SRZ Radius (m)	Comment
10	<i>Eucalyptus camaldulensis</i> – Red Gum	M	L	G	G	L	M	16 x 8	142	15 SRZ 3.8	Sound tree on municipal naturestrip. Shows canopy deadwood and past failings

The tree is sound in form and structure, but presents with minor canopy deadwood and past branch failures. The tree has along useful life and is a significant tree in the landscape of the area.

Tree 10 grows on the municipal naturestrip of the second site, presents as sound, in good health and with a long useful life expectancy. Retention of this tree should be highly considered.

Retention of the tree is achieved by implementing tree protection guided by AS4970-2009 Protection of trees on Development Sites and encroachment to the tree should not exceed any greater than 10% of its TPZ, achieved when development encroaches no closer than 10.3m from the trees trunk.
