LETTER OF SITE INSPECTION

TPZ Calculations Bellarine Rail Trail Stage 2 Jetty rd Urban Growth Plan

July 2022

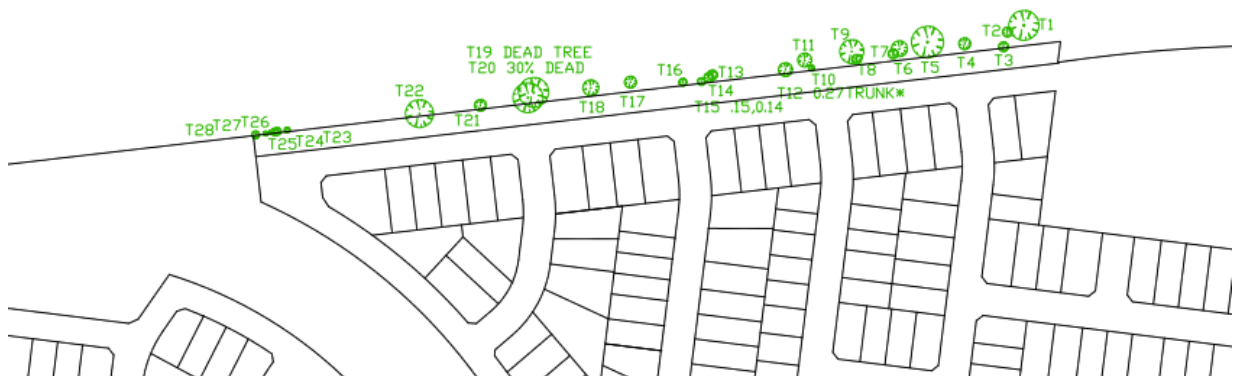
Trees on the Bellarine rail trail interface

No.	Identification	Est. Age Yrs	ULE	Health	Structure	Significance	Hazard	Esti. Height	DBH (cm) *multi stemmed	TPZ Radius (m) SRZ Radius (m)	Comment
1	<i>Eucalyptus camaldulensis</i> – Red Gum	M	L	G	G	H	L	10	65*	7.8 SRZ 2.8	Multi stemmed X 8 sound tree
2	<i>Eucalyptus camaldulensis</i> – Red Gum	M	L	G	G	H	L	10	70*	8.4 SRZ 2.8	Multi stemmed X 6 sound tree
3	<i>Eucalyptus camaldulensis</i> – Red Gum	Y	L	G	G	H	L	6	21	2.5 SRZ 1.5	Sapling Sound
4	<i>Acacia mernsii</i> – Black Wattle	M	L	G	G	H	L	7	28	3.4 SRZ 1.9	Sound Planted

No.	Identification	Est. Age Yrs	ULE	Health	Structure	Significance	Hazard	Esti. Height	DBH (cm) *multi stemmed	TPZ Radius (m) SRZ Radius (m)	Comment
5	<i>Eucalyptus camaldulensis</i> – Red Gum	M	L	G	G	H	L	11	75*	9.0 SRZ 2.9	50% Failed tree
6	<i>Eucalyptus camaldulensis</i> – Red Gum	M	L	G	G	H	L	11	40	4.8 SRZ 2.3	Planted tree sound
7	<i>Acacia pycnantha</i> – Golden Wattle	M	L	G	G	M	L	8	22*	2.6 SRZ 1.8	Sound tree with atypical form which over hangs the boundary into the development site.
8	<i>Acacia mernsii</i> – Black Wattle	M	L	G	G	H	L	7	22*	2.6 SRZ 1.8	Sound bifurcated tree
9	<i>Eucalyptus camaldulensis</i> – Red Gum	M	L	G	G	H	L	10	42	5.0 SRZ 2.3	Planted sound
10	<i>Acacia mernsii</i> – Black Wattle	Y	L	G	G	H	L	6	<15	2.0 SRZ 1.5	Sound sapling
11	<i>Eucalyptus camaldulensis</i> – Red Gum	M	L	G	G	H	L	8	36	4.3 SRZ 2.2	Planted sound
12	<i>Eucalyptus leucoxylon</i> – Yellow Gum	M	L	G	G	H	L	6	27*	3.2 SRZ 1.9	Planted tree with very poor root structure

13	<i>Allocasuarina verticillata</i> – She Oak	SM	L	G	G	M	L	7	27*	3.2 SRZ 1.9	Sound planted
14	<i>Allocasuarina verticillata</i> – She Oak	SM	L	G	G	M	L	7	18	2.2 SRZ 1.6	Sound planted
15	<i>Allocasuarina verticillata</i> – She Oak	SM	L	G	G	M	L	7	16*	2.0 SRZ 1.5	Sound planted
16	<i>Acacia mernsii</i> – Black Wattle	SM	L	G	G	M	L	6	16	2.0 SRZ 1.5	Sound planted
17	<i>Eucalyptus leucoxylon</i> – Yellow Gum	SM	L	G	G	H	L	7	23	2.8 SRZ 1.8	Sound planted
18	<i>Acacia implexa</i> - Lightwood	M	L	G	P	H	L	7	29	3.5 SRZ 2.0	Grows with a significant failing lean – Short useful life

No.	Identification	Est. Age Yrs	ULE	Health	Structure	Significance	Hazard	Esti. Height	DBH (cm) *multi stemmed	TPZ Radius (m) SRZ Radius (m)	Comment
19	<i>Eucalyptus viminalis</i> – Manna Gum	D	D	D	D	D	D	D	D	D	Dead tree indigenous remnant indigenous – not planted
20	<i>Eucalyptus viminalis</i> – Manna Gum	M	L	G	G	H	L	11	57*	6.8 SRZ 2.6	Remnant indigenous – not planted 50% dead
21	<i>Eucalyptus leucoxylon</i> – Yellow Gum	SM	L	G	G	L	L	8	24	2.9 SRZ 1.8	Sound planted
22	<i>Eucalyptus camaldulensis</i> – Red Gum	M	L	G	G	H	L	9	43	5.2 SRZ 2.3	Sound with major trunk failings
23	<i>Acacia implexa</i> - Lightwood	SM	L	G	G	L	L	5	14	2.0 SRZ 1.5	Planted Sound
24	<i>Acacia implexa</i> - Lightwood	SM	L	G	G	L	L	5	16	2.0 SRZ 1.5	Planted Sound
25	<i>Acacia implexa</i> - Lightwood	SM	L	G	G	L	L	5	14	2.0 SRZ 1.5	Planted Sound
26	<i>Acacia implexa</i> - Lightwood	SM	L	G	G	L	L	5	12	2.0 SRZ 1.5	Planted Sound
27	<i>Acacia implexa</i> - Lightwood	SM	L	G	G	L	L	5	16	2.0 SRZ 1.5	Planted Sound

28	<i>Acacia implexa</i> - Lightwood	SM	L	G	G	L	L	5	18	2.0 SRZ 1.5	Planted Sound

In conclusion I make an assessment that if a 10m buffer is provided along the boundary of the development site no trees on public lands will be encroached by development.

The trees of this report should be protected by a lineal steel mesh panel fence placed along the interface boundaries with the inspected public open spaces. This placement should be guided by AS4970-2009 protection of Trees on Development Sites.

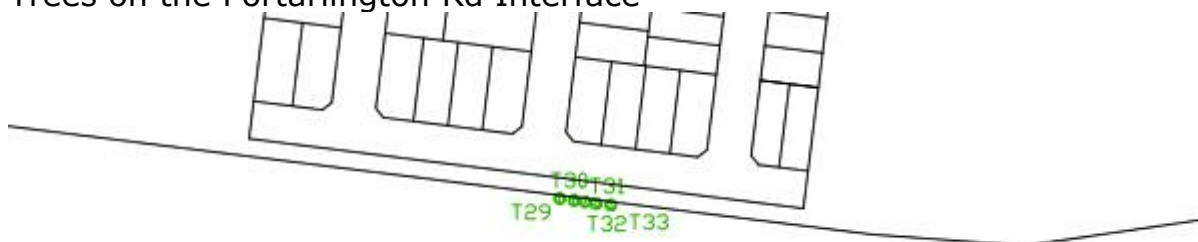
Trees on the Portarlington Rd Interface

No.	Identification	Est. Age Yrs	ULE	Health	Structure	Significance	Hazard	Esti. Height	DBH (cm) *multi stemmed	TPZ Radius (m) SRZ Radius (m)	Comment
29	<i>Melaleuca armillaris</i> – Honey Myrtle	M	M	F	P	L	M	6	18*	2.2 SRZ 1.6	Poor structure and form planted – identified as a local weed species
30	<i>Melaleuca armillaris</i> – Honey Myrtle	M	M	F	P	L	M	6	20	2.4 SRZ 1.7	Poor structure and form planted – identified as a local weed species

No.	Identification	Est. Age Yrs	ULE	Health	Structure	Significance	Hazard	Esti. Height	DBH (cm) *multi stemmed	TPZ Radius (m) SRZ Radius (m)	Comment
31	<i>Melaleuca armillaris</i> – Honey Myrtle	M	M	F	P	L	M	6	21	2.5 SRZ 1.7	Poor structure and form planted – identified as a local weed species
32	<i>Melaleuca armillaris</i> – Honey Myrtle	M	M	F	P	L	M	6	25*	3.0 SRZ 1.8	Poor structure and form planted – identified as a local weed species
33	<i>Melaleuca armillaris</i> – Honey Myrtle	M	M	F	P	L	M	6	18*	2.2 SRZ 1.6	Poor structure and form planted – identified as a local weed species
