Arborists Assessment

Geelong Saleyards

Weddell Rd,
North Geelong
VICTORIA, 3228

Date: February 2018

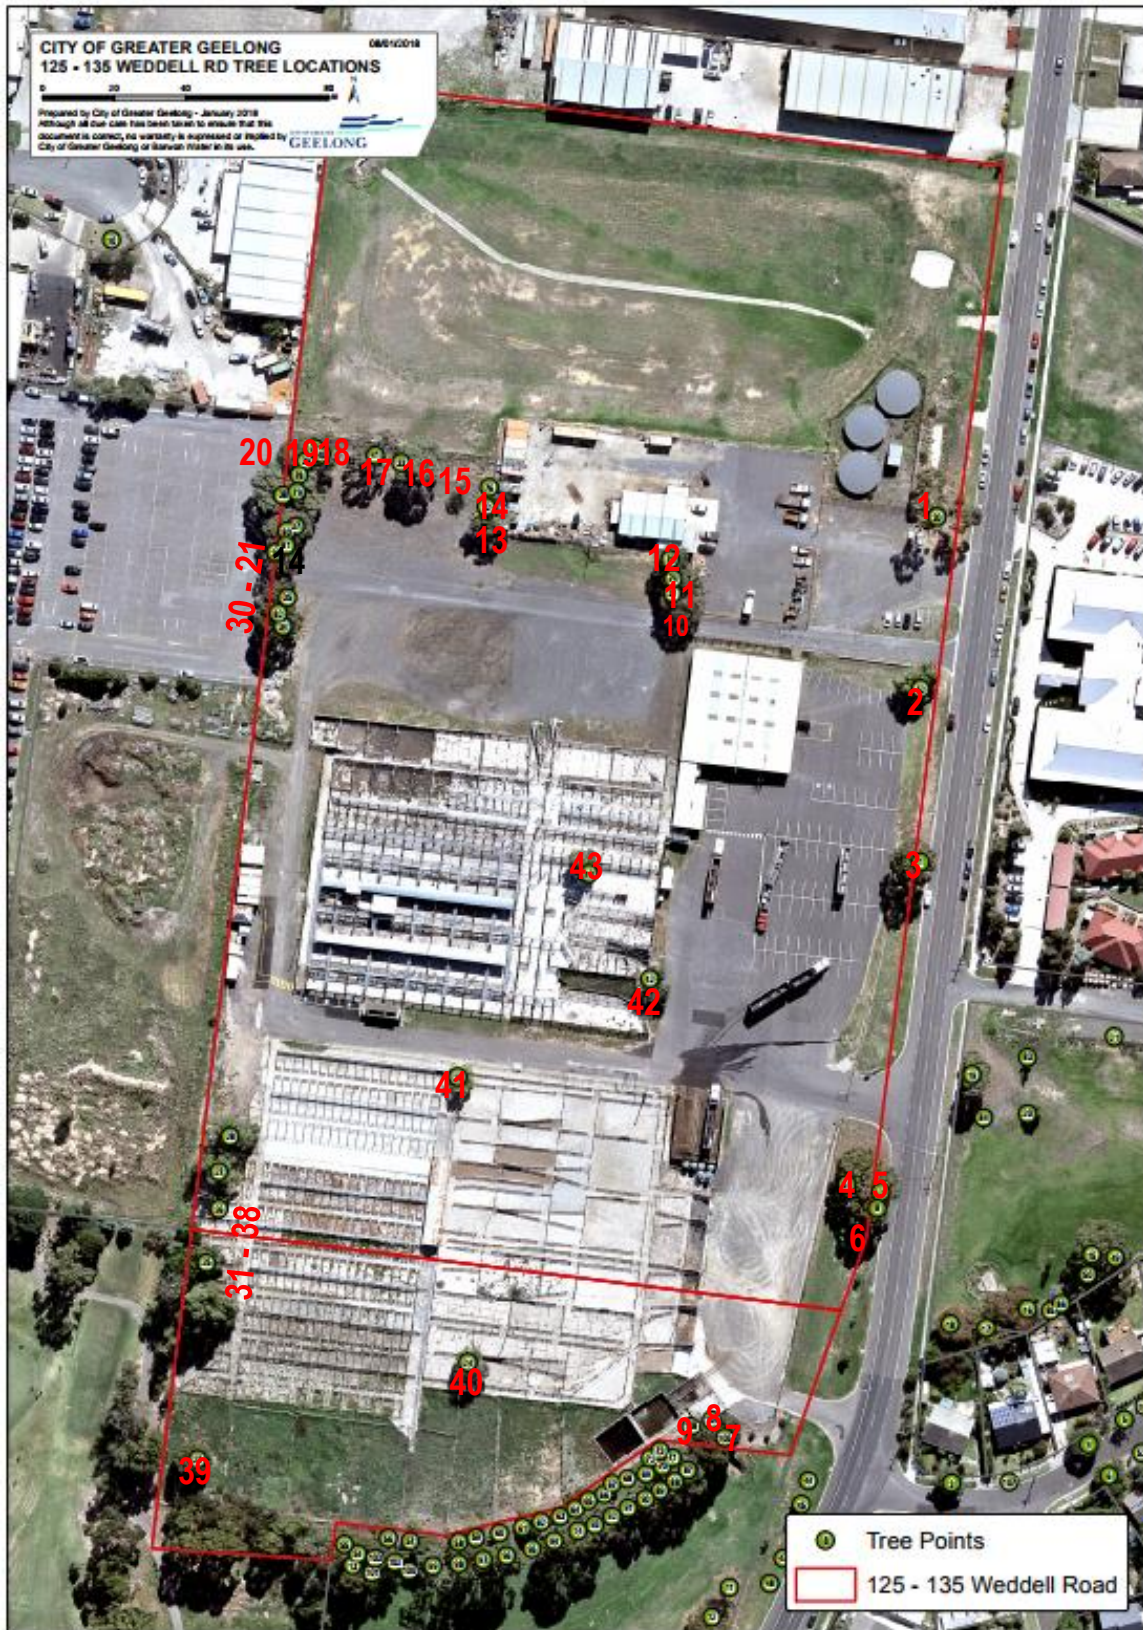
6.2 Site Plan & Initial Tree Management Plan

The trees numbered 33, 35, 36, 37 and 38 are on an adjoining allotment and could require further root protections during site development.

Trees numbered 3, 4, 5, 6 and 7 are municipal naturestrip trees. These could require further root protections during site development.

The Tree Protection Zones (TPZ) of all trees should be plotted on design drawings where trees are determined for retention. Trees should then be managed using AS 4970-2009 Protection of Trees on Development Sites.
