WOODLAND TREE REPORTS

Arboricultural Impact and Canopy Tree Assessment

3 Talbot Street
Newtown VIC

9 April 2026

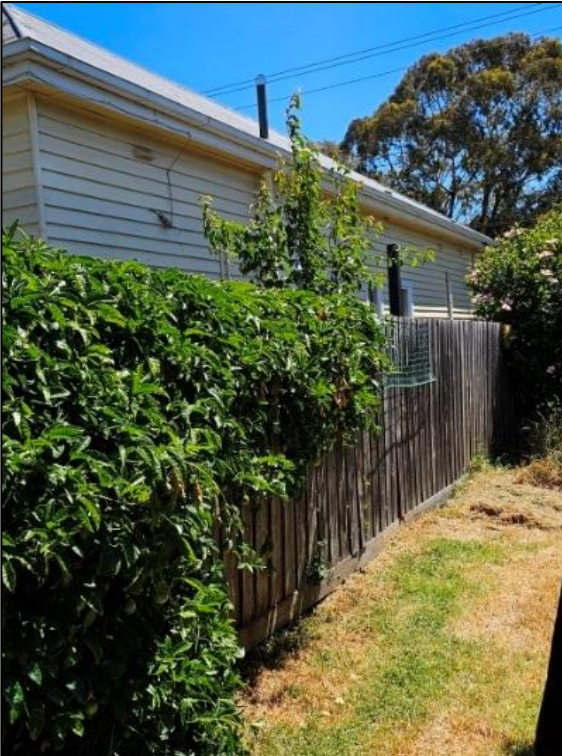
Tree 3.

Neighbouring property (5 Talbot St)	3	<i>Pyrus calleryana 'Capital'</i>	Capital Pear	Exotic	Tree	3.5	2	40	80	Juvenile	Good	Good	Good	Low	Low	20+	2	1.50	1.60	5.20%	Minor NRZ encroachment (less than or equal to 10%) as per AS4970.2025.	No	Yes	Small juvenile tree in neighbouring property in good condition. Minimum NRZ/SRZ distances. New tree so no root system interaction will occur.
Neighbouring property (5 Talbot St)	4	<i>Malus sp.</i>	Apple	Exotic	Tree	3	2	80	120	Mature	Good	Fair	Fair	Low	Low	20+	2	1.50	2.50	0.00%	No encroachment	No	Yes	Small tree in neighbouring property that has been lopped regularly to keep its current shape or for fruiting purposes.
Neighbouring property (5 Talbot St)	5	<i>Coprosma repens</i>	Mirror Bush	Exotic	Tree	3	4	60	90	Mature	Good	Poor	Fair	Low	Low	10-20	2	1.50	3.80	0.00%	No encroachment	No	Yes	Small tree in neighbouring property that has been lopped regularly to keep its current shape or for fruiting purposes.

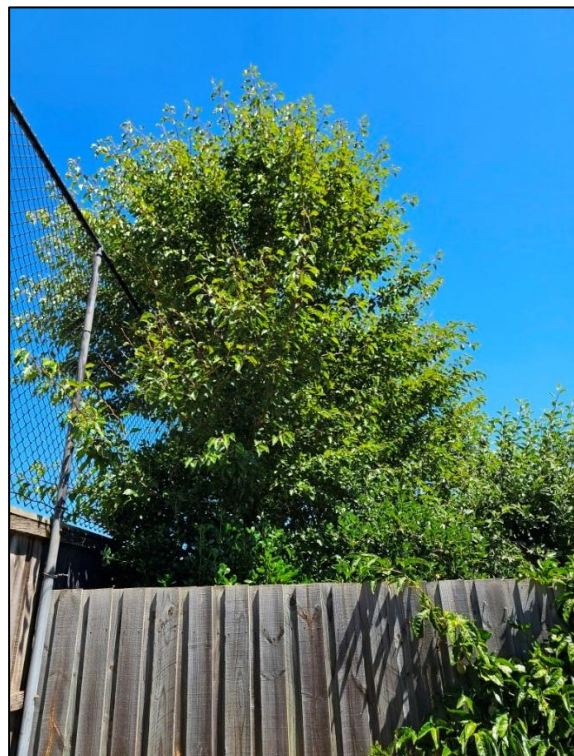
Tree 4, 5 and 6.

Neighbouring property (5 Talbot St)	6	<i>Pyrus calleryana 'Capital'</i>	Capital Pear	Exotic	Tree	5	5	140	200	Mature	Good	Fair	Fair	Low	Low	20+	3.6	1.68	6.60	0.00%	No encroachment	No	Yes	Small tree in neighbouring property in good condition.
Subject Site (3 Talbot St)	7	<i>Fraxinus excelsior</i>	European Ash	Exotic	Tree	6	10	300	420	Mature	Good	Fair	Fair	Low	Low	20+	3.6	2.30	4.10	0.00%	No encroachment	Yes	Yes	Small tree with spreading canopy located on north side of existing dwelling in fair condition.
Subject Site (3 Talbot St)	8	<i>Prunus cerasifera 'Nigra'</i>	Black Cherry Plum	Exotic	Tree	5	7	100 x 5 = 220	280	Mature	Fair	Fair	Fair	Low	Low	10-20	2.64	1.94	3.70	0.00%	No encroachment	Yes	Yes	Small tree with declining canopy located on north side of existing dwelling in fair condition.
Subject Site (3 Talbot St)	9	<i>Pittosporum undulatum</i>	Sweet Pittosporum	Australian Native	Tree	6	10	280, 350 = 450	520	Mature	Good	Fair	Fair	Low	Low	20+	5.4	2.51	4.7 (.75x1.9 incursion)	0.92%	Minor NRZ encroachment (less than or equal to 10%) as per AS4970.2025.	Yes - Boundary	Yes	Small tree with spreading canopy located on north side of existing dwelling in fair condition. Footing of carport to encroach NRZ. Ensure care is taken and roots are pruned by project arborist as per AS4373.2007.

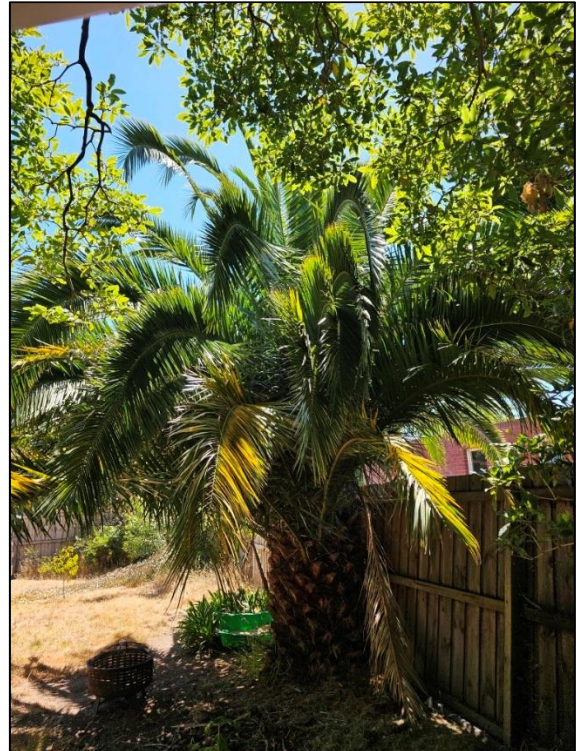
Tree 10.

Subject Site (3 Talbot St)	10	<i>Phoenix canariensis</i>	Canary Island Date Palm	Exotic	Tree	5	9	1200	1200	Mature	Good	Good	Good	Low	Low	20+	10*	2*	8.3 (2x2.7 incursion)	0.96%	Minor NRZ encroachment (less than or equal to 10%) as per AS4970.2025.	Yes - Boundary	Yes	Small tree with spreading canopy located on the north side of the existing dwelling against side boundary fence in good condition. NRZ and SRZ differ due to being a monocot. See AS4970.2025. Footing of carport to encroach NRZ. Ensure care is taken and roots are pruned by project arborist as per AS4373.2007.
Subject Site (3 Talbot St)	11	<i>Fraxinus excelsior</i>	European Ash	Exotic	Tree	2.5	2	30 x 3 = 60	90	Mature	Fair	Fair	Fair	Low	Low	20+	2	1.50	11.50	0.00%	No encroachment	No	No	Small self-sown tree located on the north side of the existing dwelling against side boundary fence.
Subject Site (3 Talbot St)	12	<i>Eucalyptus macrandra</i>	Long-flowered Marlock	Australian Native	Tree	4	4	300	600	Mature	Fair	Poor	Fair	Low	Low	0-10	3.6	2.67	10.70	0.00%	No encroachment	No	No	Small tree located on the north side of the existing dwelling against side boundary fence that has been lopped. Entire crown new epicormic growth which has failed recently during wind event.

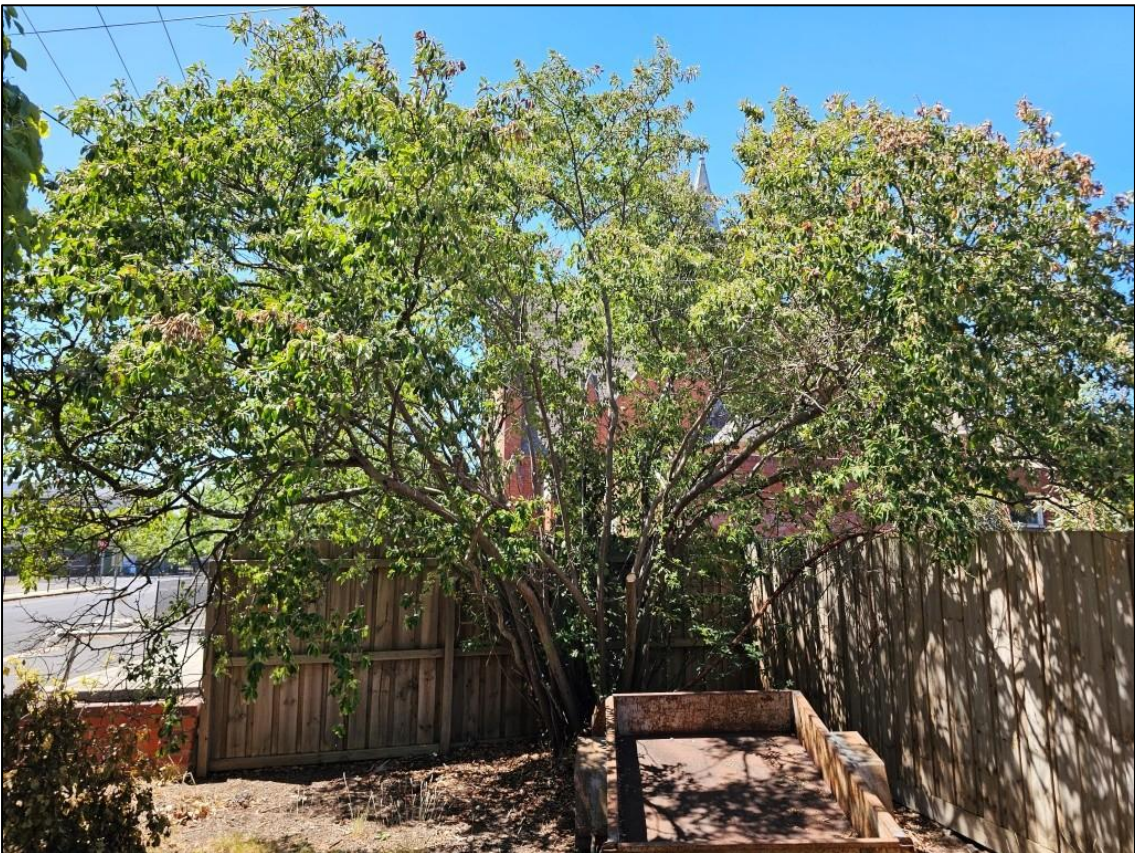
Tree 13.

Subject Site (3 Talbot St)	13	<i>Cotoneaster glaucophyllus</i>	Cotoneaster	Exotic	Tree	5	8	100 x 5 = 220	600	Mature	Good	Fair	Fair	Low	Low	20+	2.64	2.67	11.20	0.00%	No encroachment	Yes - Boundary	Yes	Small multi-stemmed tree with spreading canopy and located on the north side of the existing dwelling against side boundary fence in fair condition.
Subject Site (3 Talbot St)	14	<i>Cupressus sempervirens Swanes Golden</i>	Golden Pencil Pine	Exotic	Tree	3	1.5	100	190	Mature	Good	Fair	Fair	Low	Low	10-20	2	1.65	2.00	0.00%	No encroachment	No	No	Small tree located on the west side of the existing dwelling against house wall where it has been lopped on the east side to keep the crown away from the eve and roof of the property.

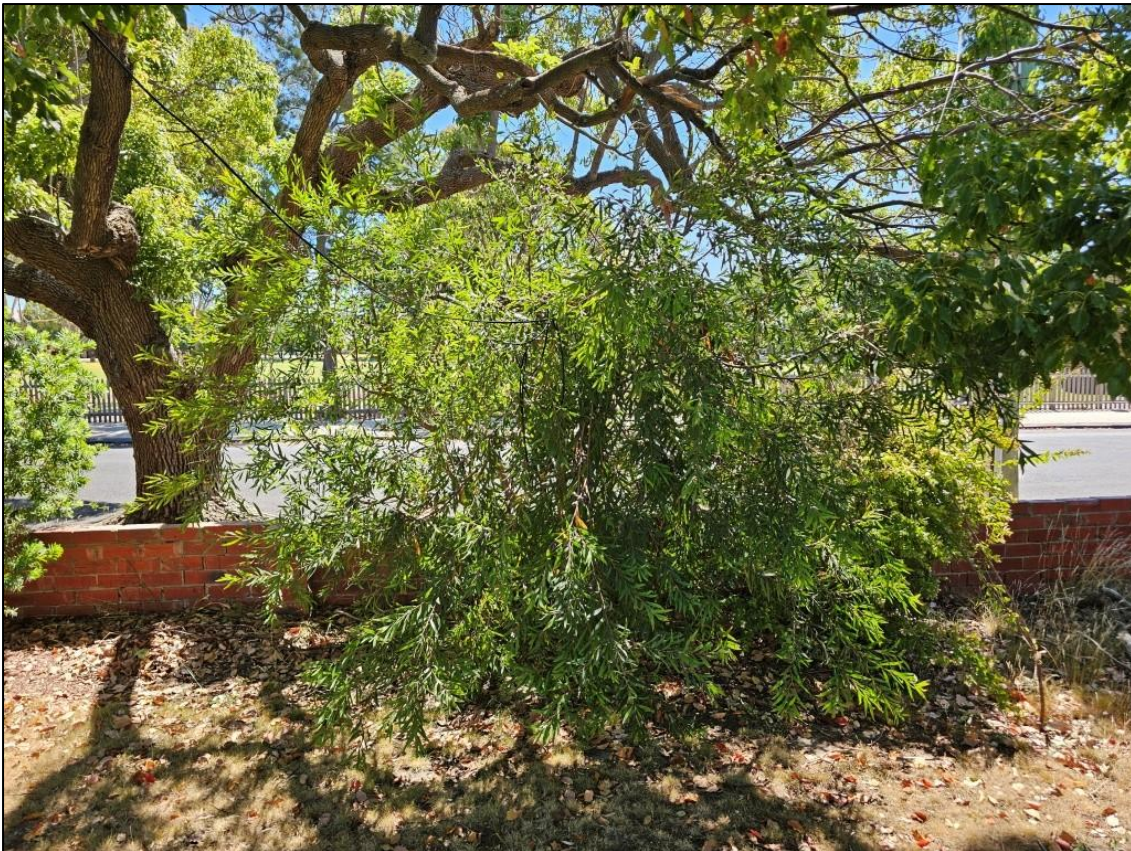
Tree 16 and 17.

Subject Site (3 Talbot St)	17	<i>Hakea laurina</i>	Pin-cushion Hakea	Australian Native	Tree	2	4	20, 30, 40 = 50	190	Semi-mature	Good	Fair	Good	Low	Low	10-20	2	1.65	9.00	0.00%	No encroachment	No	No	Small tree located on the west side of the existing dwelling against the front boundary brick fence in good condition. Listed as an environmental weed by City of Greater Geelong.
Subject Site (3 Talbot St)	18	<i>Kunzea baxteri</i>	Crimson Kunzea	Australian Native	Shrub	2.5	3	20, 30, 40 = 50	180	Semi-mature	Good	Fair	Good	Low	Low	10-20	2	1.61	6.50	0.00%	No encroachment	No	No	Small shrub located on the west side of the existing dwelling against the front boundary brick fence in good condition.
Subject Site (3 Talbot St)	19	<i>Abelia x grandiflora 'Kaleidoscope'</i>	Glossy Abelia	Exotic	Shrub	2	2	20 x 5 = 40	350	Semi-mature	Good	Fair	Good	Low	Low	10-20	2	2.13	5.60	0.00%	No encroachment	No	No	Small shrub located on the west side of the existing dwelling against the front boundary brick fence in good condition.

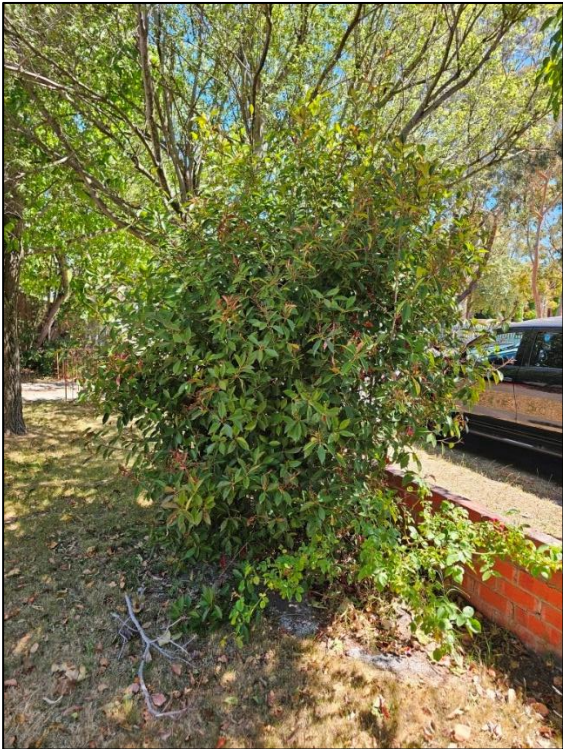
Tree 20.

Subject Site (3 Talbot St)	20	<i>Photinia robusta</i>	Photinia	Exotic	Tree	3	3	30 x 5 = 70	200	Semi-mature	Good	Fair	Fair	Low	Low	20+	2	1.68	0.6 (1.4x2.1 incursion)	17.87%	Moderate Encroachment (greater than 10% and less than or equal to 20% of the area of the NRZ) as per AS4970.2025.	No	No	Small tree located on the west side of the existing dwelling against the front boundary brick fence in fair condition. Tree will require removal due to encroachment from proposed entrance path and gateway.
Subject Site (3 Talbot St)	21	<i>Pittosporum tenuifolium James Stirling</i>	James Stirling Pittosporum	Exotic	Tree	5	7	130, 220 = 260	290	Semi-mature	Good	Fair	Good	Low	Low	10-20	3.12	1.97	0.00	100.00%	Major NRZ encroachment (greater than 20% or inside the SRZ) as per AS4970.2025.	Yes - Boundary	No	Small tree located on the west side of the existing dwelling against the front boundary brick fence in good condition. Tree will require removal due to encroachment from proposed entrance path and gateway.

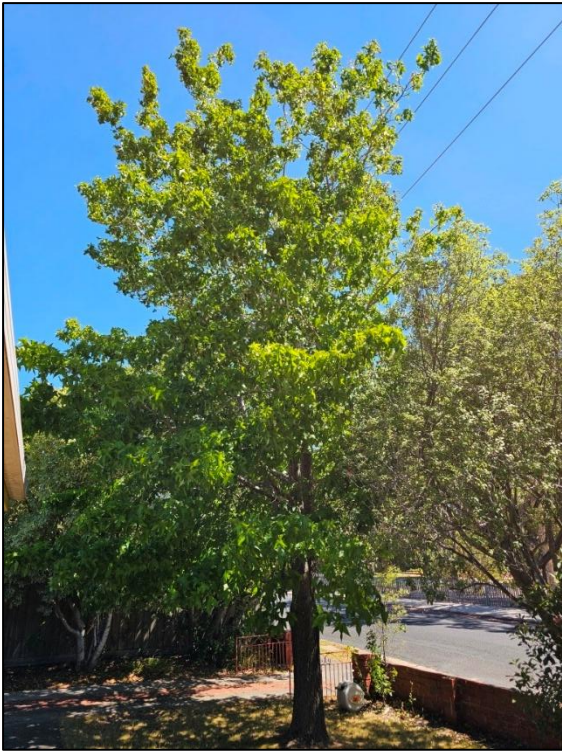
Tree 22.

Subject Site (3 Talbot St)	22	<i>Liquidambar styraciflua</i>	Sweet Gum	Exotic	Tree	7	8	350	360	Mature	Good	Fair	Good	Low	Low	20+	4.2	2.15	0.00	50.00%	Major NRZ encroachment (greater than 20% or inside the SRZ) as per AS4970.2025.	Yes - Boundary	No	Small tree located on the west side of the existing dwelling in the middle of the lawn area in good condition. Tree will require removal due to encroachment from proposed driveway and entrance path and gateway.
Subject Site (3 Talbot St)	23	<i>Pittosporum eugenioides Variegatum</i>	Lemonwood	Exotic	Tree	5	6	80, 90, 130, 160 = 240	300	Mature	Good	Fair	Fair	Low	Low	10-20	2.88	2.00	0.50	39.00%	Major NRZ encroachment (greater than 20% or inside the SRZ) as per AS4970.2025.	Yes - Boundary	No	Small tree located on the west side of the existing dwelling against the south boundary fence in fair condition. Tree will require removal due to encroachment from proposed driveway.

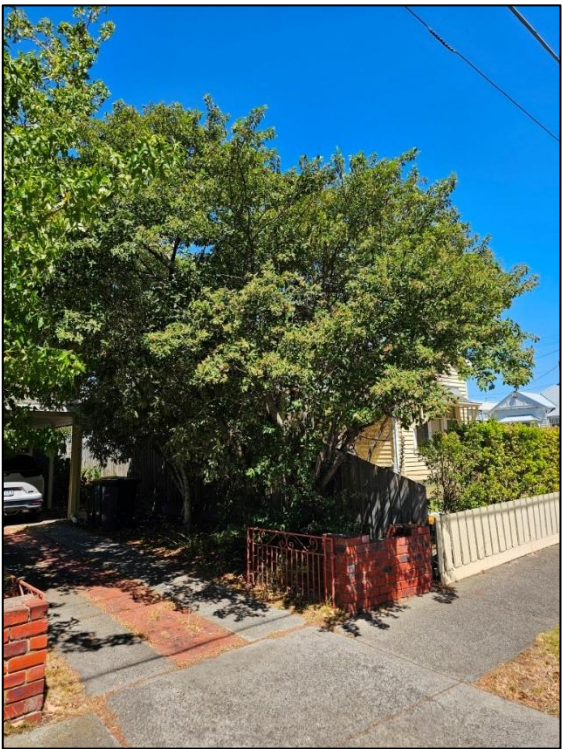
Tree 24.

Subject Site (3 Talbot St)	24	<i>Cotoneaster glaucophyllus</i>	Cotoneaster	Exotic	Tree	6	8	100 x 3, 120, 150 = 260	500	Semi-mature	Good	Fair	Good	Low	Low	20+	3.12	2.47	1.7 (1.2x3.4 incursion)	11.27%	Moderate Encroachment (greater than 10% and less than or equal to 20% of the area of the NRZ) as per AS4970.2025.	Yes - Boundary	Yes	Small tree located on the west side of the existing dwelling against the south boundary fence in fair condition. NRZ and SRZ encroachment from proposed driveway footprint. Existing driveway is closer to the base of the tree so feasible to suggest minimal actual impact will occur.
Talbot Street (Council Tree)	25	<i>Camphora officinarum</i>	Camphor Tree	Exotic	Tree	8	12x17	360, 640 = 740	660	Mature	Fair	Poor	Fair	Low	Medium	10-20	8.88	2.78	1.70	0.00%	No encroachment	Yes	Yes	A large mature tree with a spreading canopy that has been severely modified for electrical line clearance located within the thin parcel of partially grassed nature strip in front of the subject site. The NRZ and SRZ encroach into the subject site.
