# TREE HEALTH AND CONDITION REPORT

| PREPARED BY | PREPARED FOR |
|---|---|
| | 13 Purrumbeet Ave Manifold heights |

Version: 1.0| Date: 4/08/2026

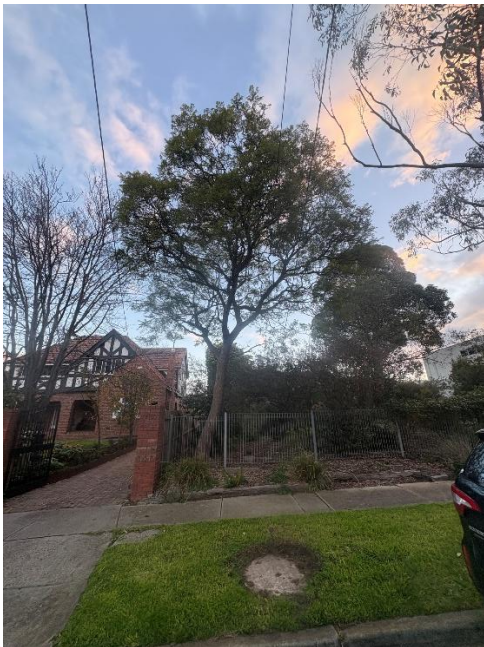
1.

As per the time of inspection this tree is in **good** health with **good** structure and no major defects. The Arboricultural value is medium as it is not a large specimen of this species. As per the plans provided, this tree is does not need removal.

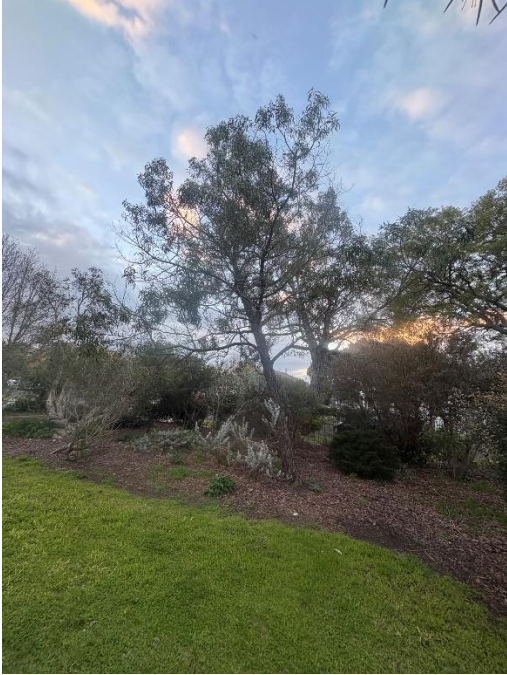
3. *Acacia melanoxylon*

At the time of inspection this tree showed good health and structure and no major defects. This arboricultural value of this tree is medium at best. I don't believe this tree is close enough to the front boundary, nor has the required width for a permit.

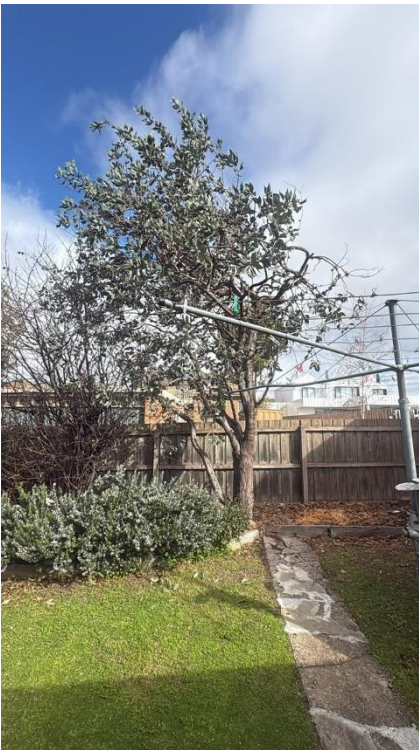
19. *Eucalypt* sp.

At the time of inspection this tree showed Fair health and fair to poor structure. This arboricultural value of this tree is low as it is still fairly small and has a fair to poor structure. As for the permit requirements, the data shows that is does not mee the size requirements. As such, I do not believe a permit is required.

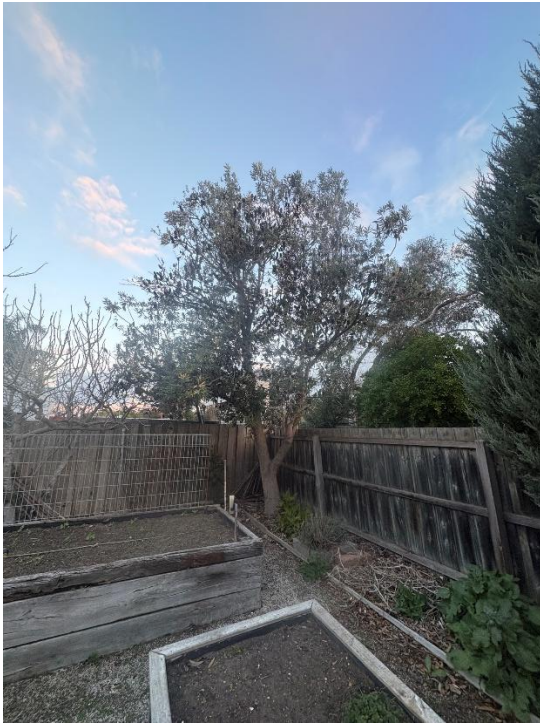
22. *Banksia integrifolia*

At the time of inspection this tree showed good health and structure and no major defects. This arboricultural value of this tree is medium as it is still fairly small. As for the permit requirements, the data shows that is does not mee the size requirements. As such, I do not believe a permit is required.
