## Arboricultural Assessment & Report 181 Separation Street, Bell Park

February 2026

Prepared for:  
Planning & Design Pty Ltd

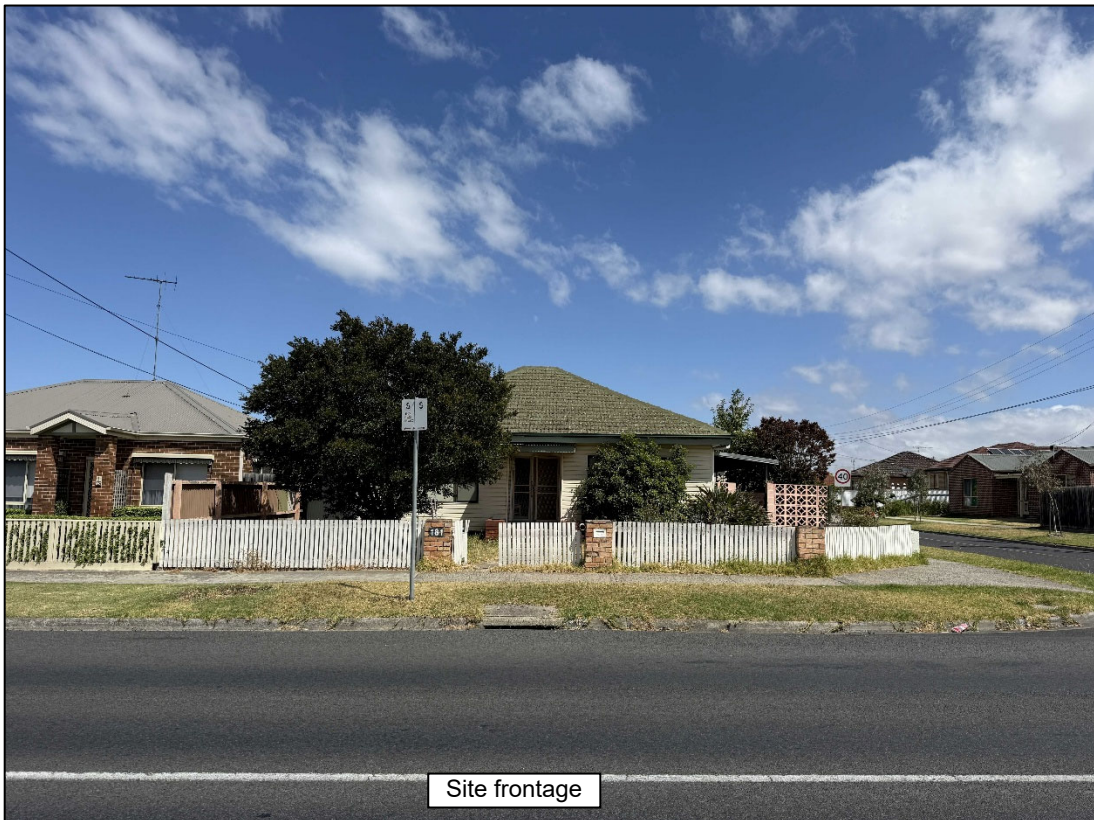
- 6.1 The site under review presented as a single residential allotment with an existing dwelling and detached shed. The site is a corner allotment, and it adjoins residential properties to the east and south. Separation Street frontage is located to the north and Hughes Street frontage is located to the west. The site contained shrubs, fruit trees and weeds.

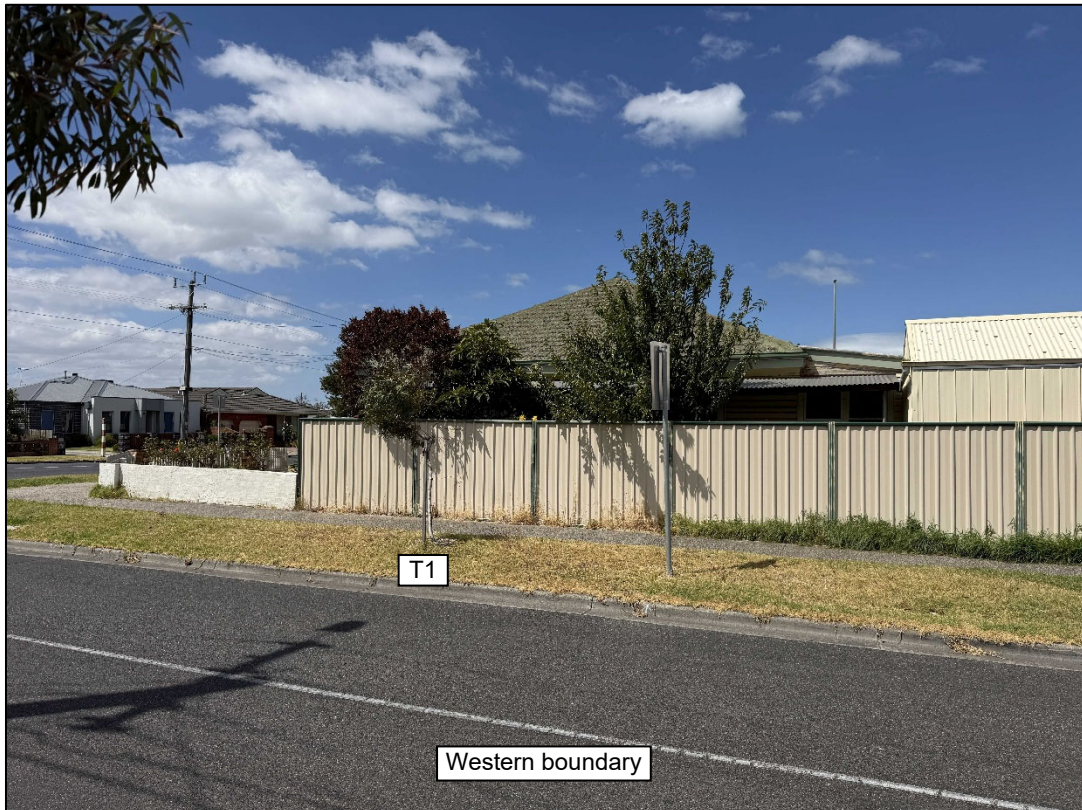
The site contained shrubs, fruit trees and weeds. The retention values of the trees and shrubs on the site were rated 'Low' or 'None'. The very low quality and suitability of the vegetation on the site supports an approach whereby existing trees or shrubs should offer limited constraint to any proposed site changes. All of the trees and shrubs on the site are recommended for removal (Trees 2-11). A permit is not required to remove any trees.

- 8.1 The retention values of the trees and shrubs on the site were rated 'Low' or 'None'. The very low quality and suitability of the vegetation on the site supports an approach whereby existing trees or shrubs should offer limited constraint to any proposed site changes. All of the trees and shrubs on the site are recommended for removal (Trees 2-11). A permit is not required to remove any trees.

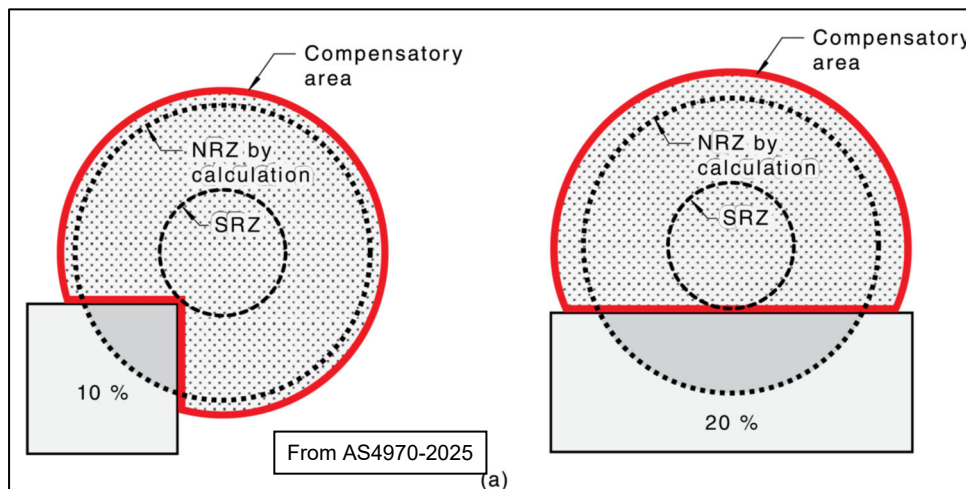
There is scope to encroach the tree protection zone by an area of 10% without further investigations. The rationale for any reduced tree protection distance is detailed in AS4970:2025 (Australian Standard – *Protection of trees on development sites*). Under various encroachment types, it is acceptable to encroach the notional root zone (NRZ) area by up to 20%. This can be applied if there is contiguous space around the tree for root development to occur and the Structural Root Zone is avoided.

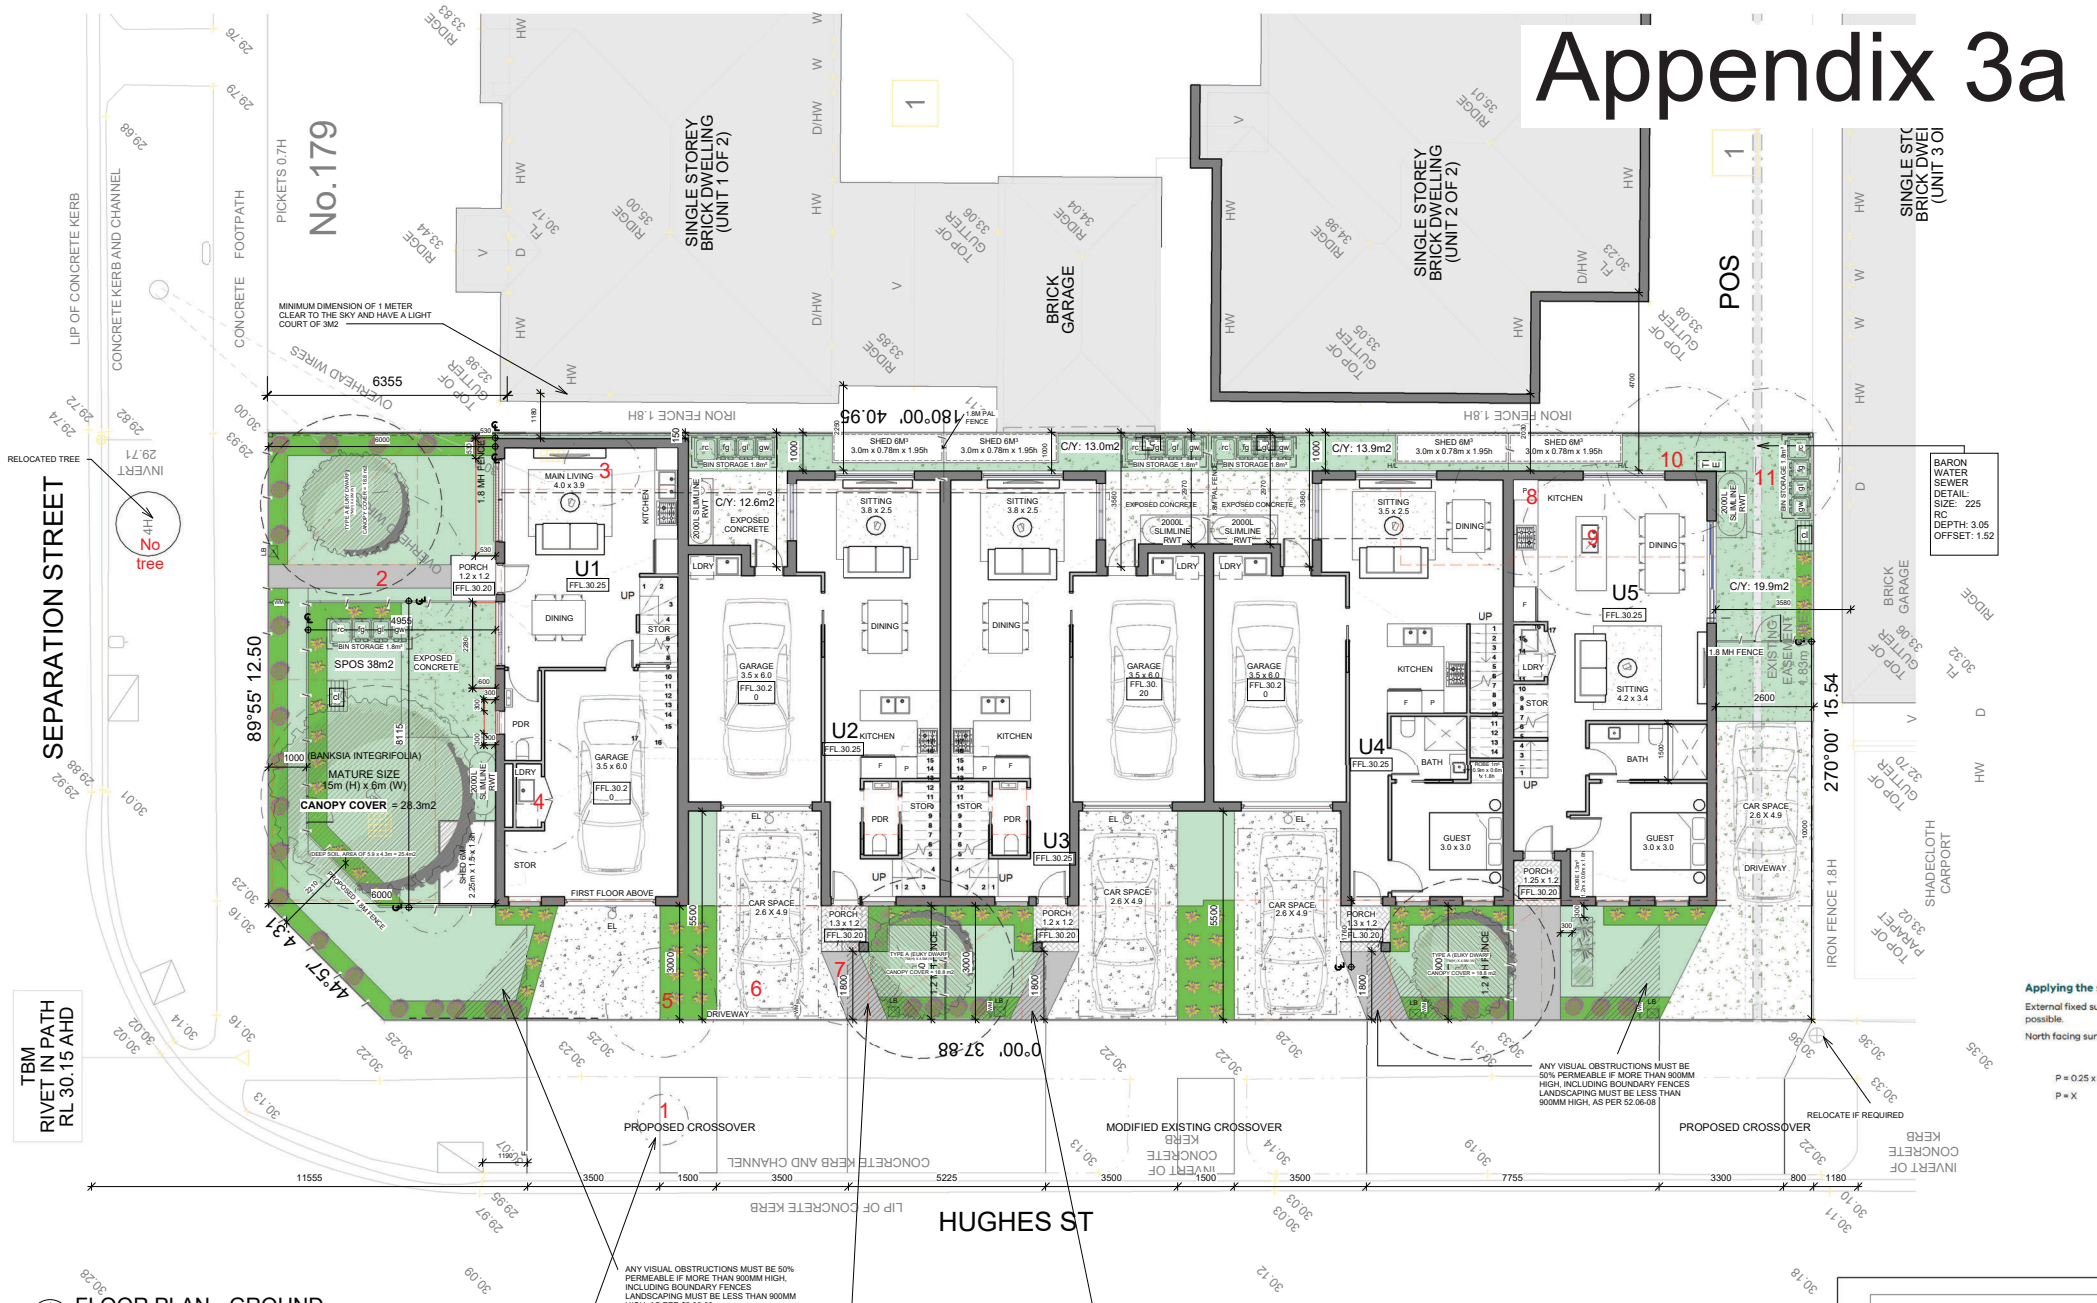
# Appendix 3a

- 5.5 A proposed ground floor plan was provided by the client for analysis (Ground Floor Plan prepared by Planning & Design P/L, Ref 8529, Revision A dated 11/07/25). The trees have been numbered on this plan and Notional Root Zones and Structural Root Zones are indicated for specific trees (Appendix 3a).

A factor that may influence site changes will be the proposed design in the vicinity of the street tree. The Notional Root Zone and Structural Root Zone for trees located on adjoining land are indicated on the plan at Appendix 3a.
