17 March 2026

Arborist Impact Assessment & Report

37 Riverview Terrace, Belmont

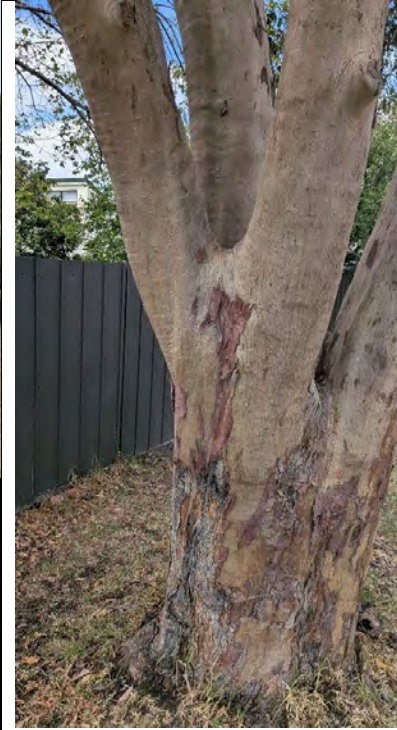
- 4.3.1. The NRZ of Tree 5 will be encroached by less than 10% of area and outside the SRZ. In accordance with Australian Standards AS 4970:2025, this constitutes a minor encroachment and does not warrant further investigation.
- 4.3.2. Provided the remainder of the NRZ is protected from construction activity and soil disturbance, the longterm health and stability of these trees is unlikely to be compromised (refer to Appendix 4).

Tree #	Species	NRZ Radius	NRZ Encroachment (%)	SRZ Encroachment (%)
5	<i>Lophostemon confertus</i>	8.2m	4.3%	0%

- 5.2.4. The NRZ area of **Tree 5** is encroached by 4.3% which is defined as minor under the standard. Per the applicable standard, this is considered a minor encroachment, which standard states that in general, it is unlikely that tree health, longevity or structure will be materially affected.

- 5.2.5. A mix of fencing and ground protection will be needed to protect trees from ancillary works. Tree Protection Fencing must be erected to the full extent of the NRZ to prevent material impact on tree health. The protection fencing to conform to AS4970 2025 (refer to Appendix 4).

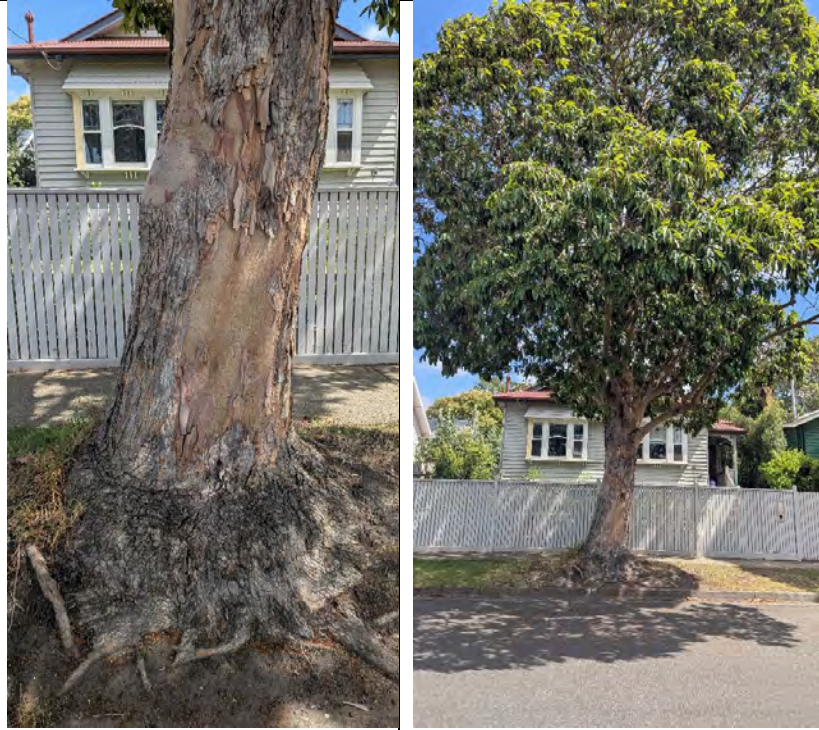
Tree 6

- 4.2.1. The Notional Root Zone (NRZ) of **Tree 6** will not be encroached by the proposed building or driveway footprint.
- 4.2.2. If the full extent of each NRZ is isolated from construction activity and soil disturbance, the long-term health and stability of these trees is not likely to be affected (refer Appendix 4).

- 5.2.2. The plan in Appendix 5 seeks to protect two street trees (**Trees 5 and 6**) in proximity to the works.
- 5.2.3. **Trees 6** is not encroached within the NRZ and therefore its health will remain unaffected.

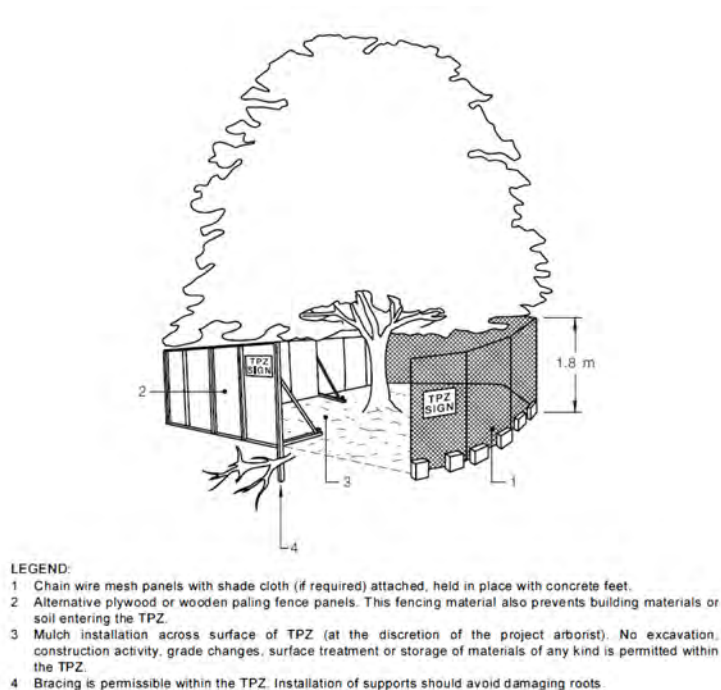
Figure 1: Protection Fencing

The actual fence specifications should be a minimum of 1.2 - 1.5 metres of chain mesh or like fence with 1.8 meter star pickets every 3-4 metres and a top line of high visibility plastic hazard tape. This fence will deter the entry of heavy equipment and vehicles and also the entry of workers and/or the public into the Tree Protection Zone. The tree protection zone shall be clearly signed on all visible sides “Tree Protection Zone – No entry without permission from site manager”

These fences should only be removed or shifted by the consent of the Responsible Authority.

The area inside this Tree Protection Zone should be mulched with a covering of approximately 75mm of woodchip mulch or like material.

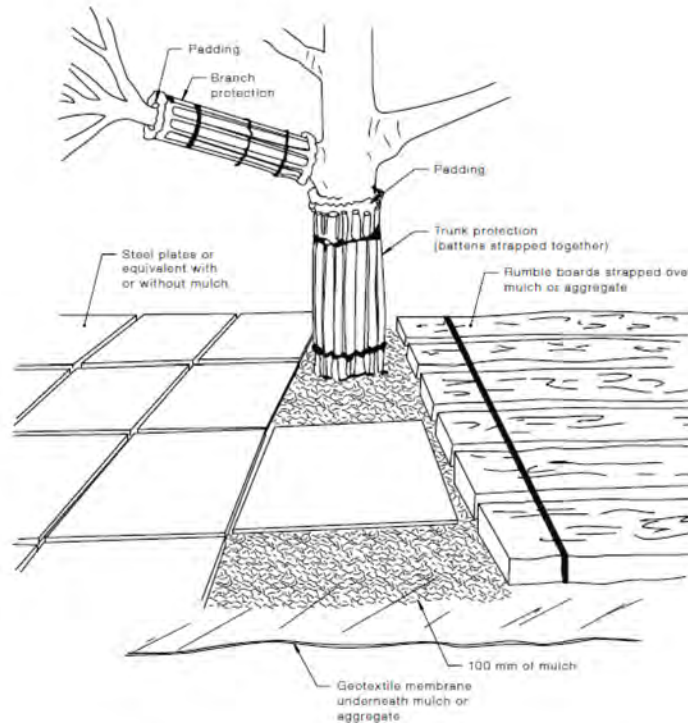
If temporary access is required through a Tree Protection Zone this may be carried out using sheets of heavy plywood or like protection but should not be considered for long term requirements (see figure 2).

Figure 2. Protection of tree during temporary access arrangement.
