## Land Capability Assessment For Proposed Development

165 Waurin Ponds Drive, Waurin Ponds

July 2026

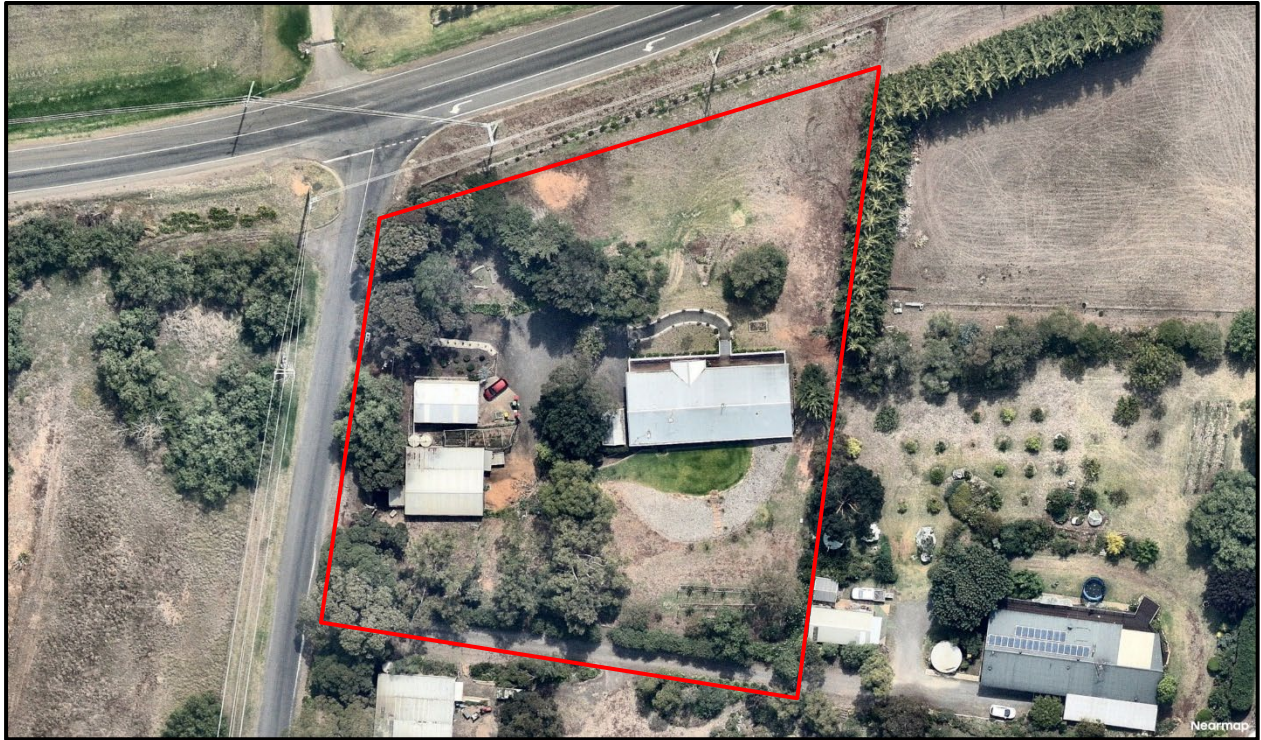
Figure 1: Aerial photograph of the site and surrounding area, nearmap.com.

The subject site is on the southside of the street. The site slopes towards the north. The site aspect is good with respect to exposure to sunshine and wind. Surface drainage is considered to be fair. The natural soil types comprise loam and sandy loam. Existing vegetation consists mainly of grasses in the proposed effluent disposal area. The site has been heavily modified (cuttings) to accommodate an access road and existing buildings. A satellite view of the site is presented in Figure 1.

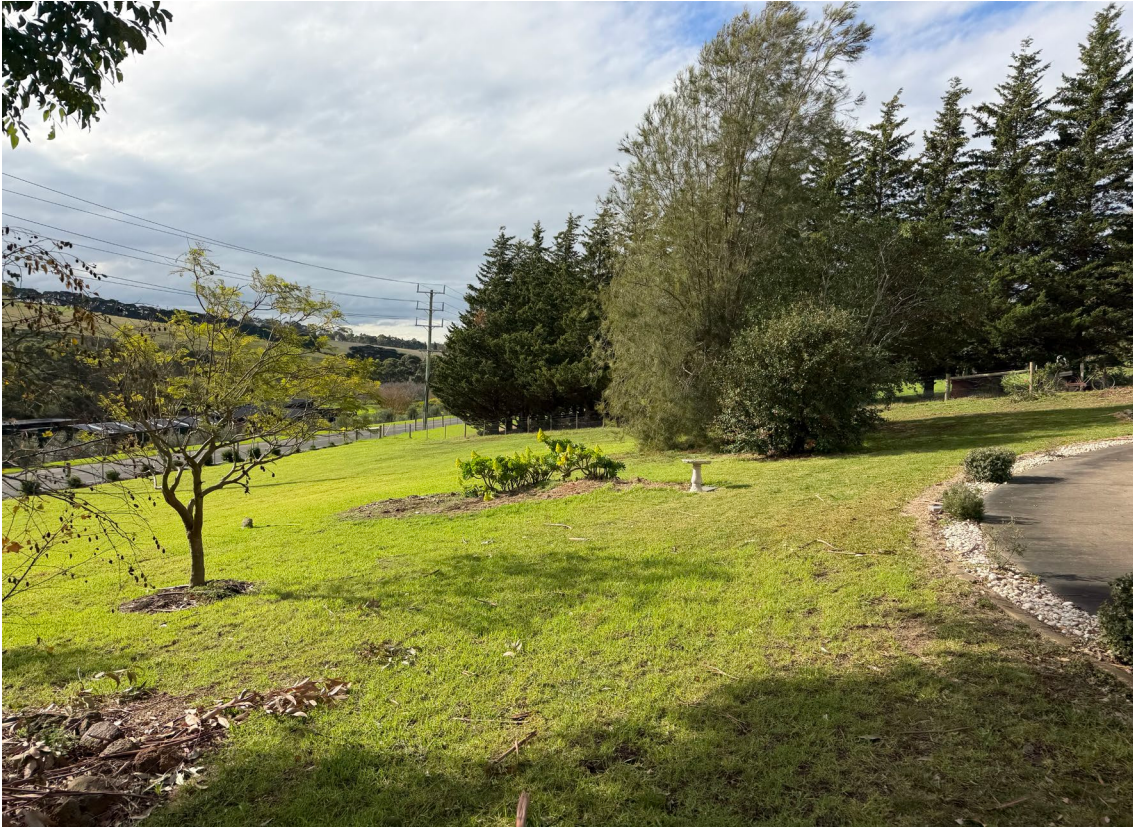
Photo 1: Existing site conditions, proposed land application area, north-east view

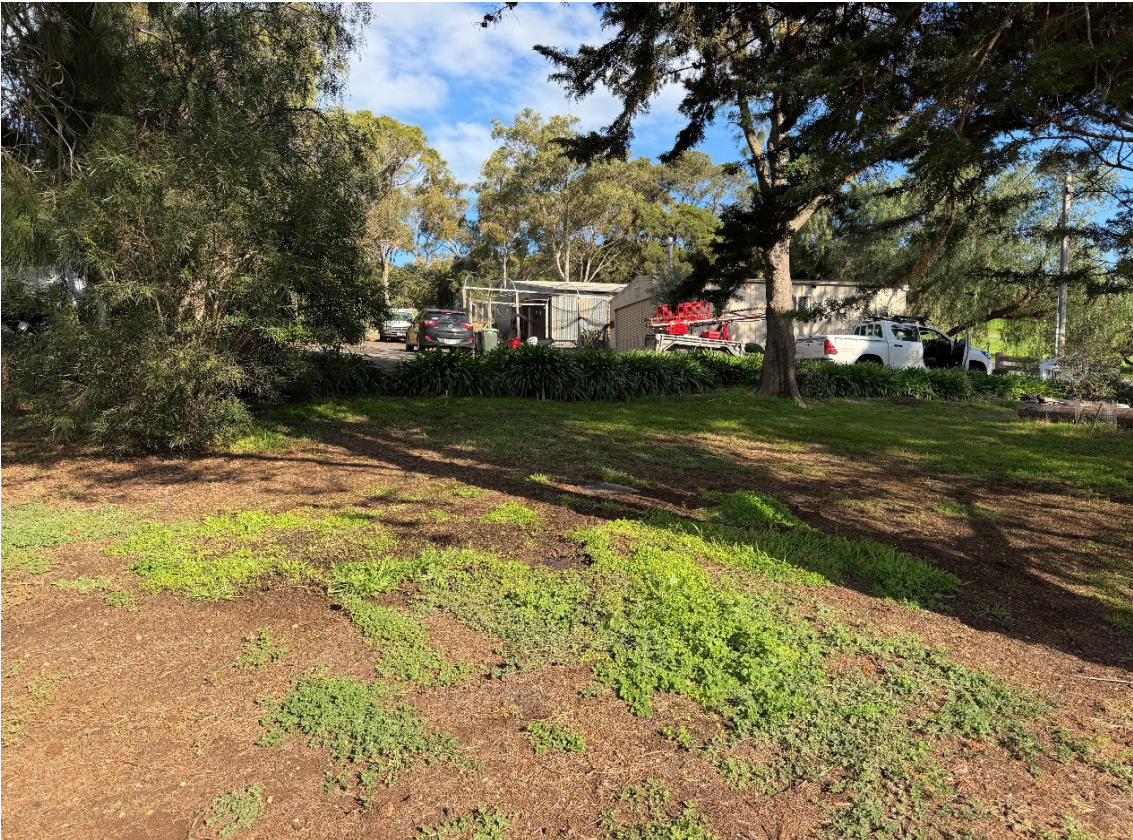
Photo 2: Existing site conditions, inferred existing land application area

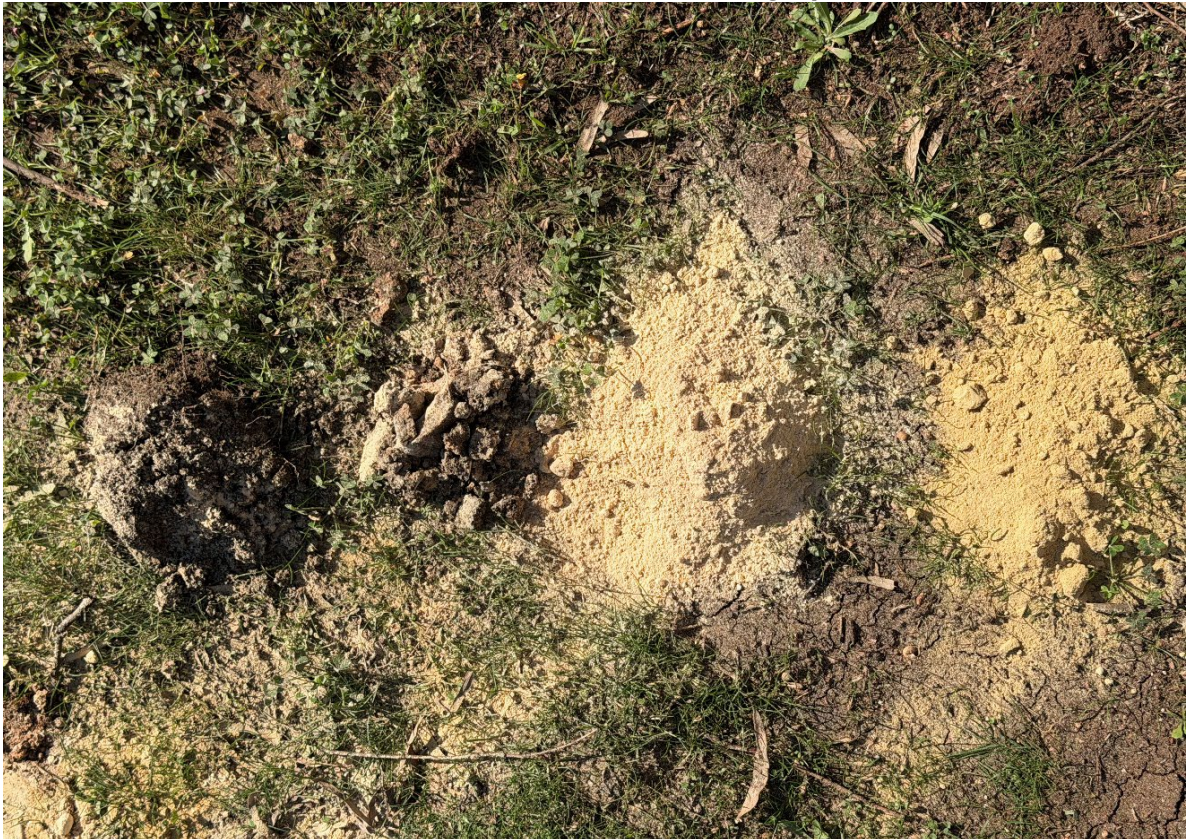
Photo 3: Extruded borehole 1 profile

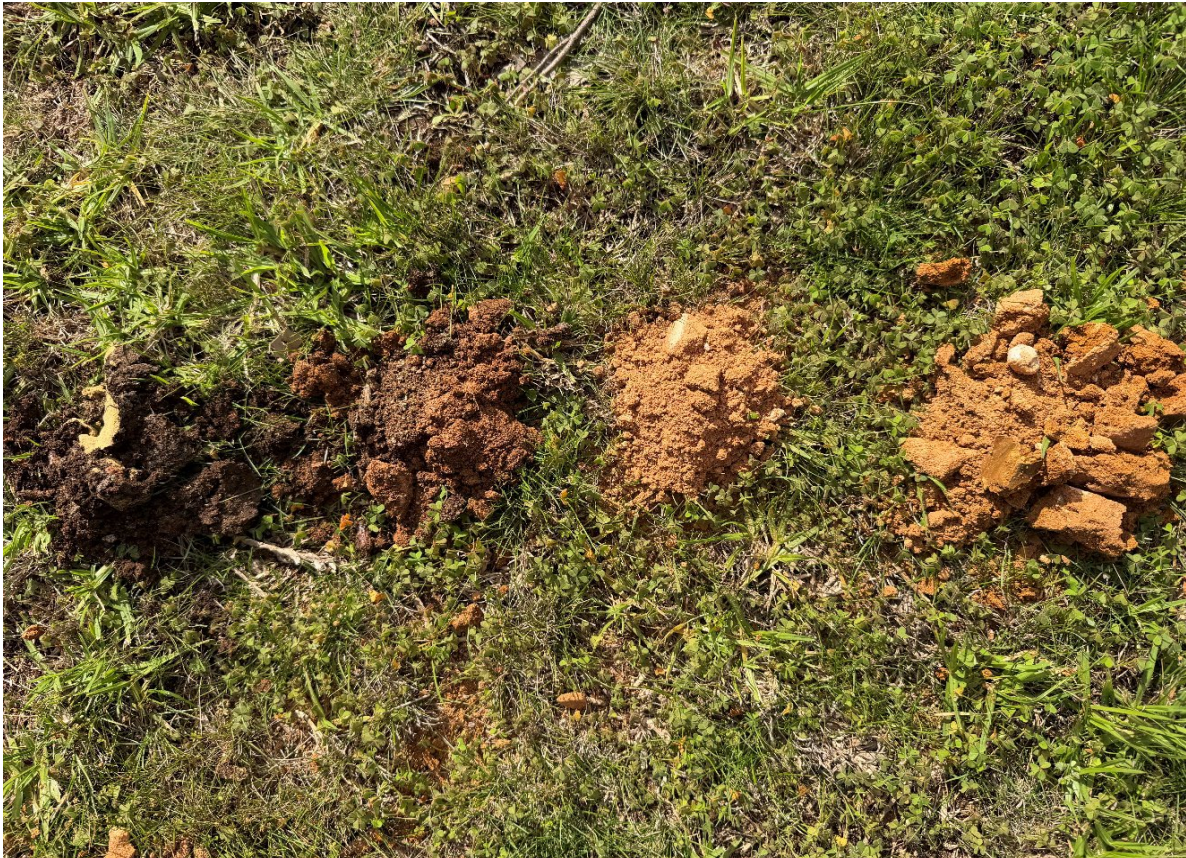
Photo 4: Extruded borehole 2 profile
