# **Sustainability Management Plan**

**98 Marshalltown Road,  
Grovedale**

**Melbourne  
Sustainability  
Consultants.**

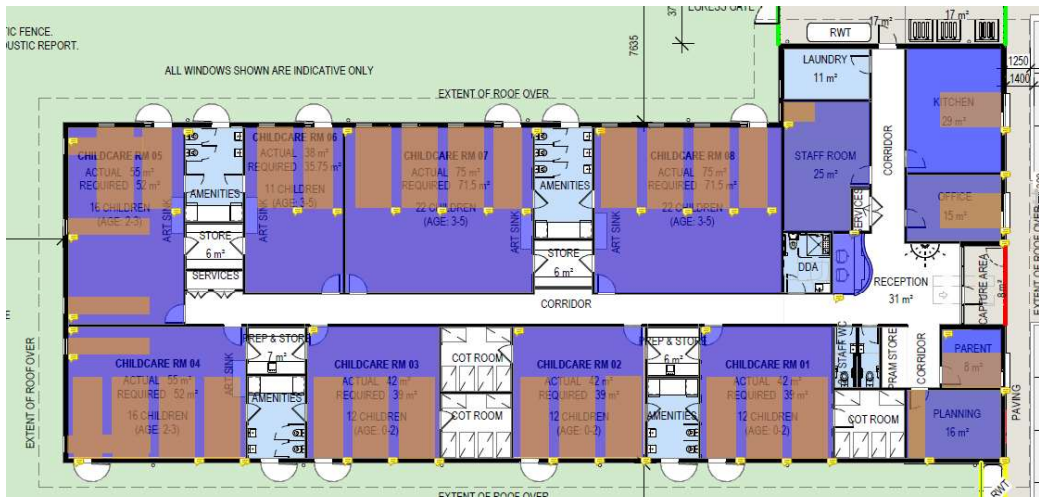
Working plane is 400mm for child rooms, 700mm for office. See below for a mark-up of nominated areas (blue) and compliant areas (orange):

Figure 3: Daylight Hand Calculation mark-up.

Note the below table represents daylight performance outcomes.
