Newland Developers Pty Ltd

**Warralily Desktop Contamination
Assessment**

Desktop Contamination Assessment to Support
Council Exhibition Requirements

ENAUABTF20214AA-R01

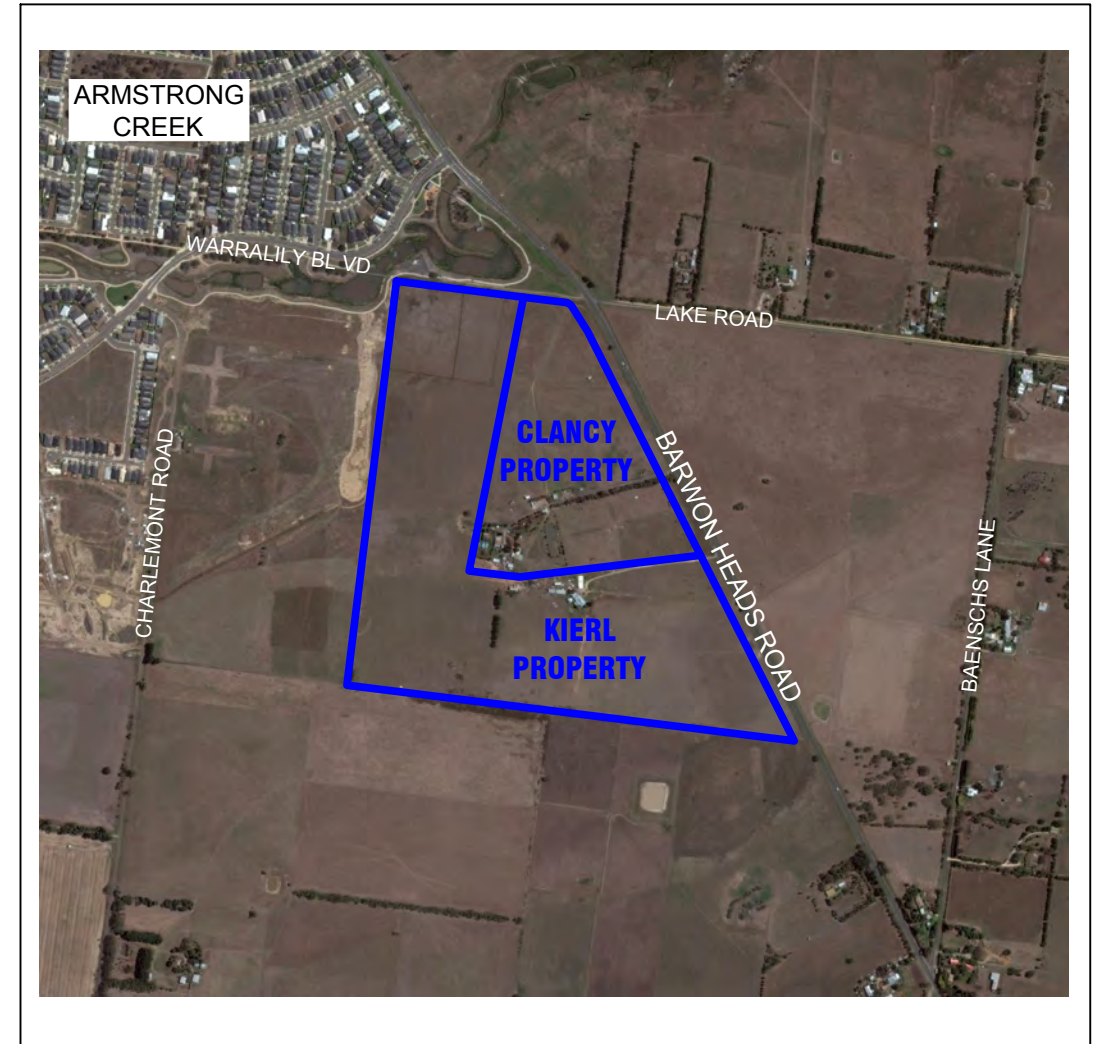
client:	NEWLAND DEVELOPERS PTY LTD		
project:	892-958 & 960-990 BARWON HEADS ROAD BARWON HEADS, VICTORIA		
title:	SITE LOCALITY PLAN		
project no:	ENVAUBTF20214AA-R01	figure no:	FIGURE 1
rev:	A

REGIONAL AREA MAP

LOCAL AREA MAP

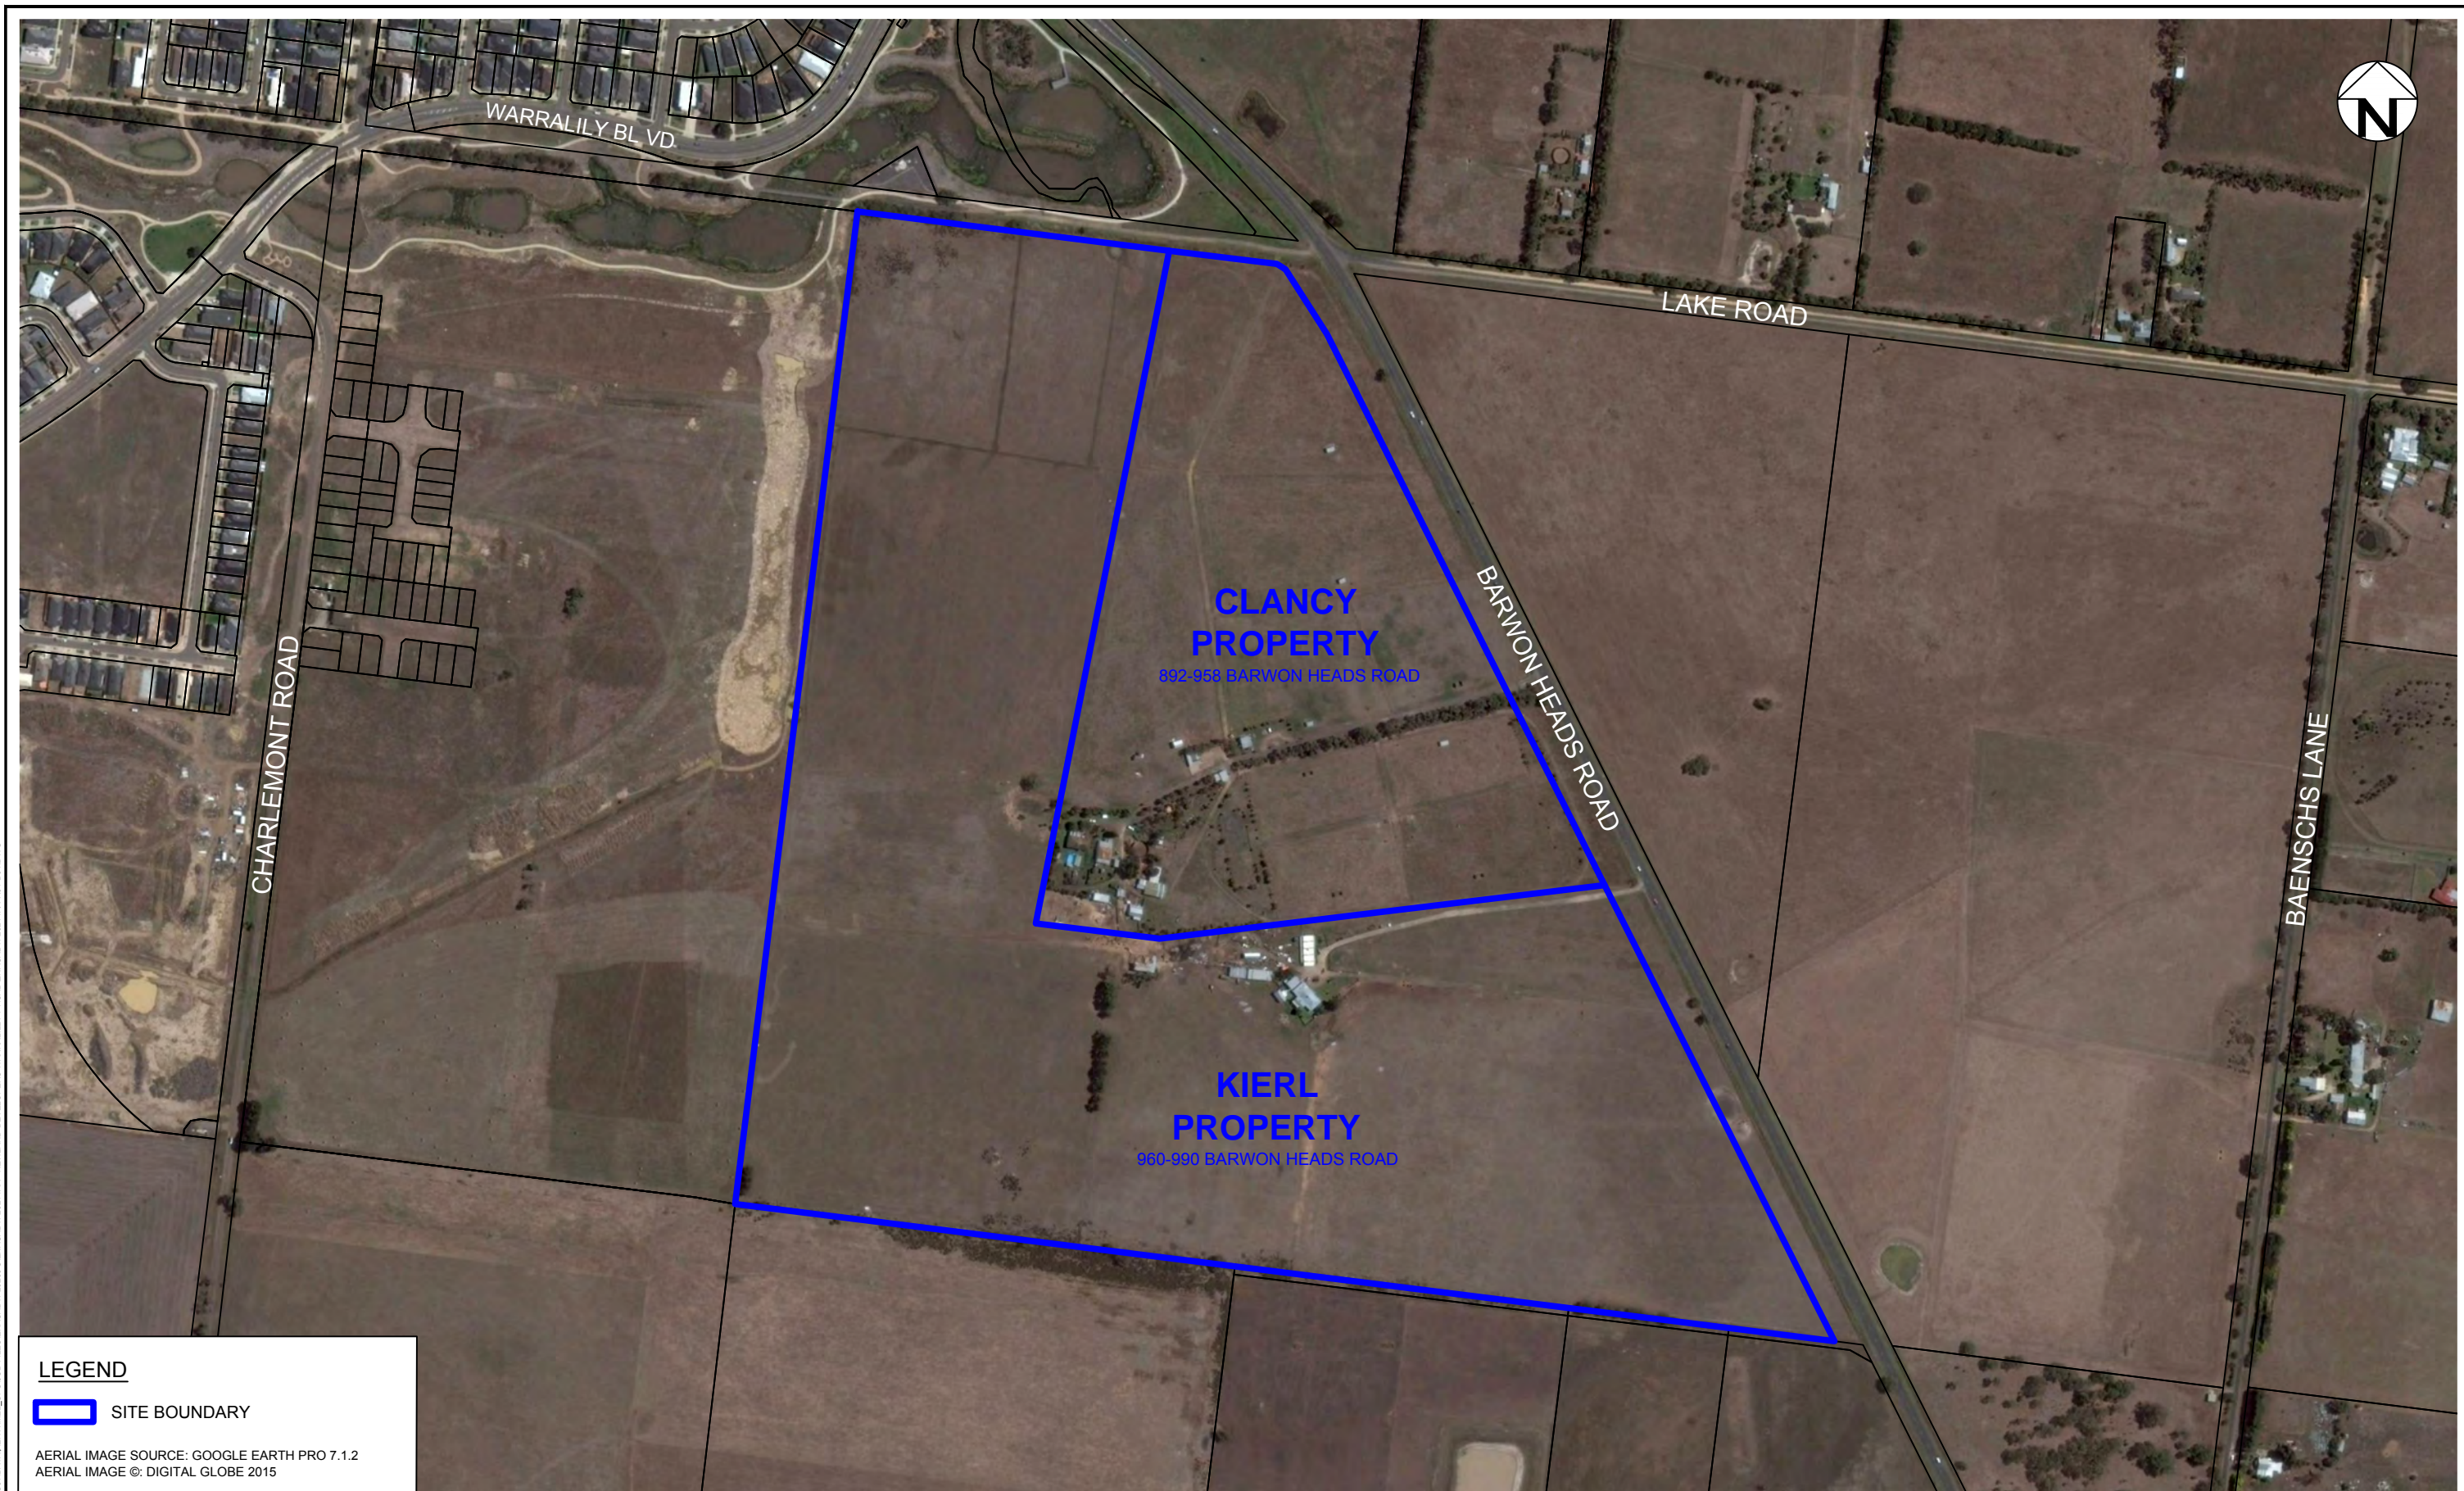
client:	NEWLAND DEVELOPERS PTY LTD		
project:	892-958 & 960-990 BARWON HEADS ROAD BARWON HEADS, VICTORIA		
title:	SITE PLAN		
project no:	ENAUABTF20214AA-R01	figure no:	FIGURE 2
rev:	A

SITE BOUNDARY
