9 Bridge Road, Barwon Heads

Heritage Values Review

May 2016

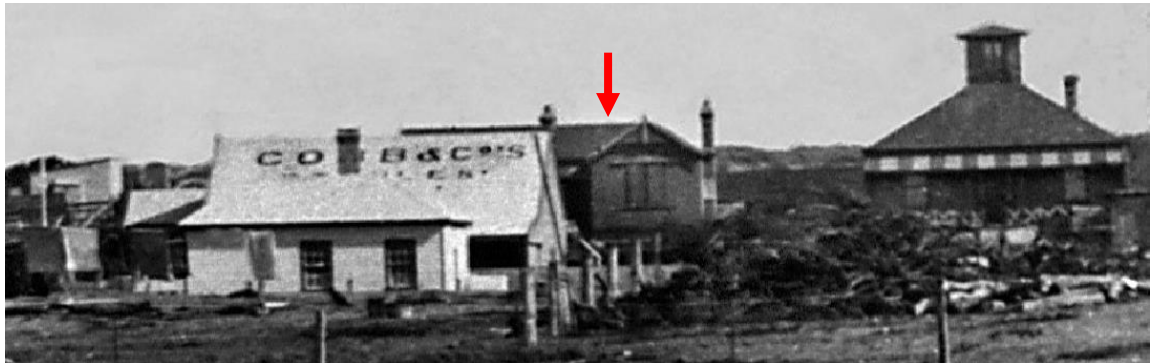
On 13 April 1892, ownership was transferred to Joseph Gell (tailor, Geelong). The house appears in the c.1895 photograph below.

'View of Barwon Heads looking south about 1895.' The Cobb & Co. stables can be seen the foreground. Refer appendix for full photograph. The subject house is indicated in the background.

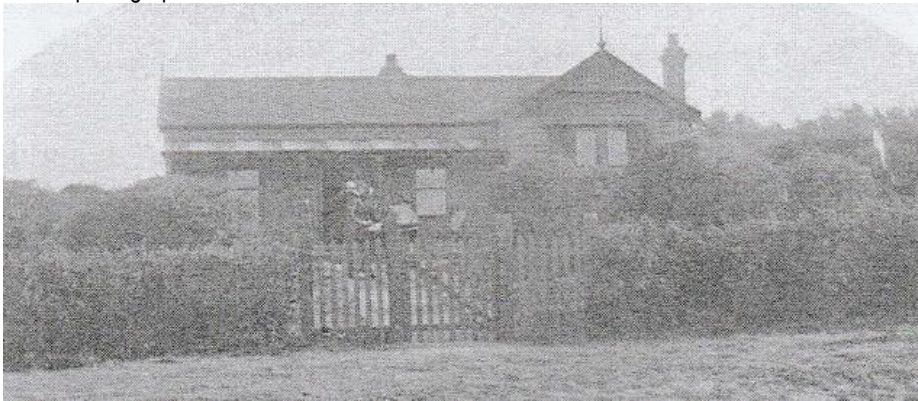
The c.1900 photograph below shows that originally the house, known to the Thomas family as 'The Cottage', only had one projecting gable end (west side). The front verandah had a striped roof and there was a double hung sash window either side of the centrally located entrance. It is possible that the verandah posts at this time may have been cast iron (difficult to determine from the photograph). The gable end featured a finial and vertical slatted timber detailing, and a window with sliding shutters. There were two chimneys, one to the west side and a central one to the rear. The

photograph also shows timber picket fencing and established hedging and shrubs which are not evident in the earlier c.1895 photograph.

'The Cottage' c.1900. Note the fencing and established hedging and shrubs.
(Source: CW Coates & M L Burrows (nee Thomas), *The Thomas Family of Illogan, Cornwall and Beaufort, Victoria*, p9)

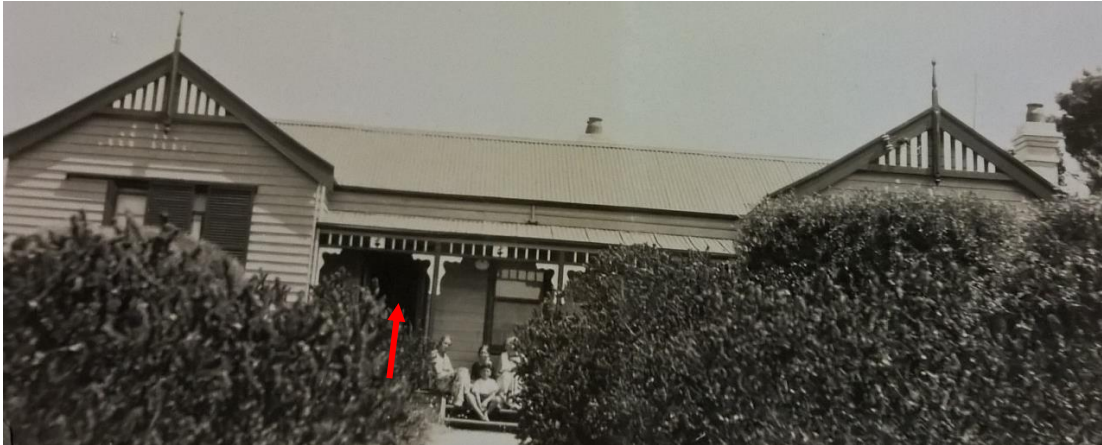
Sometime between 1900 and 1930 (more likely to have been 1900s-1910s than the 1920s) the house was enlarged on the east side with the introduction of another gable end matching that to the west side. The entrance was relocated

from its central position to the eastern end of the verandah, and a window replaced the former door opening. It is possible that the frieze and posts to the verandah may have been replaced at this time.

c.1930. The introduced gable end is on the left. The relocated entrance is indicated by an arrow.
(Source: Thomas Family)

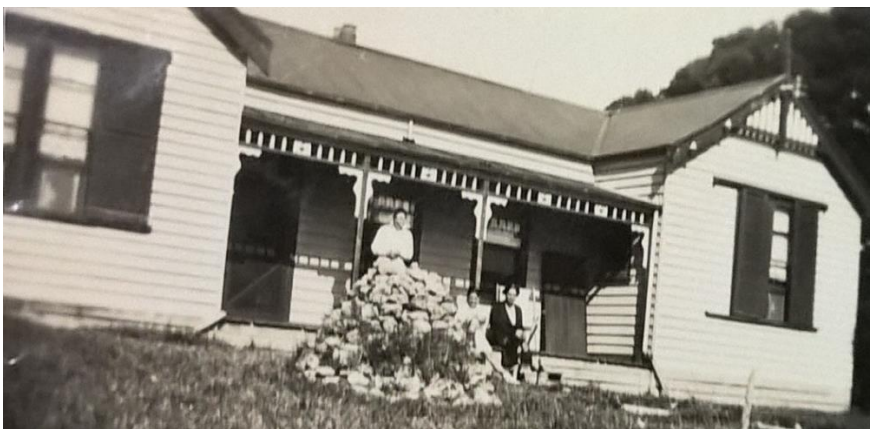
c.1935
(Source: Thomas Family)

During the 1940s the windows to the gable ends were replaced with tripartite windows with double hung sashes at the sides. Further changes were also made to the verandah with the entrance relocated to the east end and glass windows fitted to the western part of the verandah (two of the earlier flyscreen openings were retained to the eastern part). A pair of young cypress trees in the front yard are evident in photographs of this time.

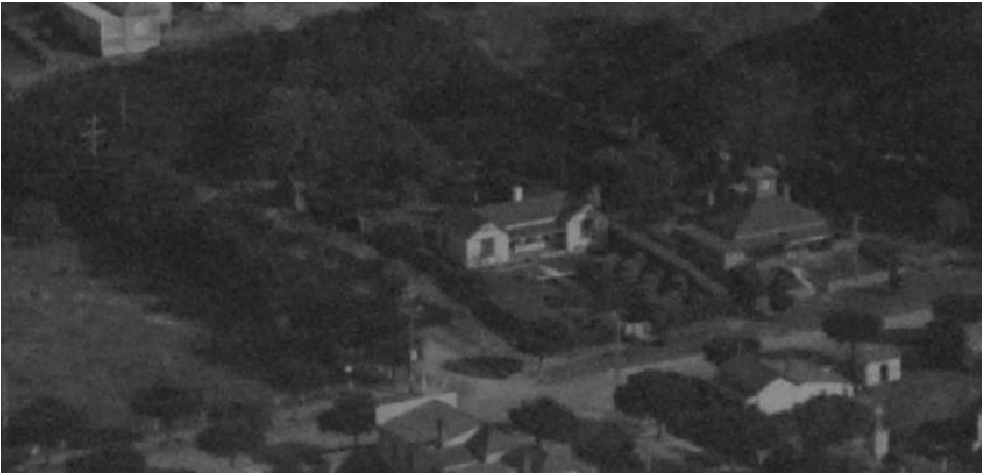
April 1936, prior to the alteration to the verandah.
(Source: State Library of Victoria, H91.160/606)

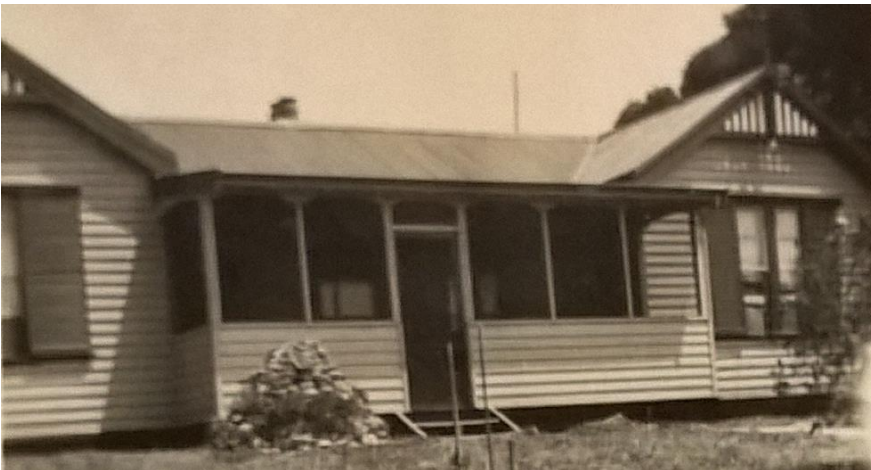
In about 1937, the front verandah was extended forward of the gable ends and enclosed with weatherboards to the lower part and slightly arched window openings, most likely fitted with flyscreens, to the upper part (this was probably a sleep-out, a common feature of the Interwar period for its healthful benefits). The entrance was through the front of the enclosed verandah.

c. 1939. Note the extended and enclosed verandah.
(Source: Thomas Family)

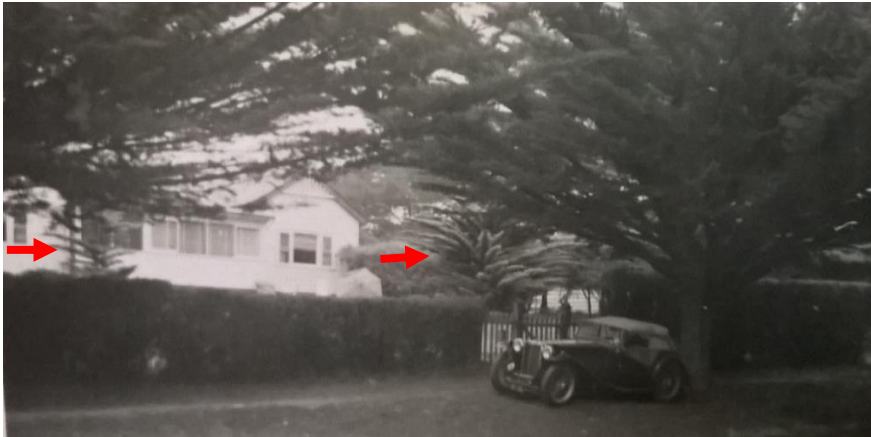
1940s. Note the new windows to the gable ends. Two young cypress tree are visible in the front yard. (Source: Thomas Family)

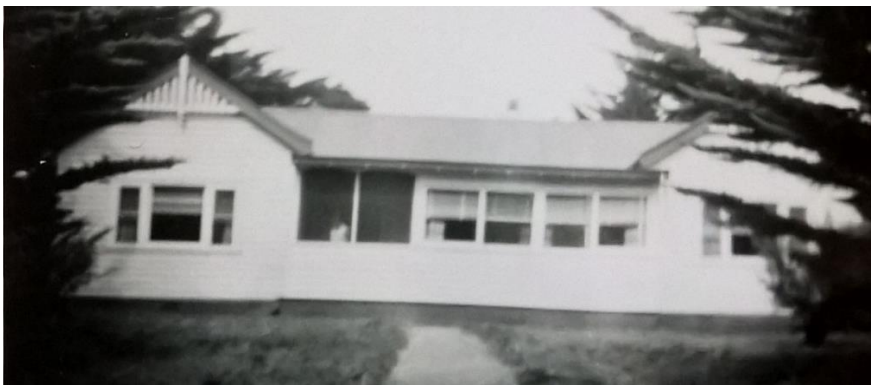
1955. Note the glass windows to the western part of the verandah. (Source: Thomas Family)

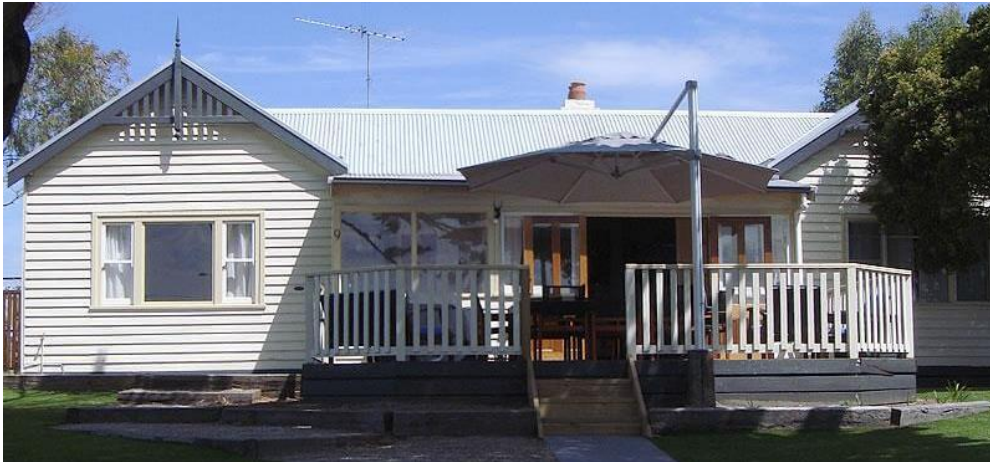
Front

The front elevation is comprised of two gable ends (west gable original, east gable early 20th century) either side of an enclosed verandah (enclosed c.1937) which projects about half a metre forward. The gable ends retain their original slatted timber detailing and worked timber finials (replaced c.late 20th century – 1950s photo shows east finial broken). The windows to the the gable ends, introduced during the 1940s, are tripartite with sashes to the side sections and replaced earlier windows in the same location with sliding timber shutters. The roof is clad in corrugated sheet metal (like original). The rendered chimney located to the rear (although visible from the front) is original and retains a pair of terracotta chimney pots. It appears that the second chimney to the west side no longer remains. A modern deck has been introduced to the front of the house with a low timber balustrade.

It is fortunate in this instance that clear photographic documentation survives of the house's earlier appearance (the 20th century photographs in particular), such that the missing details and configuration of the verandah and the windows to the gable ends could potentially be reconstructed to an earlier appearance.

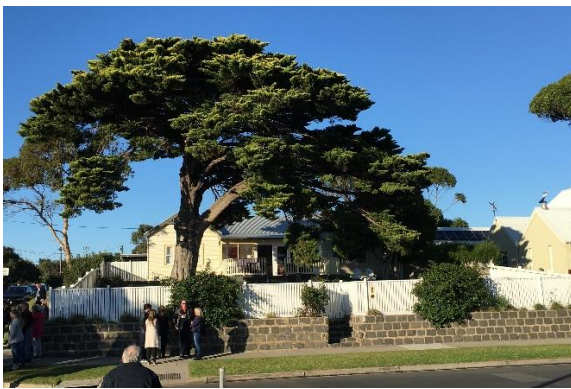
The single storey weatherboard house is centrally positioned on the highest part of the site. The land slopes downwards at the front and the rear of the property. The front yard is enclosed by a low timber fence (not the original, but sympathetic) which sits atop a bluestone retaining wall (dating to the mid-late 20th century) along the front boundary. In the front yard there is a large cypress tree (one of a pair planted c.1940).

Large cypress tree in front yard

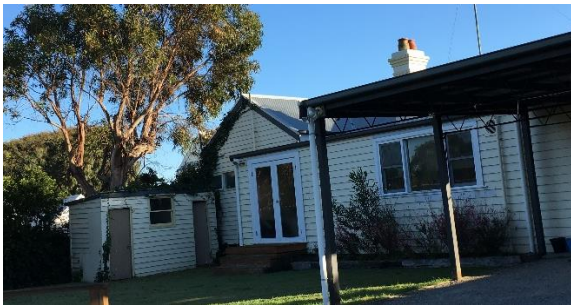
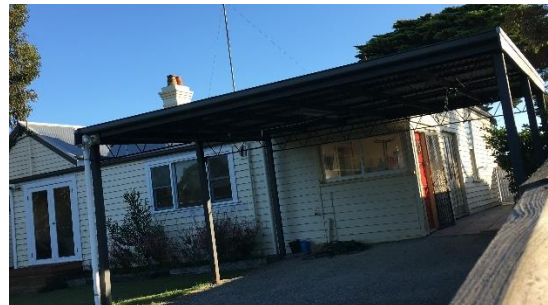
To the rear there is a skillion/flat roofed section which may have been an addition or modified. The gable end remains exposed to the west. There is a freestanding timber outbuilding and a carport. The rear has some visibility from Hitchcock Avenue over the timber paling fence.

Rear of the house

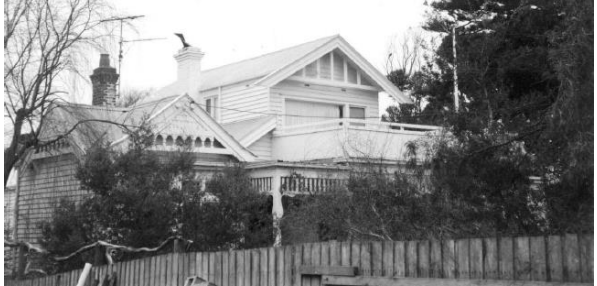
Description	Image
<p>18 Ewing Blyth Drive Built c.1886-1890 Altered 1977, and post-2000 Integrity (according to GGOAHS): Fair Weatherboard house, corrugated sheet metal roof, 2 early chimneys, return verandah. Alterations include a skillion addition and a 2 storey rear addition. Almost entirely concealed by vegetation.</p> <p>Included in Flinders Heritage Area (HO1649)</p>	  <p>(Source: Google Maps)</p>
<p>33 Flinders Parade Built 1891 Altered 1893, 1922-23 Integrity (according to GGOAHS): Good Substantial weatherboard guesthouse, return verandahs, corrugated sheet metal roof. Alterations include substantial 19th century additions, the verandah and loss due to fire damage. Partly concealed by vegetation (front views).</p> <p>Included in Flinders Heritage Area (HO1649)</p>	  <p>(Source: Google Maps)</p>
<p>39 Flinders Parade Built 1890-91 Altered 1912, c.1990 Integrity (according to GGOAHS): Fair Weatherboard house, early chimneys, bay windows, shingling to gable ends, projecting flat roofed verandah with worked timber posts and frieze. Alterations include prominent c.1990 second storey gable addition with balcony. Substantial Norfolk pine trees at front. Entirely concealed by vegetation.</p> <p>Included in Flinders Heritage Area (HO1649)</p>	  <p>(Source: Google Maps)</p>

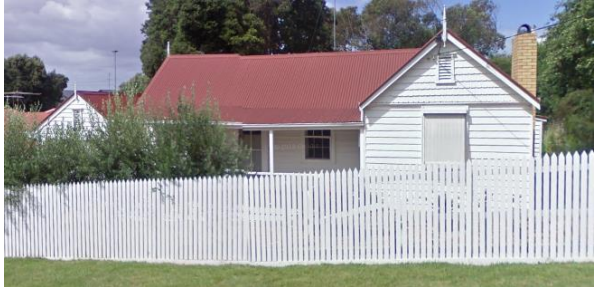
<p data-bbox="831 546 1007 577">(Source: GGOAHS)</p>
<p data-bbox="284 589 485 618">8 Grandview Parade</p> <p data-bbox="284 629 395 658">Built c.1891</p> <p data-bbox="284 669 564 698">Dates of alterations unknown</p> <p data-bbox="284 710 655 739">Integrity (according to GGOAHS): Fair</p> <p data-bbox="284 750 778 936">Weatherboard house, corrugated sheet metal roof, gable end to front with shingling and ventilator, finials, front skillion roofed verandah, multi-paned windows. Alterations include verandah details, chimney, recent windows to side, rear lean-to extension, freestanding garage.</p> <p data-bbox="284 947 464 976">Visible from street.</p> <p data-bbox="284 1025 719 1055">Included in Flinders Heritage Area (HO1649)</p>

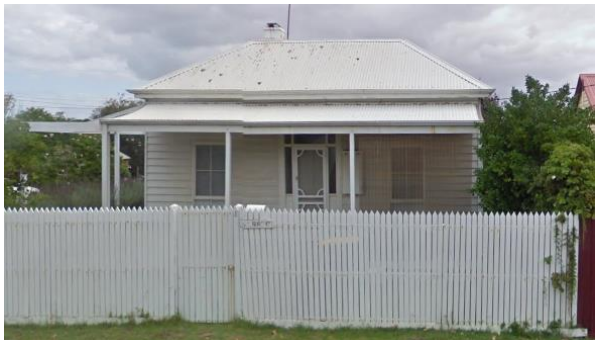
<p data-bbox="831 875 1038 904">(Source: Google Maps)</p>
<p data-bbox="284 1077 448 1106">1 Margate Street</p> <p data-bbox="284 1117 395 1146">Built c.1875</p> <p data-bbox="284 1158 501 1187">Altered 1918-19, 1978</p> <p data-bbox="284 1198 655 1227">Integrity (according to GGOAHS): Fair</p> <p data-bbox="284 1238 799 1391">Weatherboard house, corrugated sheet metal hipped roof, concave front verandah. Alterations include aluminium framed windows, verandah posts, and the removal of a substantial pine tree in the front (post-2000).</p> <p data-bbox="284 1402 564 1431">Relocated to site in 1918-19.</p> <p data-bbox="284 1442 464 1471">Visible from street.</p> <p data-bbox="284 1520 719 1550">Included in Flinders Heritage Area (HO1649)</p>

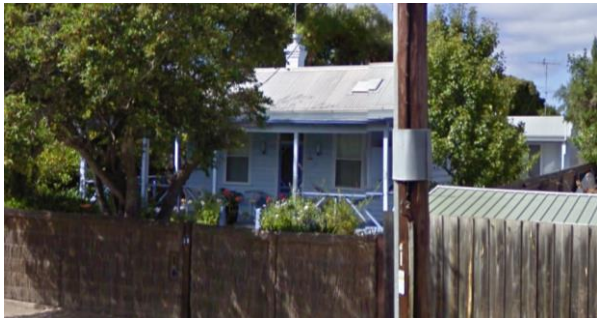
<p data-bbox="284 1574 437 1603">19 Ozone Road</p> <p data-bbox="284 1615 395 1644">Built c.1890</p> <p data-bbox="284 1655 517 1684">Altered 1918-19, c.1940</p> <p data-bbox="284 1695 655 1724">Integrity (according to GGOAHS): Poor</p> <p data-bbox="284 1736 778 1823">Weatherboard house, corrugated sheet metal roof, return verandah, early chimney. Has been substantially altered and extended.</p> <p data-bbox="284 1834 564 1863">Relocated to site in 1918-19.</p> <p data-bbox="284 1874 464 1904">Visible from street.</p> <p data-bbox="284 1953 719 1982">Included in Flinders Heritage Area (HO1649)</p>

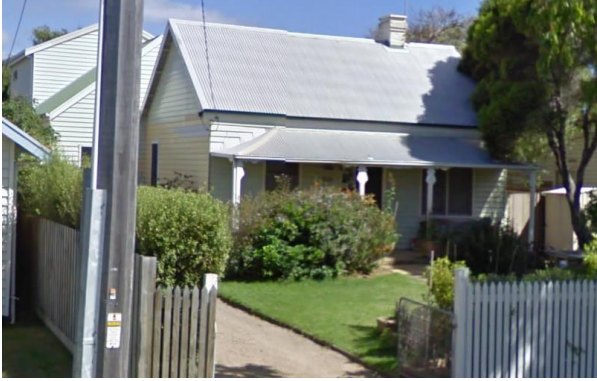
Description	Image
<p>11 Grove Road Built c.1890 Alterations 1916-17, c.1973 Integrity (according to GGOAHS): Fair Weatherboard house, corrugated sheet metal gable roof, concave verandah. Alterations include chimney (c.1916), two storey rear additions, possibly front windows. Apparently relocated to site 1916-17. Visible from street.</p> <p>Individual Heritage Overlay (HO1676)</p>

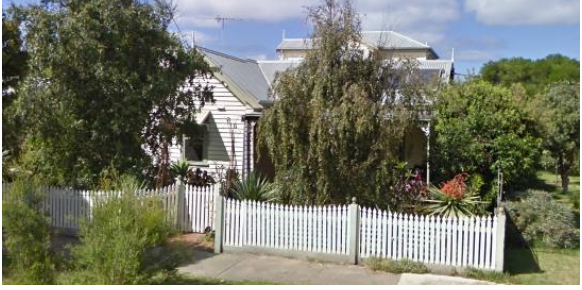
<p>(Source: Google Maps)</p>
<p>31 Ozone Road Built c.1890 Altered 1918-1919 Integrity (according to GGOAHS): Fair Weatherboard house, corrugated sheet metal gable roof, skillion front verandah, timber finials. Alterations include chimneys (c.1918), verandah posts and brackets. Apparently relocated to site 1918-19. Visible from street.</p> <p>Individual Heritage Overlay (HO1695)</p>

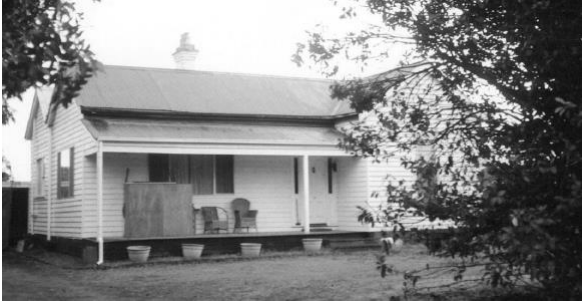
<p>(Source: Google Maps)</p>
<p>29 Seaview Avenue Built c.1891 Altered 1977 Integrity (according to GGOAHS): Fair Weatherboard house, parallel gable roof forms with corrugated sheet metal, projecting gable end to front, front verandah, chimney. Alterations include, verandah posts, aluminium framed sliding windows. Partly obscured from street – large trees</p> <p>Individual Heritage Overlay (HO1700)</p>
