## **Cultural Heritage Management Plan – Notice of Approval**

*'35 hams Road and 151-229 Anglesea Road, Waurin Ponds – Proposed Residential' Subdivision'*

**Cultural Heritage Management Plan number: 14600**

**Cultural Heritage Management Plan**

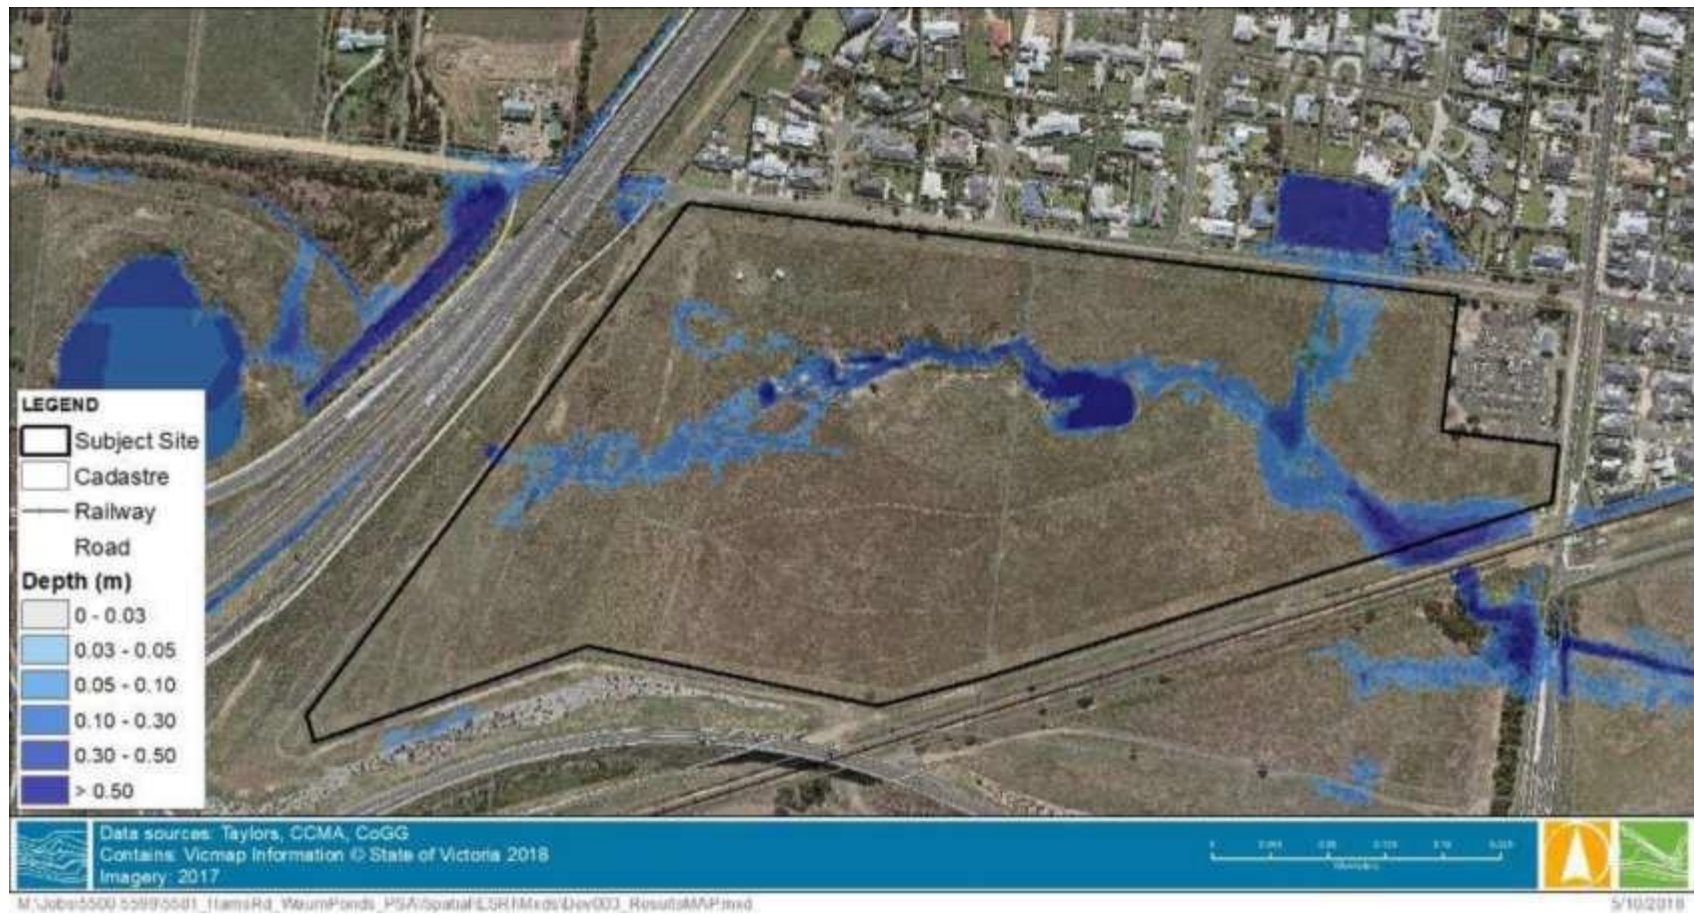
Figure 2: Hydrology Model

Wadawurrung have agreed to an 'on-line water treatment system' in which the retention basins are constructed within the Armstrong Creek linear reserve. This system is shown in the development plan in Figure 1. Wadawurrung have agreed to allow works on Armstrong Creek on the condition that the alignment of the creek is such that it is consistent with the existing hydrology model shown in Figure 2.

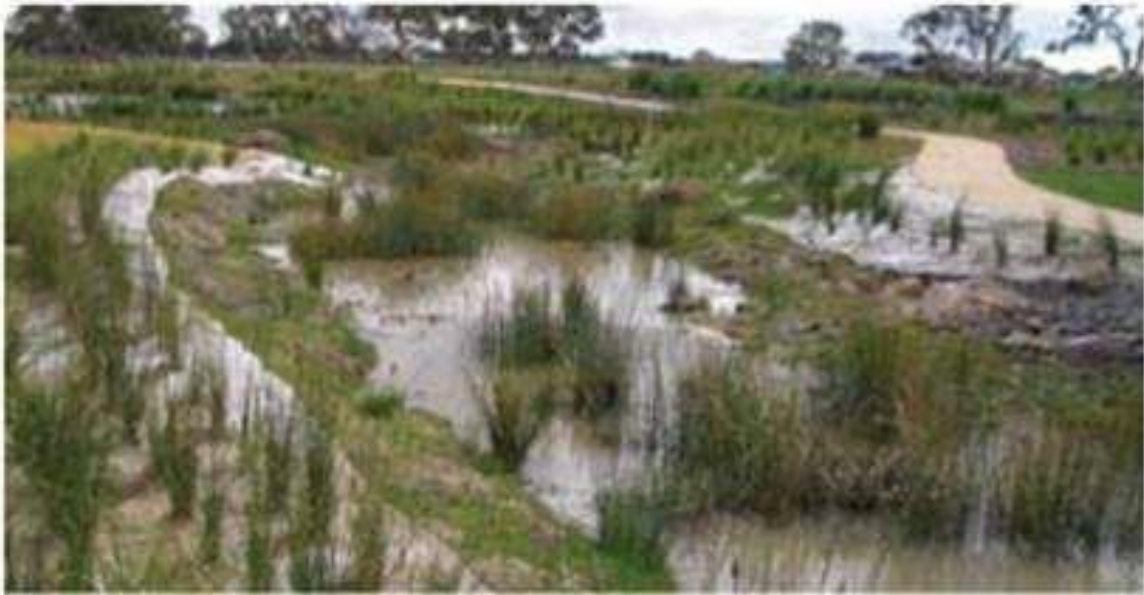
**Plate 27: Example of retention basins to be used at Armstrong Creek.**

The construction of the retention basins must be broadly in keeping with the image that were presented to Wadawurrung at the meeting held on 2<sup>nd</sup> October, 2018 and shown below in Plate 27.

The retention basins must be constructed broadly in keeping with Plate 28 to ensure that they enhance the aesthetic value of the area as required by Wadawurrung.

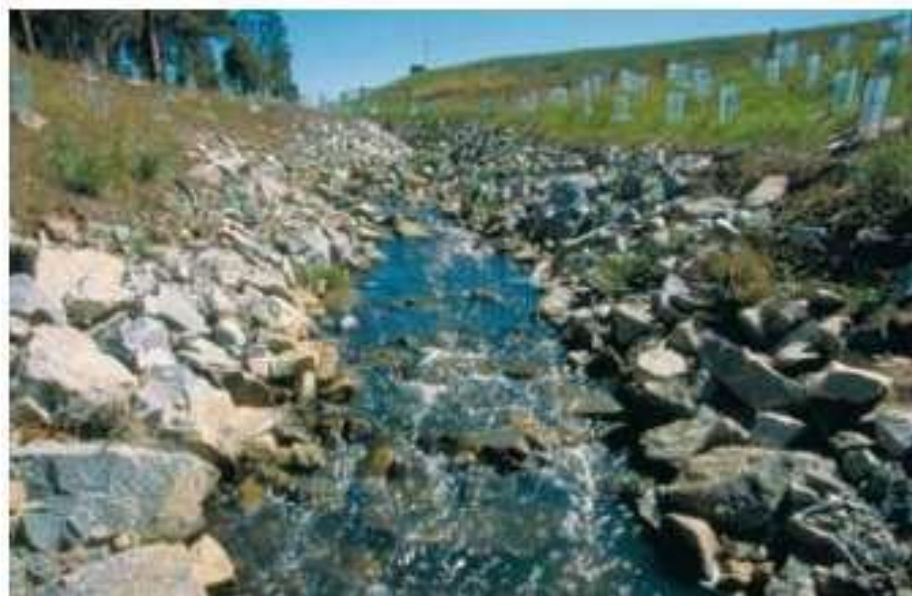
**Plate 28: Example of rock beaching/armouring to be used at Armstrong Creek.**

Works on Armstrong Creek, including rehabilitation works and the installation of rock beaching/armouring must be broadly in keeping with the image that were presented to Wadawurrung at the meeting held on 2<sup>nd</sup> October, 2018 and shown below in Plate 28.

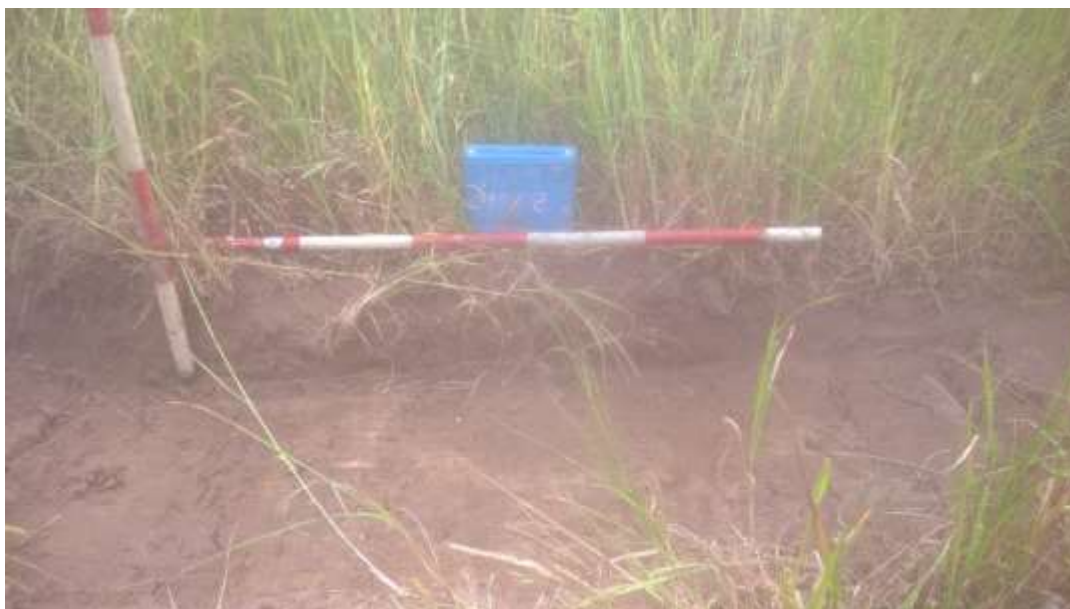
Plate 22: MT2 Stratigraphy

The stratigraphic profiles of the individual shovel test pits are contained in Table 5. Photographs showing examples of the Machine Trenches (MTs) excavated are shown in Plates 22-24.

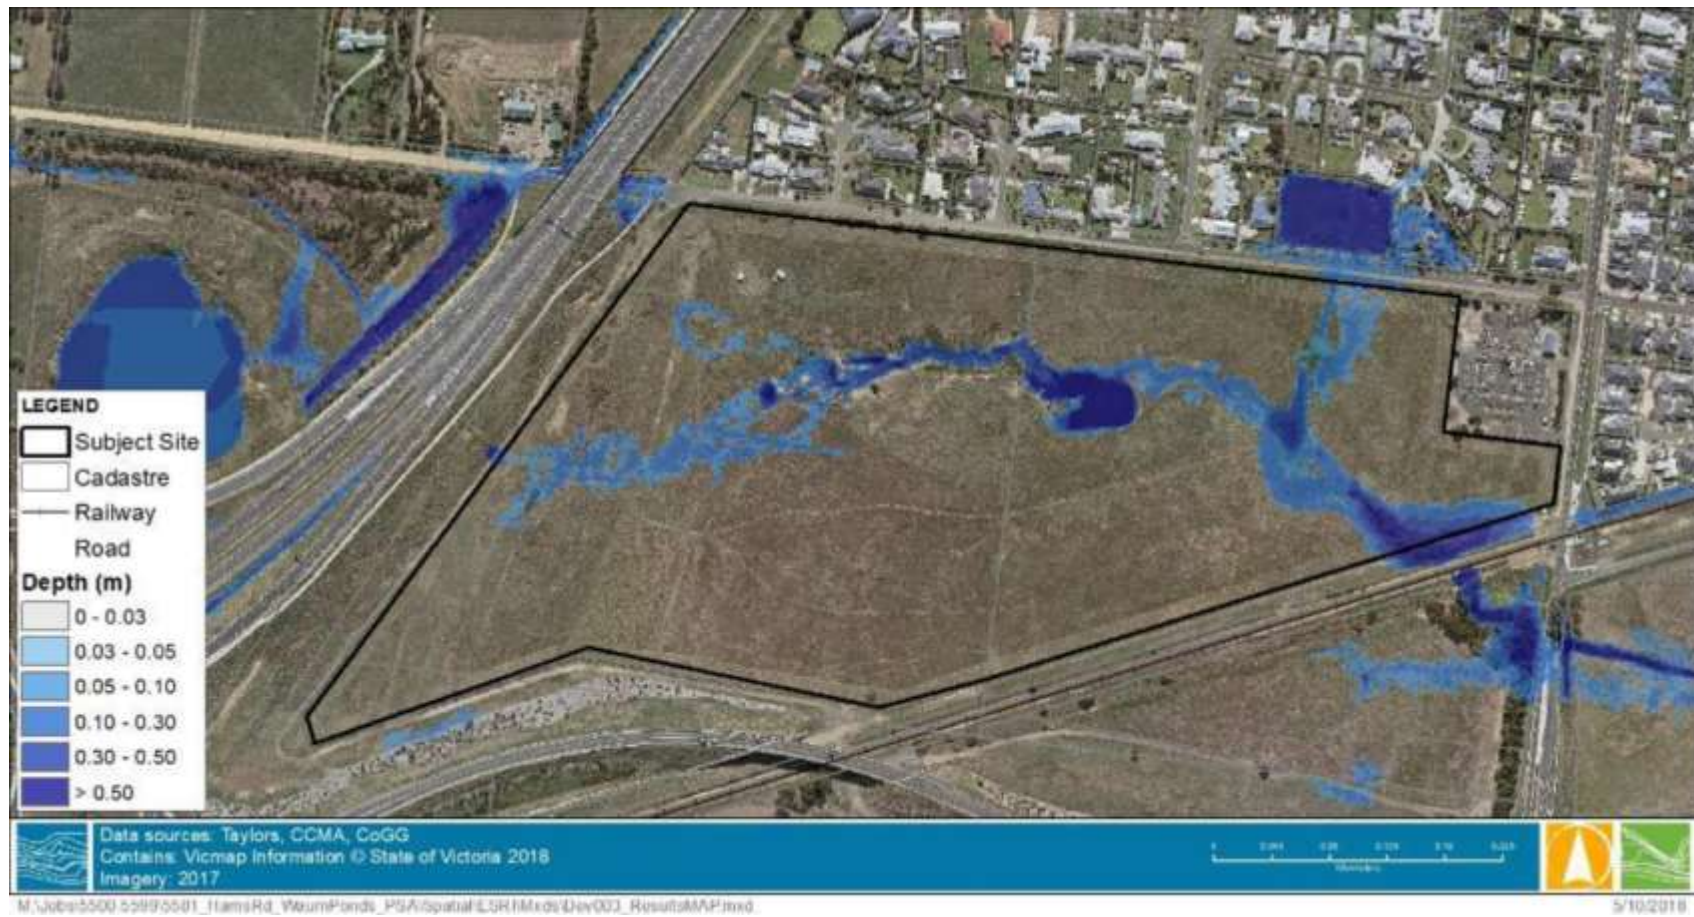
Figure 2: Hydrology Model

Wadawurrung have agreed to an 'on-line water treatment system' in which the retention basins are constructed within the Armstrong Creek linear reserve. This system is shown in the development plan in Figure 1. Wadawurrung have agreed to allow works on Armstrong Creek on the condition that the alignment of the creek is such that it is consistent with the existing hydrology model shown in Figure 2.

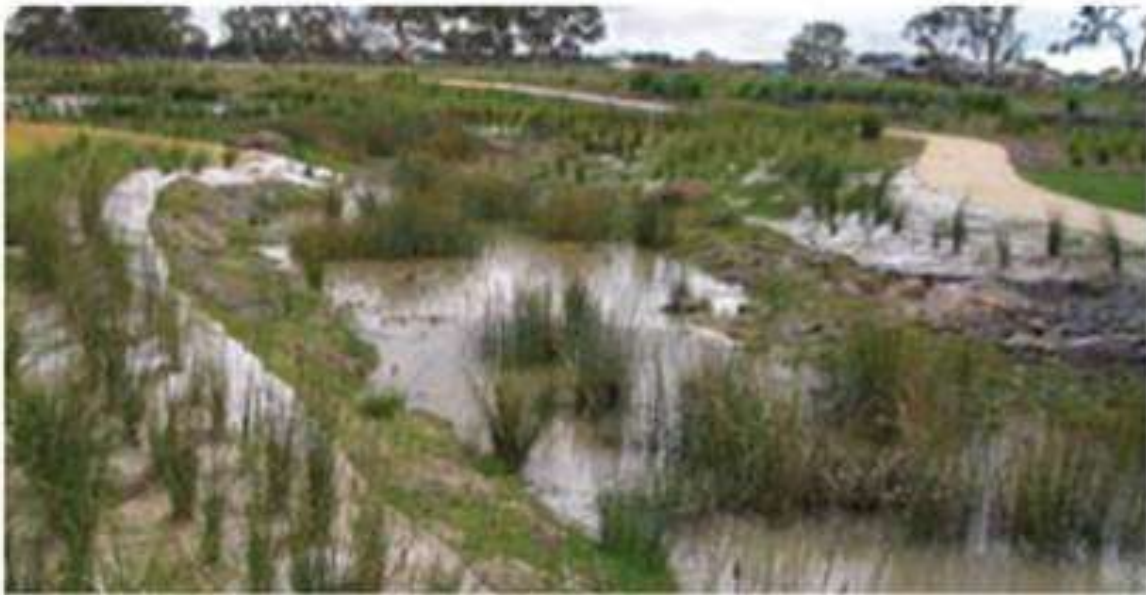
**Plate 27: Example of retention basins to be used at Armstrong Creek.**

The construction of the retention basins must be broadly in keeping with the image that were presented to Wadawurrung at the meeting held on 2<sup>nd</sup> October, 2018 and shown below in Plate 27.

The retention basins must be constructed broadly in keeping with Plate 28 to ensure that they enhance the aesthetic value of the area as required by Wadawurrung.

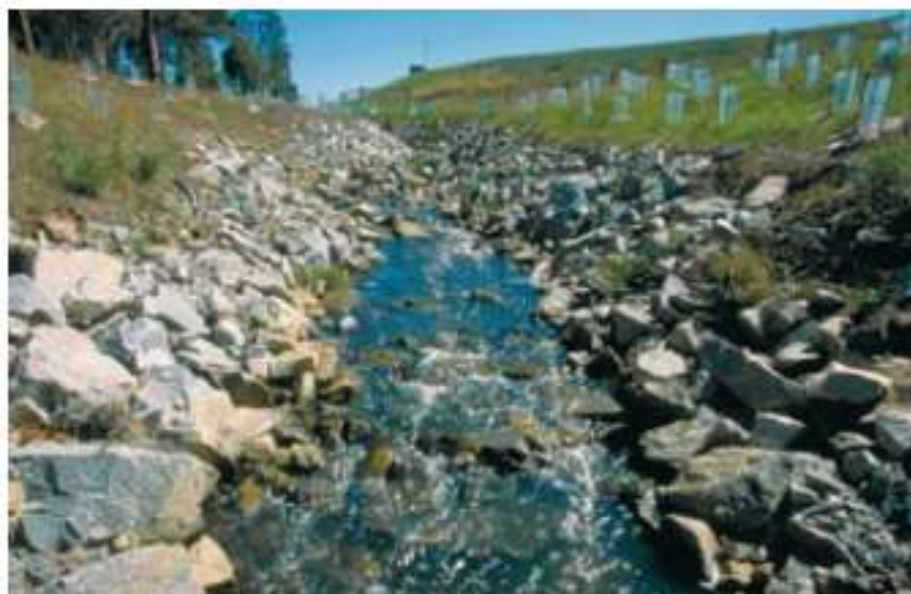
**Plate 28: Example of rock beaching/armouring to be used at Armstrong Creek.**

Works on Armstrong Creek, including rehabilitation works and the installation of rock beaching/armouring must be broadly in keeping with the image that were presented to Wadawurrung at the meeting held on 2<sup>nd</sup> October, 2018 and shown below in Plate 28.
