Report on  
Geotechnical, Hydrogeological & Preliminary  
Environmental Study

Phase 1 - Western Geelong Growth Area Project  
Fyansford & Batesford

Prepared for  
McCann Group, Adelaide Brighton Ltd and Ramsey  
Property Group

Project : 87027.00  
R.001.Rev1  
9 May 2017

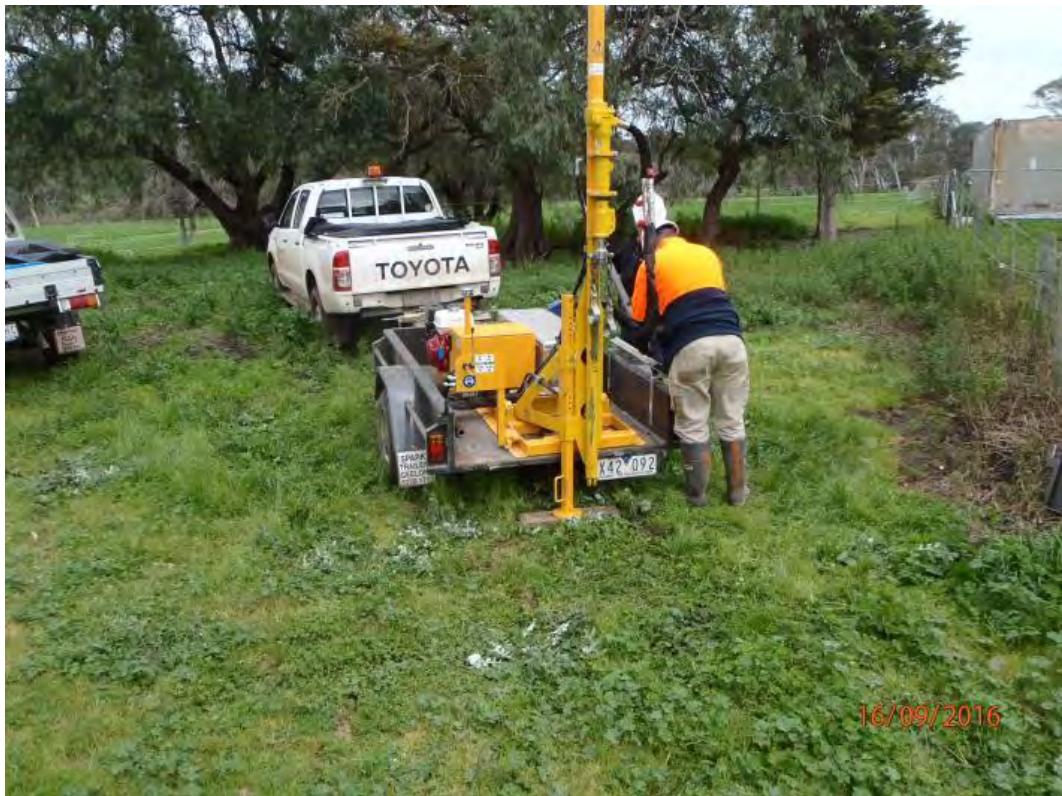
Photo 1 : BH 1 location trailer mounted push tube rig.

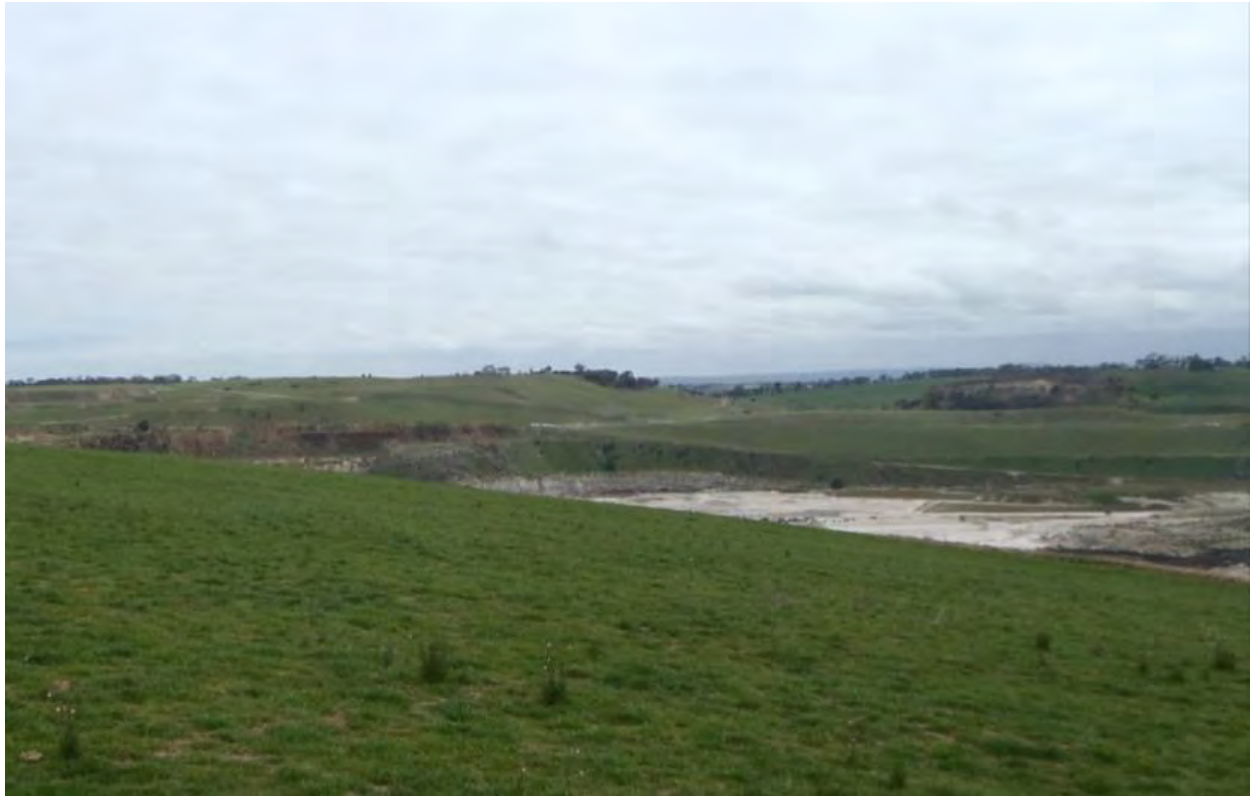
Photo 5 : View of the Batesford Quarry and the Western overburden stockpiles.

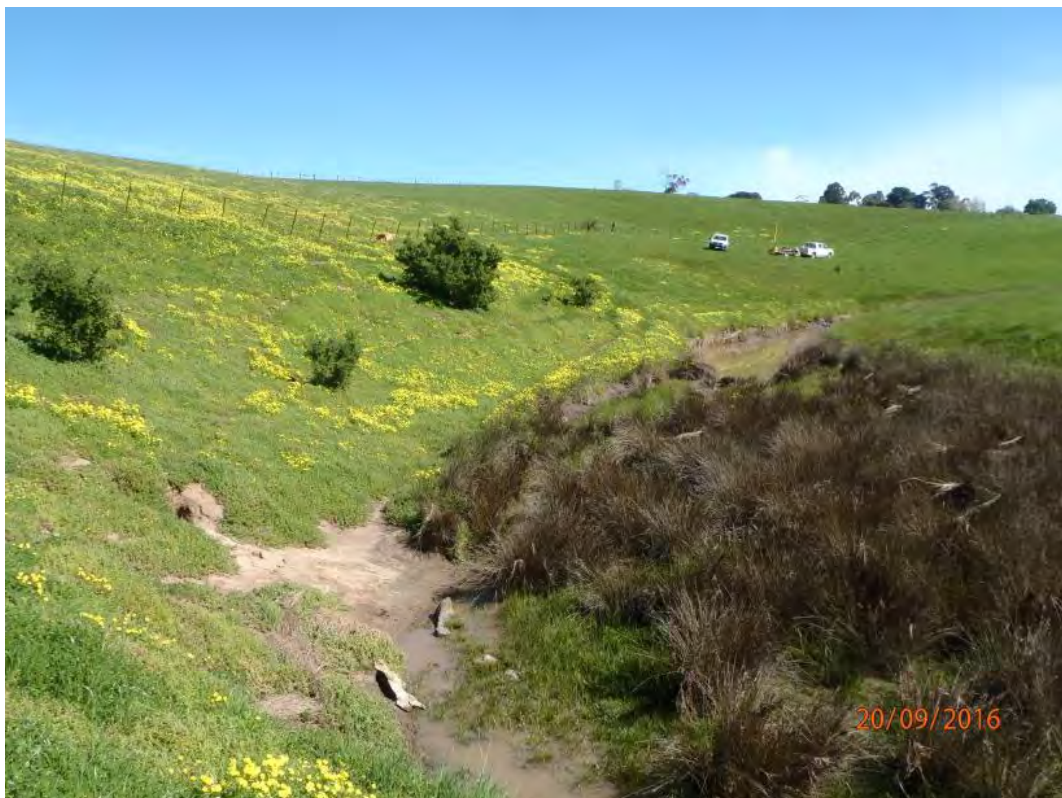
Photo 6 : Cowies Creek with exposed soil at tight bends

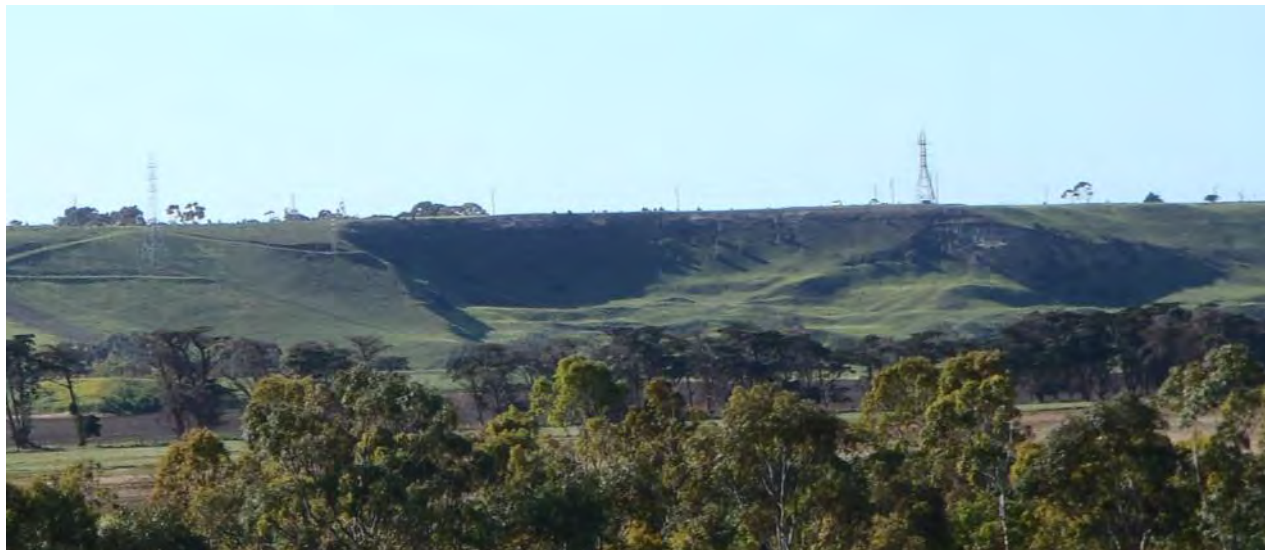
Photo 7 : View of the historical landslide at the downstream end of the Moorabool Deviation Channel

Another large landslip is known to have occurred in the VicRoads owned land on the eastern bank of the Moorabool River, close to the Geelong Ring Road and near the end of the Moorabool River Deviation Channel. The date of the original failure is unknown and could be pre-1930s, but it is understood that a smaller slip within the large slip area occurred in the 1950's. These slips occurred through Fyansford Clay and have exposed a near vertical escarpment up to 35 m high, with the failures occurring over a plan area of approximately 280 m by 160 m.

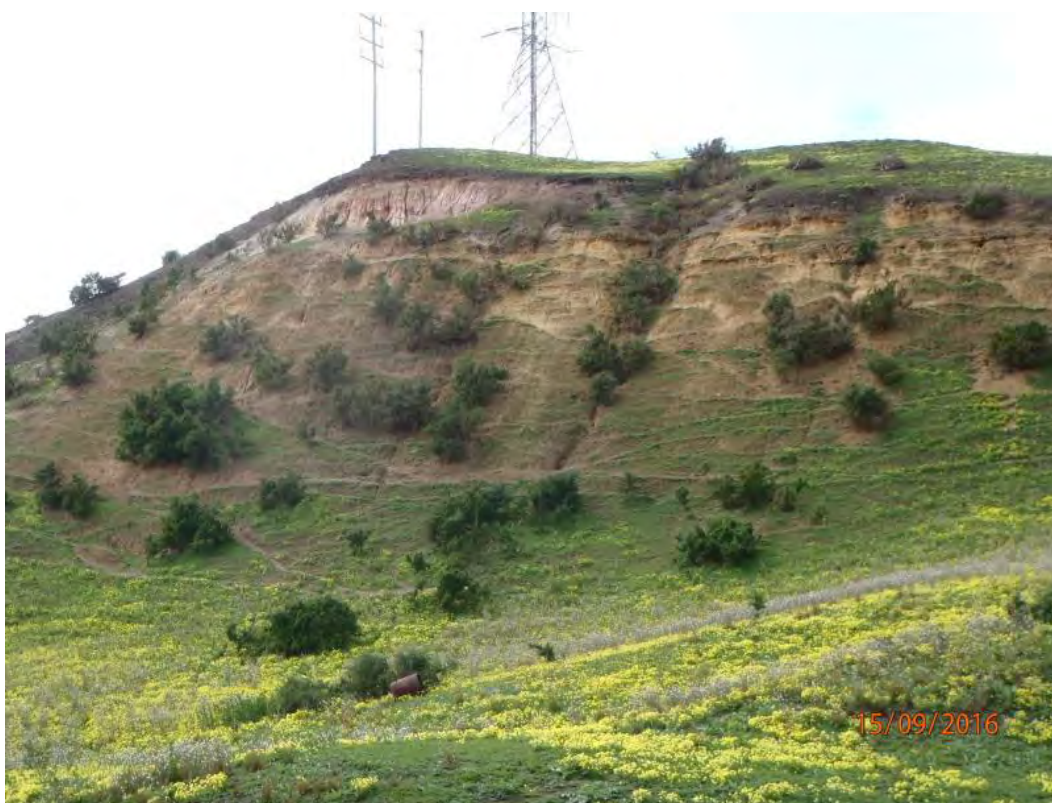
Photo 8 : Exposed Fyansford Formation clays and sands adjacent to the historical landslide
