THE CITY OF
GREATER GEELONG

C387ggee DEVELOPMENT PLAN OVERLAY SCHEDULE 46

BACKGROUND LANDSCAPE REPORT

NOVEMBER 2022

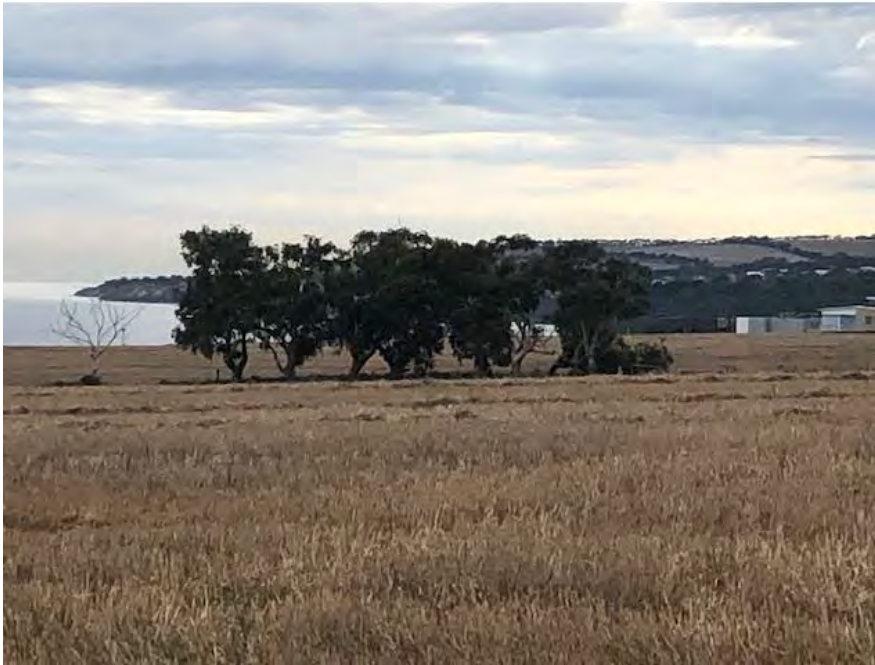
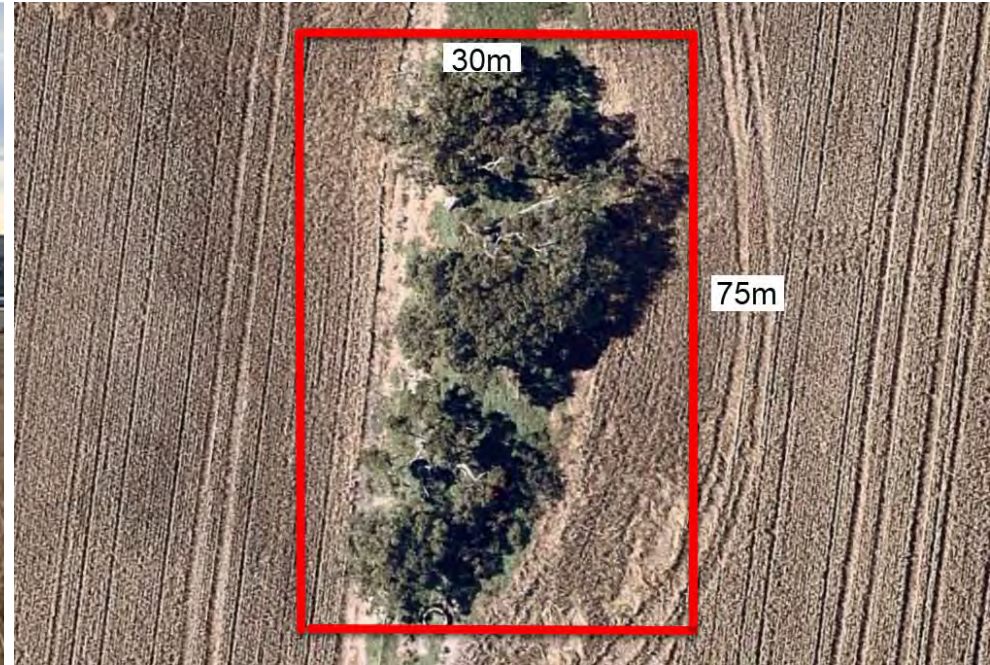
Significant trees to be retained

Approximately 8 large Gum trees (possibly remnant *Eucalypts camaldulensis*, *Eucalyptus viminalis* or *Eucalyptus leucoxylon* subsp. *bellariensis* / mixture of several) should be listed for retention as part of any future works within this property. The protection area for these trees would be an approximate 30m x 75m perimeter for this area.

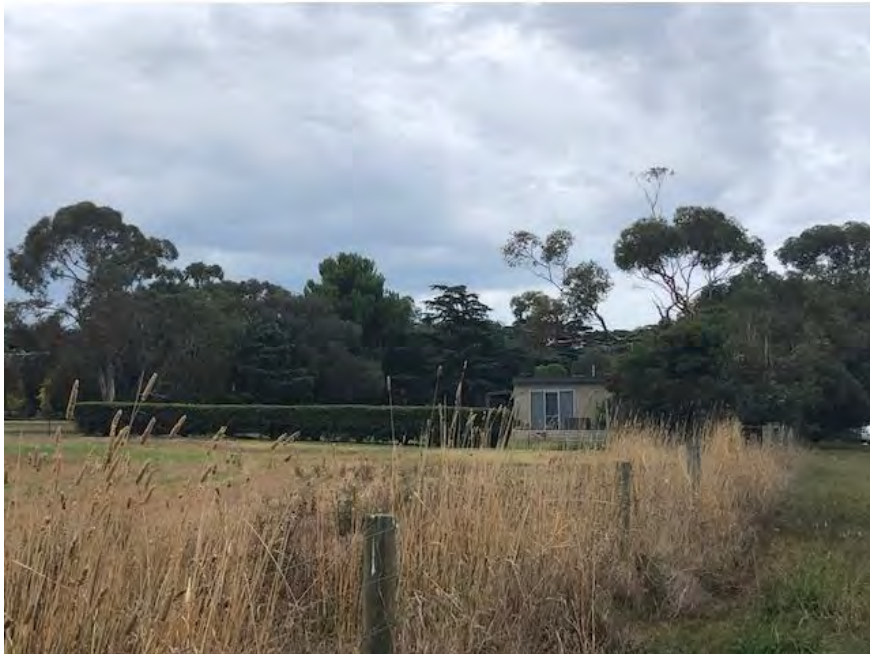
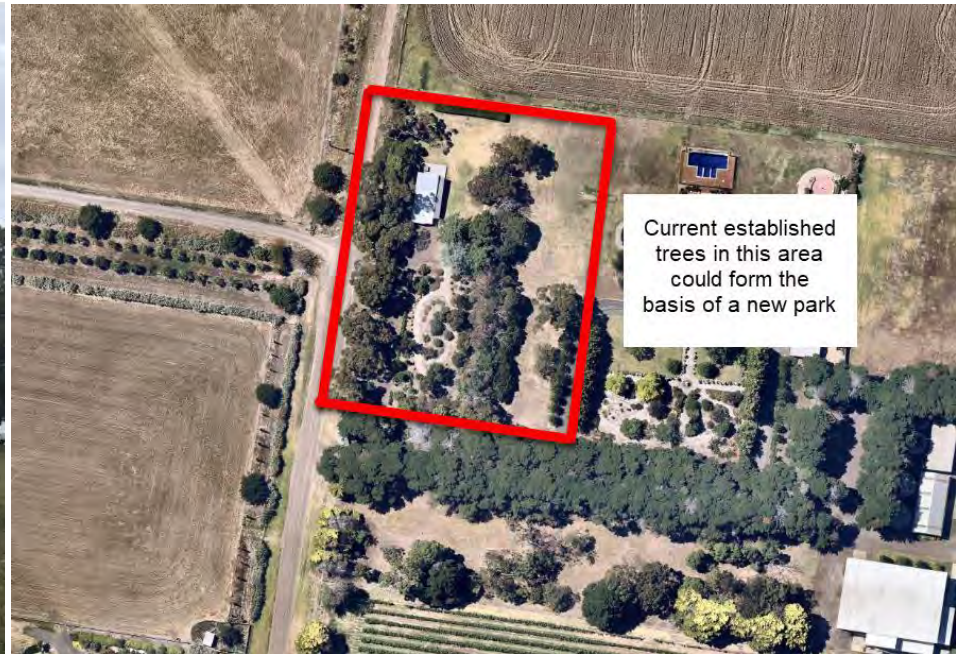
Proposed open space

The trees which form the western garden area for the property at 120 McDermott Road (mixture of native and exotic species) would form a good basis for any proposed parks / open space areas in this parcel of land.

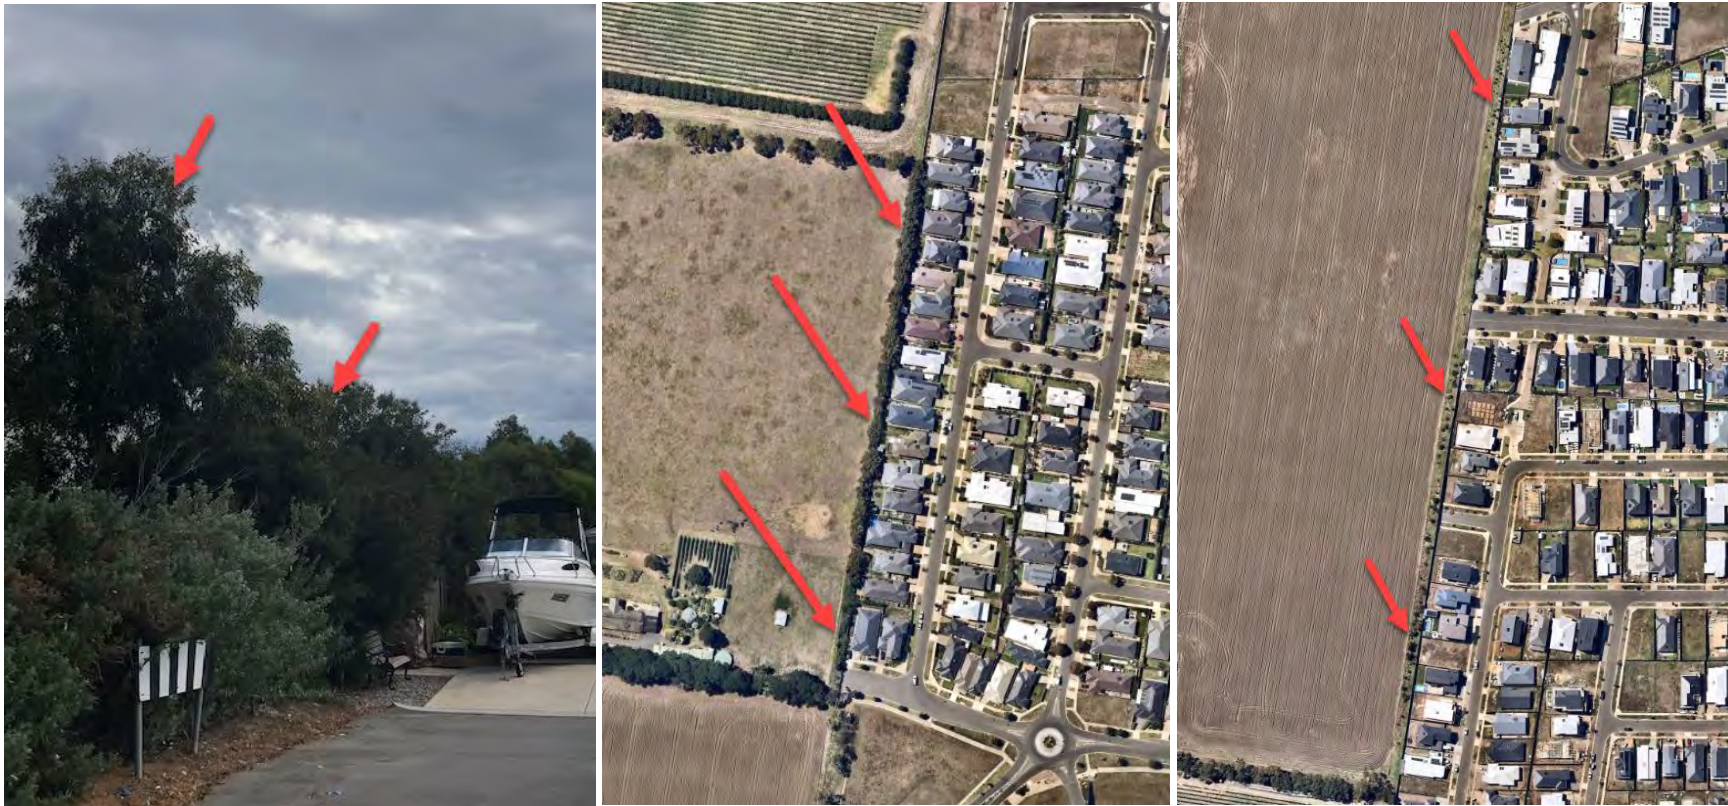
Perimeter vegetation

72-100 McDermott Road – The planting in this vicinity has the hallmarks of a land care group which has planted local native tree and shrub species along the eastern boundary of this property approximately 10-12 years ago. This vegetation now forms a good buffer planting strip between the newly constructed dwellings and the farmland.

102-170 McDermott Road – The planting along this eastern boundary is similar to the property to the south, but is not as advanced (approx. 5 years of age).

If this re-vegetation work was funded using public money (in the form of Government grants or similar), then environmental offsets will apply for the removal of this vegetation.

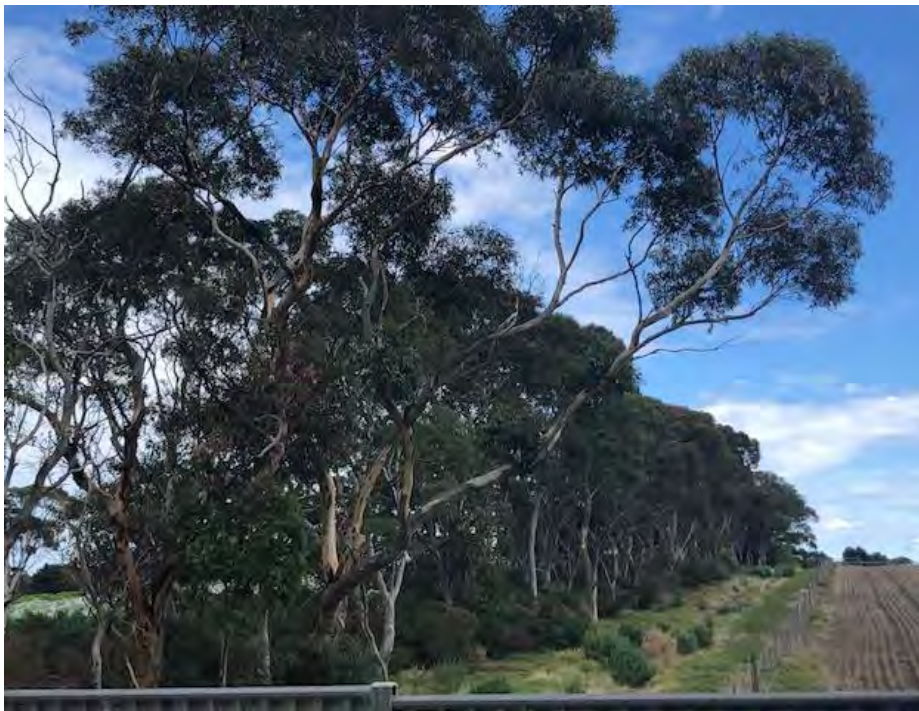
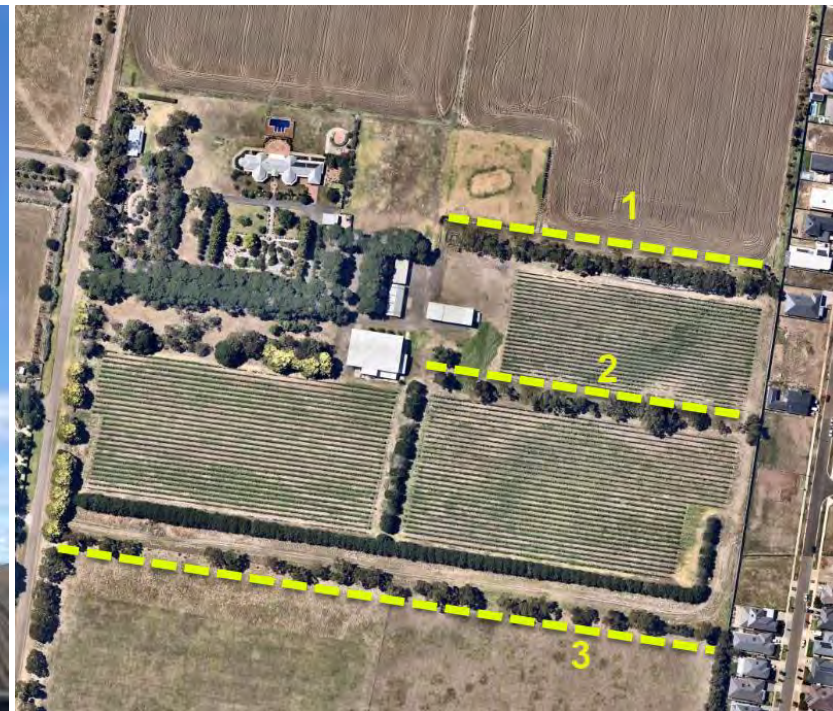
Native hedgerow planting

102-170 McDermott Road – Row No. 1 (image below) is a dense planting of native trees in good condition, which is complimented by an understorey of small and medium sized shrubs.

102-170 McDermott Road – Row 2 – A scattered planting of native trees in good condition, some of which are *Eucalyptus camaldulensis* (River Red Gum).

72-100 McDermott Road – Row 3 – A scattered planting of native trees, some in poor condition.

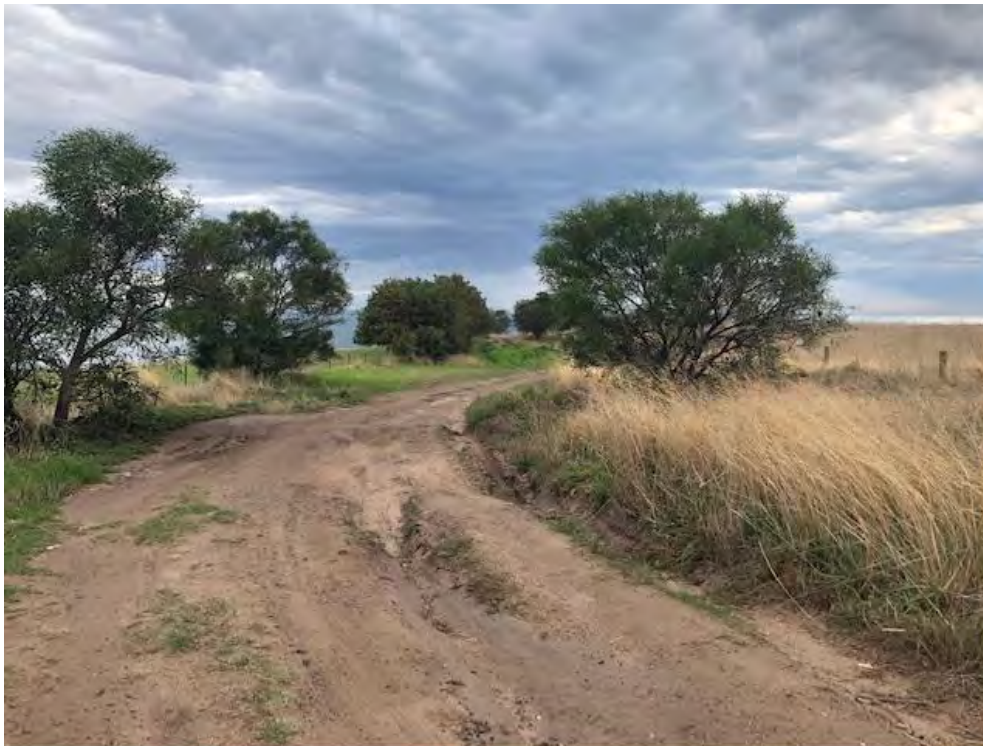
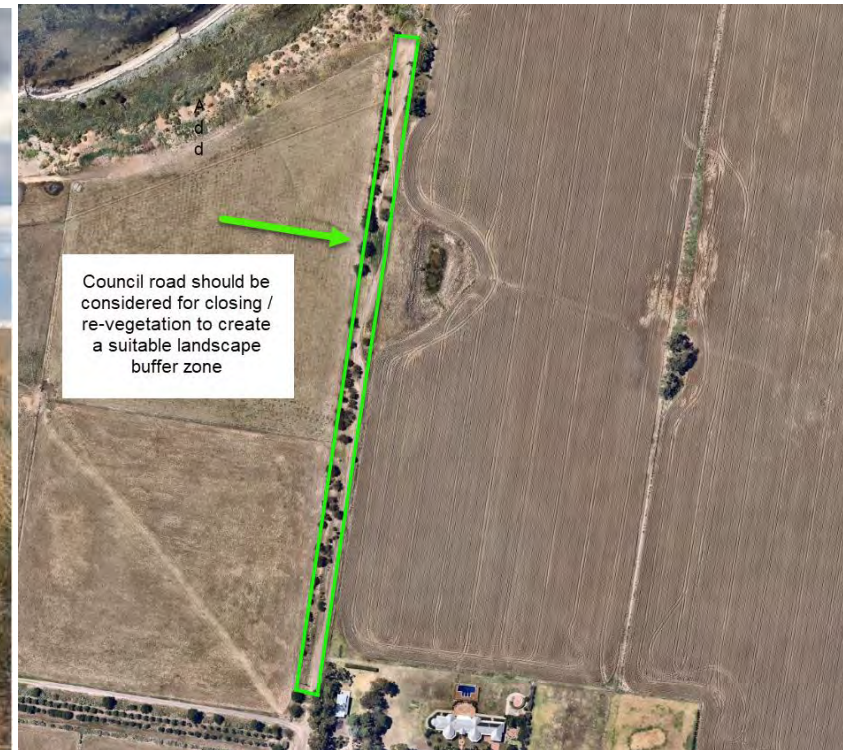
McDermott Road – northern section

In order to create a suitable vegetation buffer zone for the western boundary of 102-170 McDermott Road (north of the current property driveway), Council could consider closing this section of road to enable an approximate 18m wide revegetation planting area. The proposed shared pathway connection could also be included in this parcel of land.

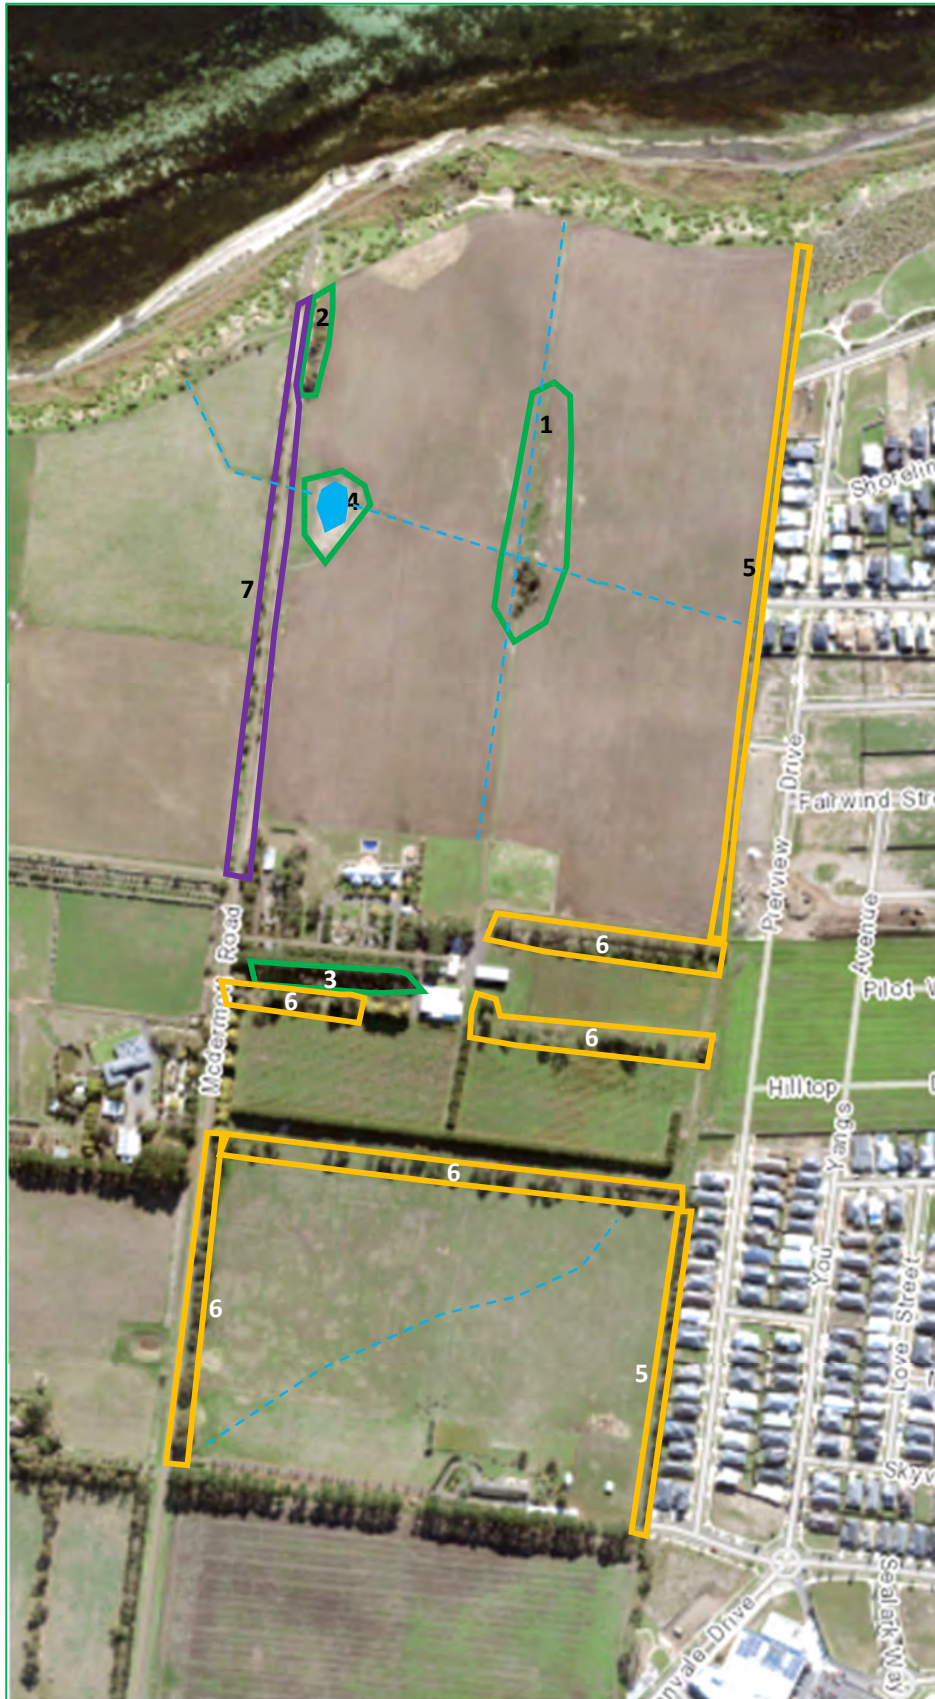
Green – denotes likely/possible **remnant vegetation**

1. This patch appears remnant from the roadside and may include the State significant Bellarine Yellow-gum *Eucalyptus leucoxydon* subsp. *bellarinensis* as well as other eucalypt species. Further investigation will be required to assess species, size of trees, canopy, hollows and understorey vegetation. Stags (dead larger trees) were also observed which should be retained as habitat. The Environment Unit would prefer a wider retention area to help enable further natural regeneration, preferably within a larger conservation area or linear corridor connecting this patch to the foreshore vegetation to the north and open space within the development to the south.

2. This patch of vegetation was not assessed whilst on-site but aerial imagery indicates it may be remnant vegetation. A closer inspection and more detailed investigation will be required, but if this is a remnant patch it is preferable it be retained and incorporated into the roadside reserve/foreshore conservation areas.

3. Possible native grasses were observed in this area, however a closer inspection will be needed. It may not be possible or feasible to retain this area.

4. It is possible there are native aquatic or semi-aquatic species around the periphery of this dam, however this could not be ascertained during the site visit. A closer inspection will be needed. This dam and its connected drainage lines should be incorporated into the design.

Orange – denotes **planted indigenous or native vegetation**

5. These two linear patches along the eastern boundary support a mixed planting of indigenous species approximately five metres wide. The planting to the south is more advanced in size than the northern planting. It is likely that the landholder received some funding to revegetate these boundaries. If public funds were used to facilitate these plantings then a permit and assessment will be required for any removal under Clause 52.17.

6. These patches consist of mature native trees planted many years ago. Species include Sugar Gums and River Red Gums. Some linear patches support trees in better condition than others (Parks can comment more on this aspect). There are no permit requirements for any potential removal of these trees, however this will require further inspection on-site. One linear strip (the northern-most east-west strip) supported some regenerating understorey shrub species such as *Cassinia* and could be considered a remnant patch pending further investigations.

Purple – denotes **vegetated roadside reserve**

7. This roadside reserve supports a mixture of indigenous, planted and dispersing woody weed species across an approximate 18 metre width. This could be closed off and used for passive use only which would create a recreational opportunity as well as an opportunity to rehabilitate what is already here. This forms a natural connection for both people and wildlife between the development and conservation area and bay to the north.

Blue – denotes **watercourses or dams**

These existing water features, drainage channels and natural lays of the land can be worked with for improved water retention and drainage and to also create connections across the landscape. This could be in the form of stormwater retention and revegetated linear waterway or drainage corridors with open space and shared path connections.
