GEOTECHNICAL INVESTIGATION
FOR CLIFF STABILITY

Jetty Road Foreshore

72 – 100 McDermott Road and
102 – 170 McDermott Road, Curlewis

V220433Report04.1

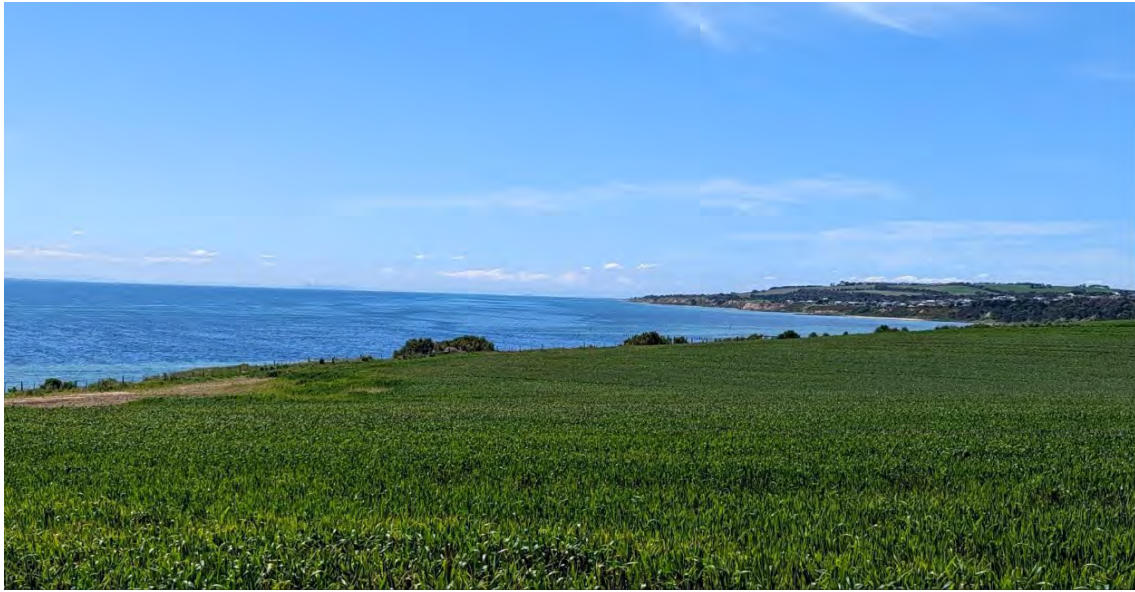
Figure 3-2 - Site View looking Northeast from BH02

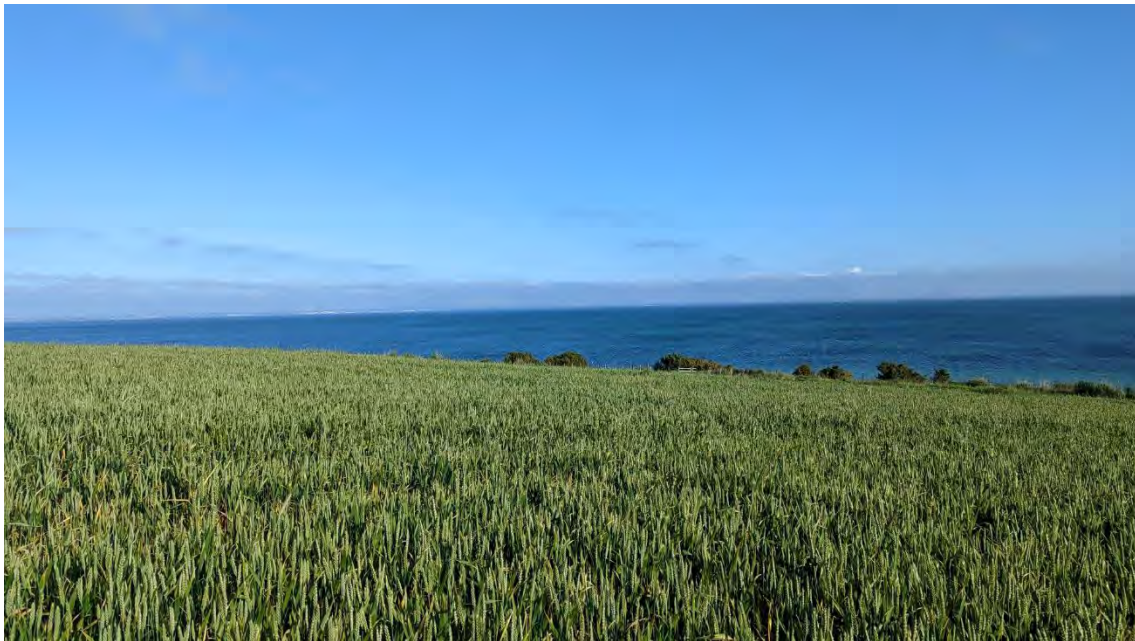
Figure 3-3 - Site View looking Northwest from BH05

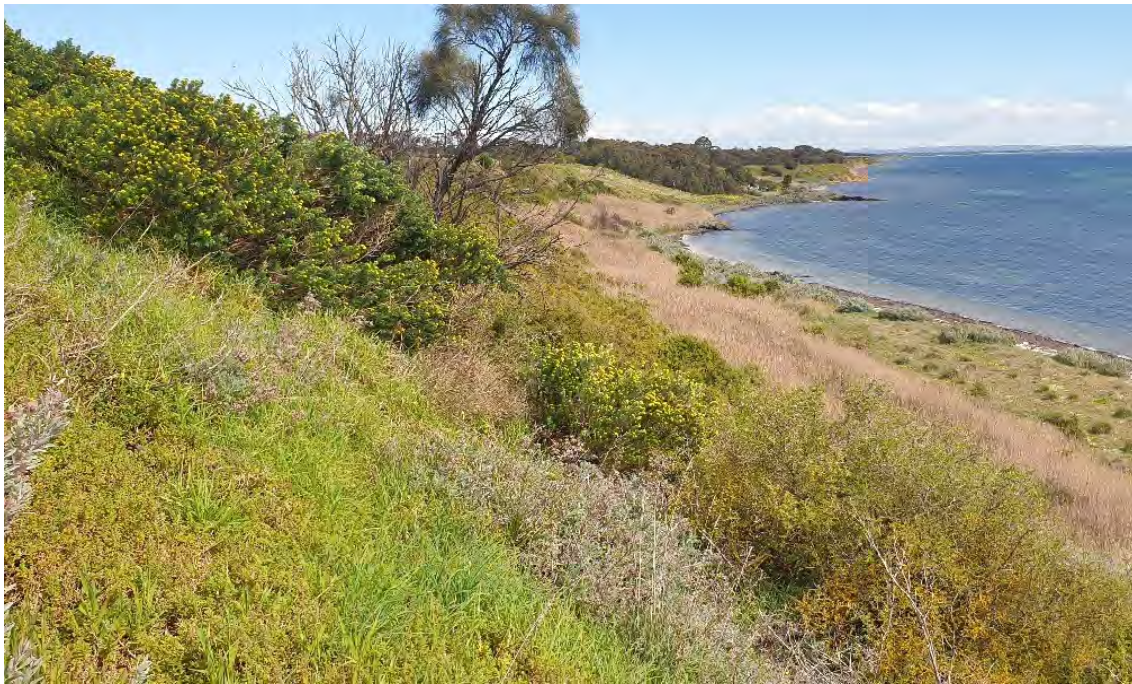
Figure 3-4 – View of Foreshore Area from top of cliff.

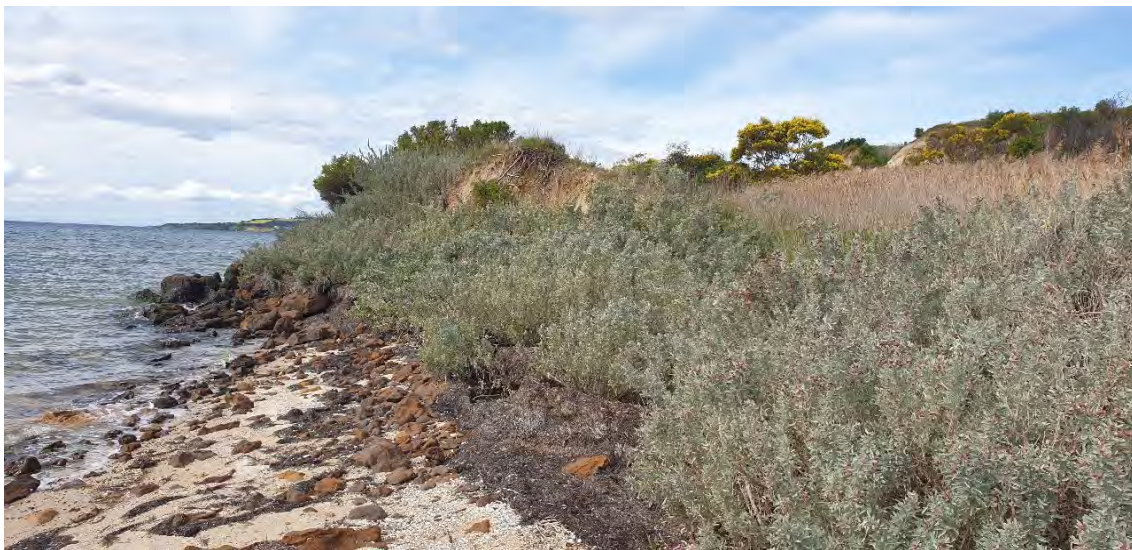
Figure 3-5 – View of the cliff from the foreshore

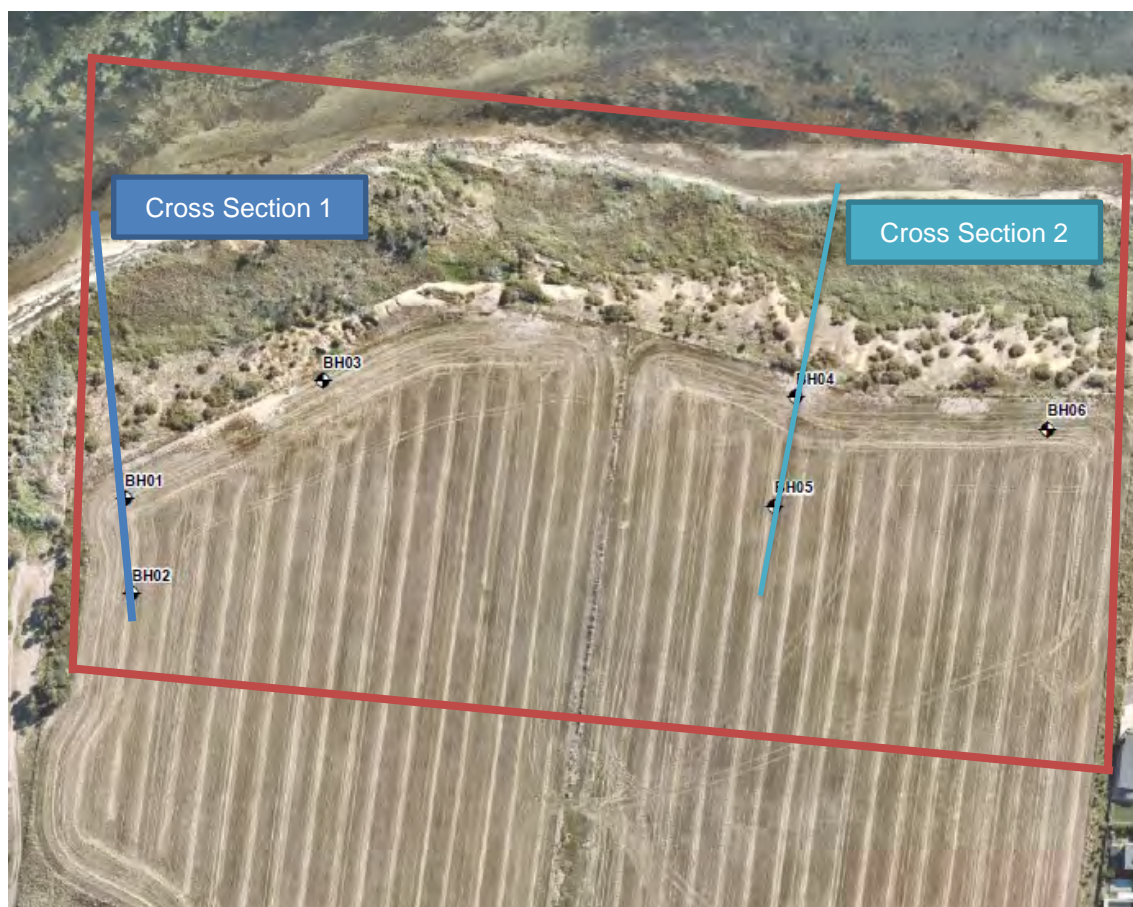
Figure 8-1: Excerpt from Nearmap (Dec 2022) depicting Extent of the of Current investigation, Approximate Borehole Location and Cross Section Locations

Two representative sections were considered for the analysis as depicted in Figure 8-1. Cross Section 1 runs through BH02 and BH01 before continuing down to the shoreline. Cross section 2 runs through BH05 and BH04 before continuing down to the shoreline. Both cross sections were located through areas where landslides have been observed to be occurring.

Cross Section 1 represents a larger scale landslide in a more developed phase of movement while Cross Section 2 represents a smaller scale landslide in an earlier phase of movement.
