Balmoral Quay Stage 5 Residential Building,
Harbourside Drive, Rippleside

Cultural Heritage Management Plan 18376

Report to Balmoral Quay Pty Ltd

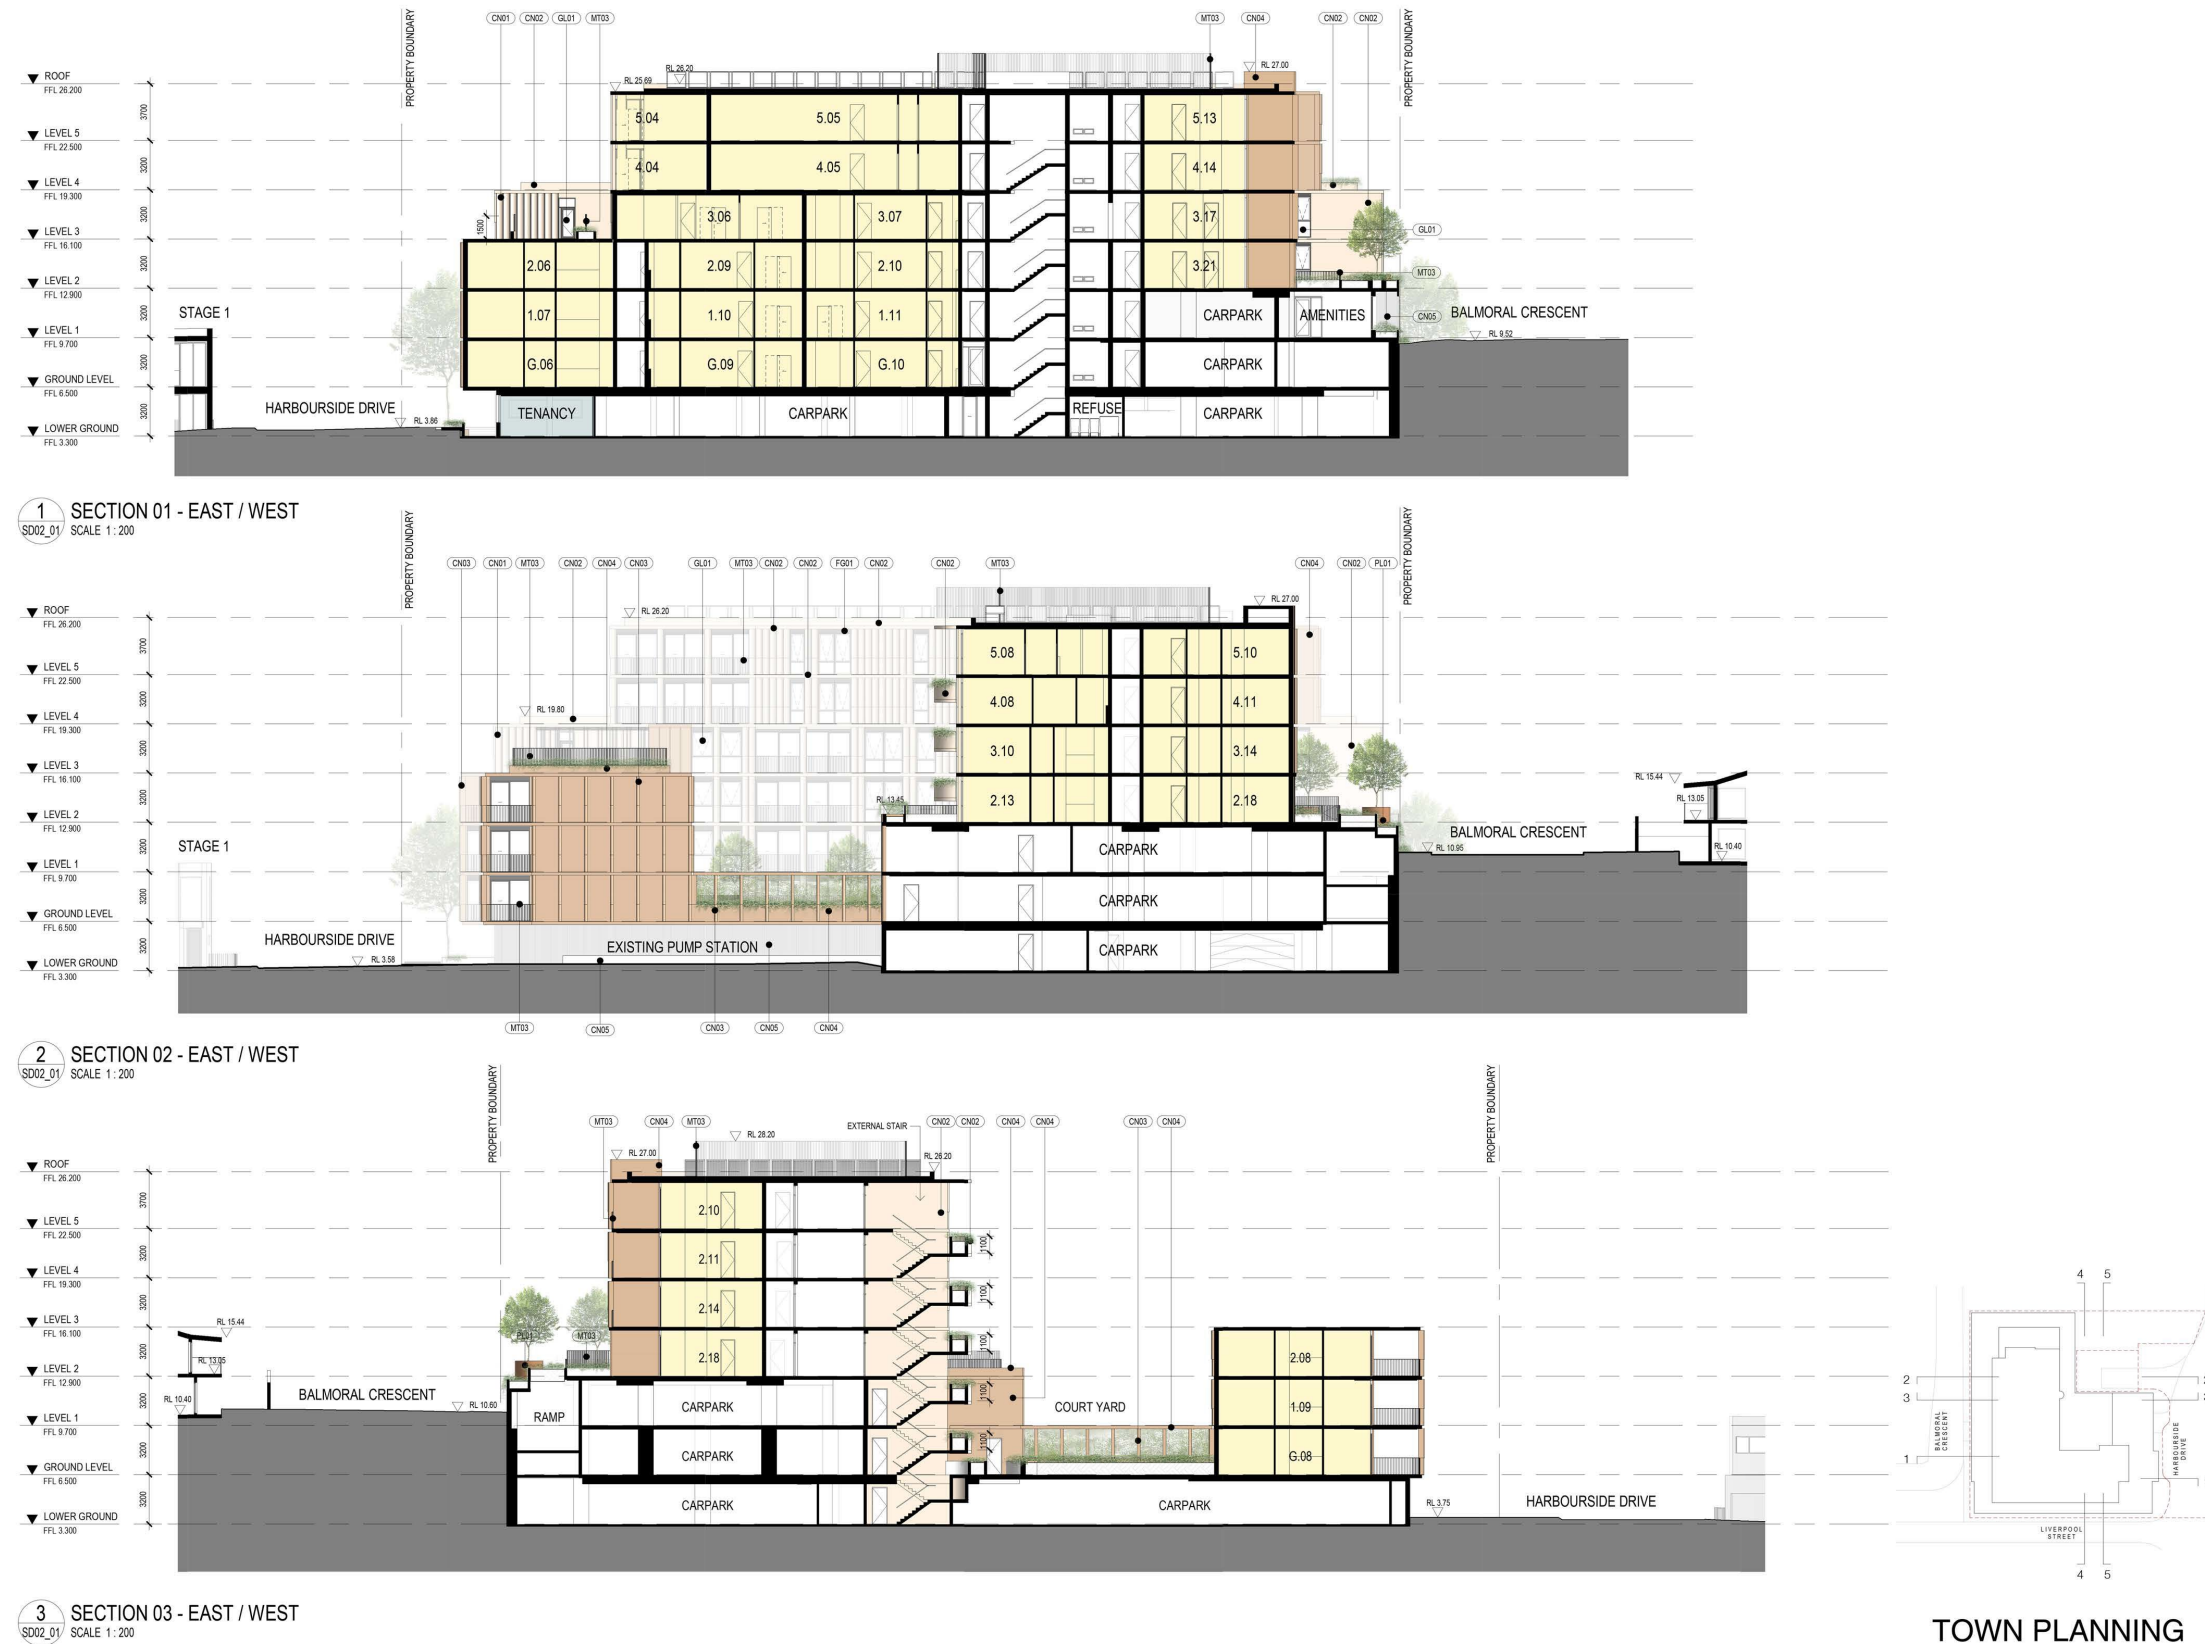
Figure 4: Indicative sections of residential building (courtesy Balmoral Quay Pty Ltd 2021)

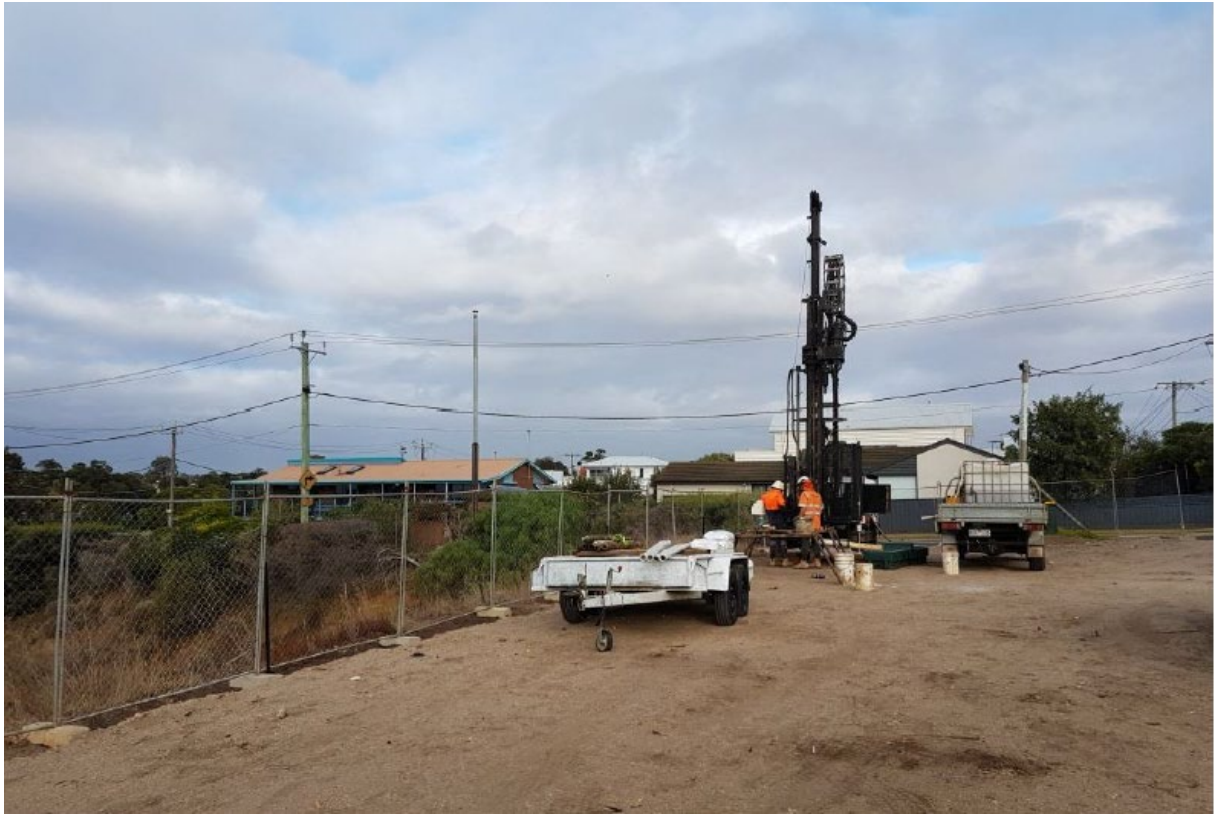
Figure 18: Location of geotechnical borehole, in adjacent property near NW corner of the activity area (Douglas Partners 2019, view SW)

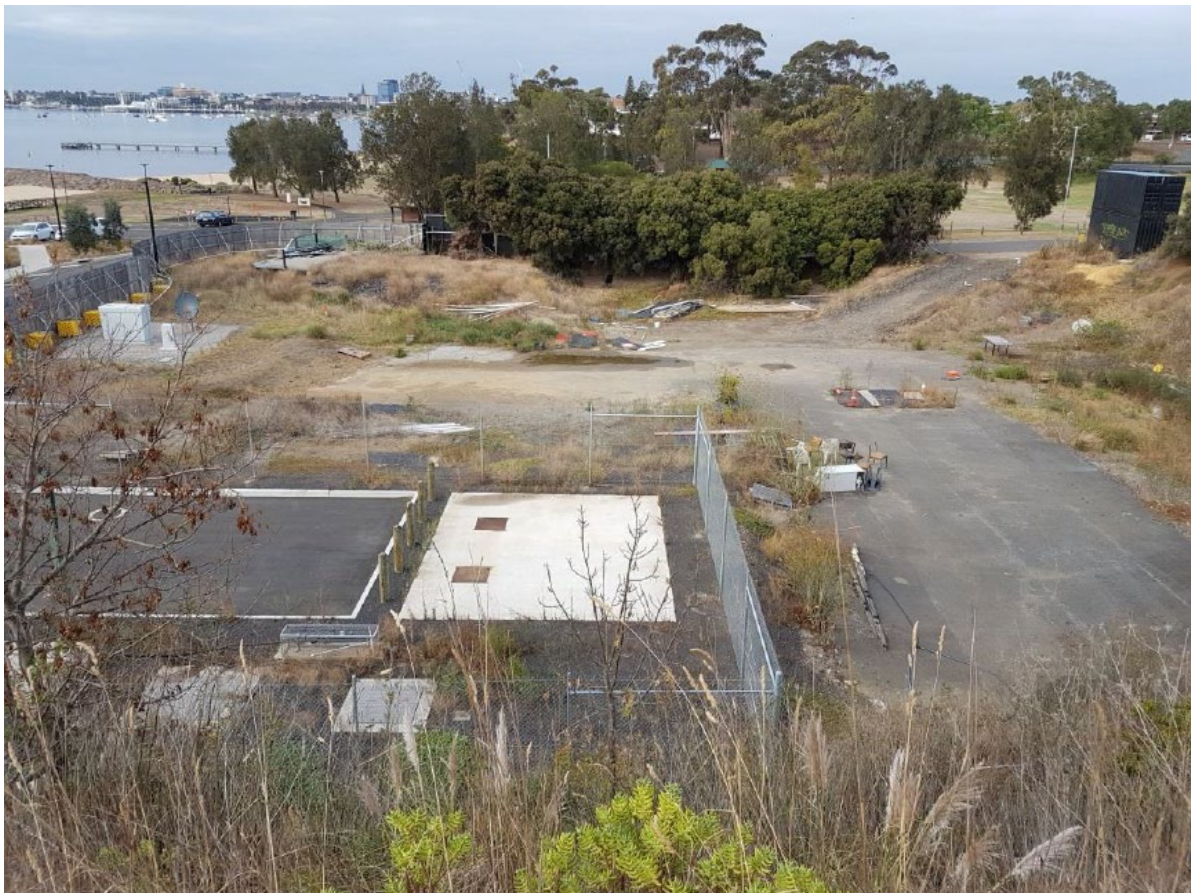
Figure 22: Current condition of activity area, facing south (Douglas Partners 2019)

The geotechnical report also contains photographs of the current condition of the site, which are shown in Figure 22 and Figure 23. The report also concludes that much of the northern batter is unstable in its current state (as shown in Figure 24 and Figure 25).

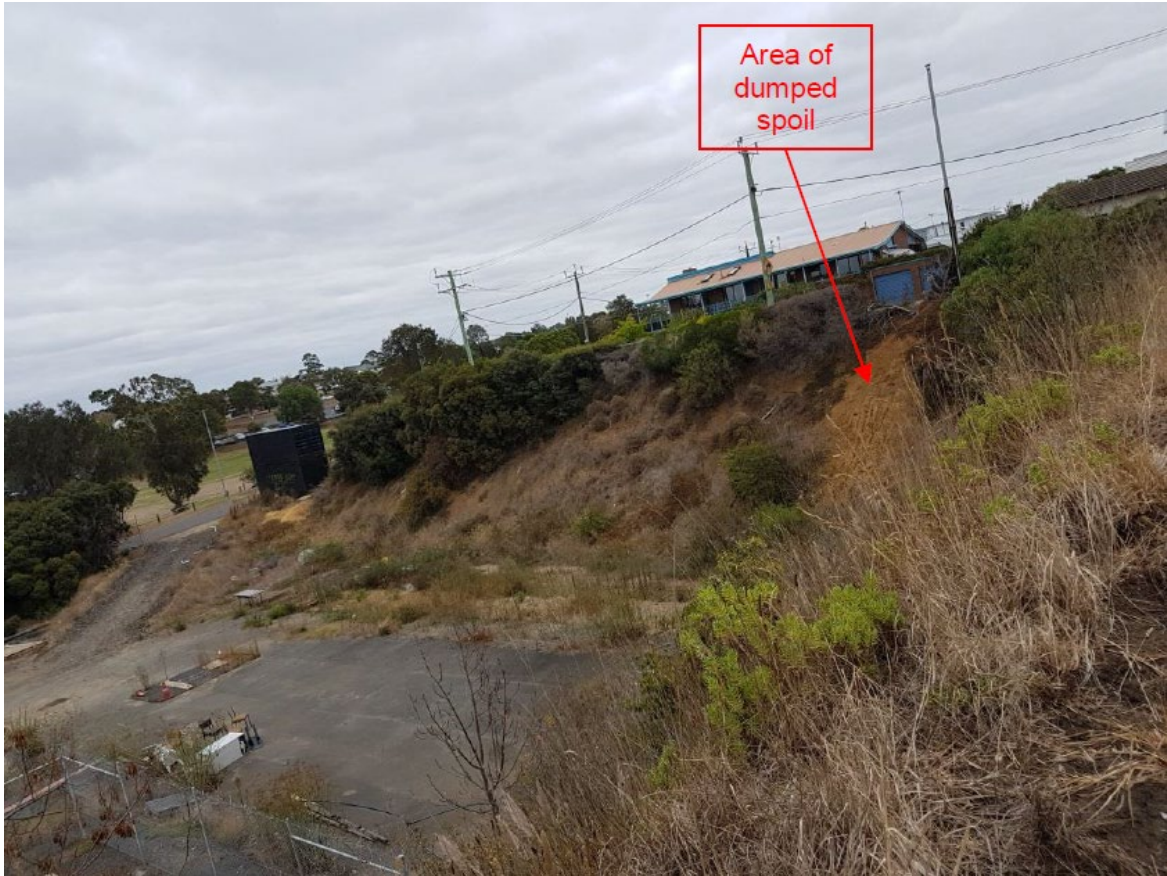
Figure 23: Current condition of activity area, facing south-west, showing western batter (Douglas Partners 2019)

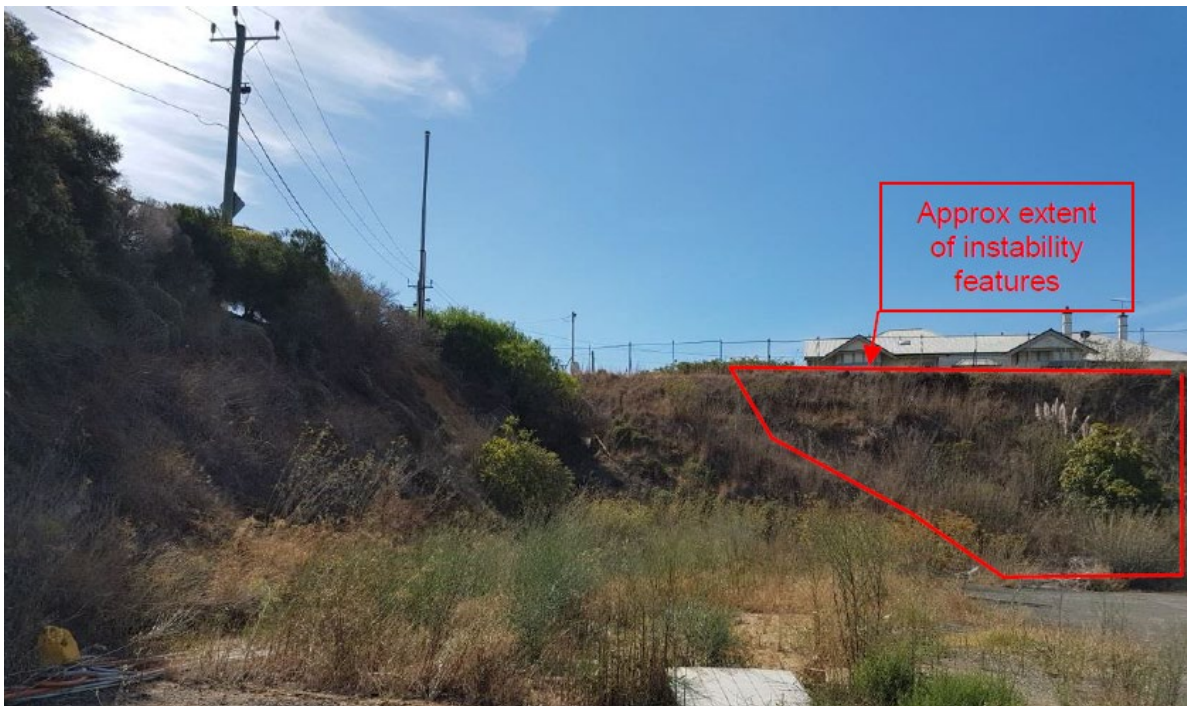
Figure 24: Northern batter, facing north showing instability as marked in geotechnical study (Douglas Partners 2019)

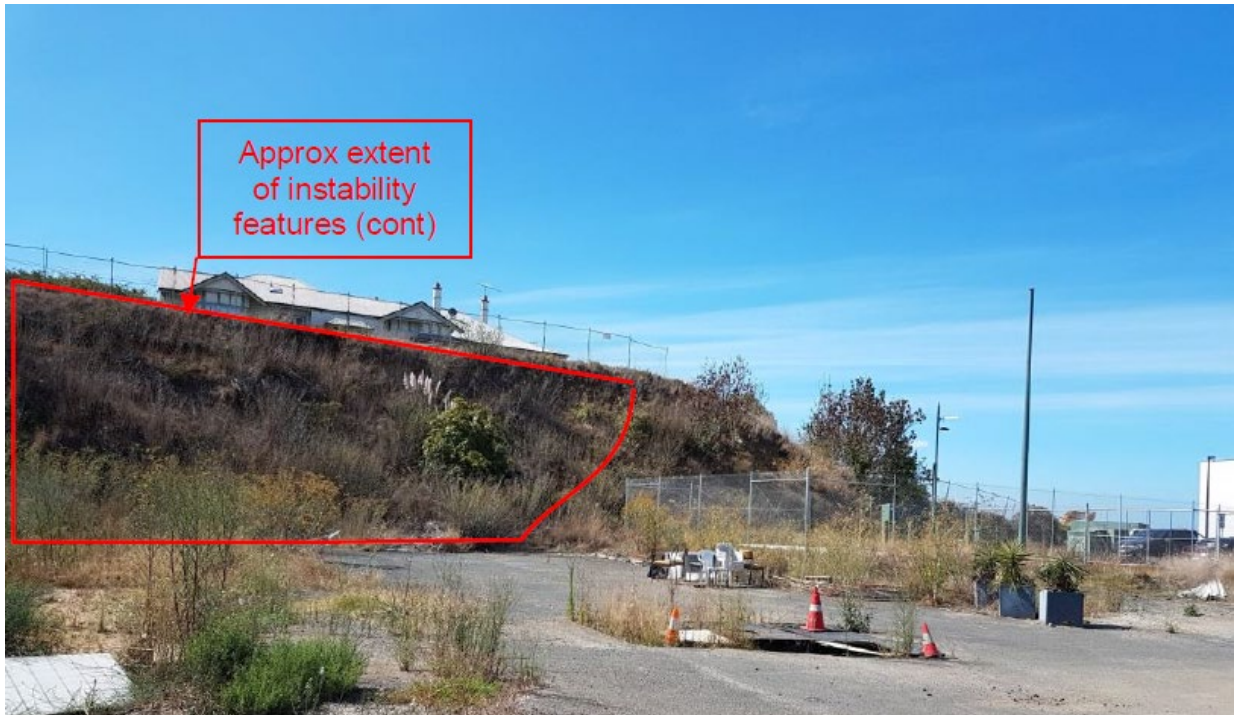
Figure 25: Northern batter, facing north east showing instability as marked in geotechnical study (Douglas Partners 2019)

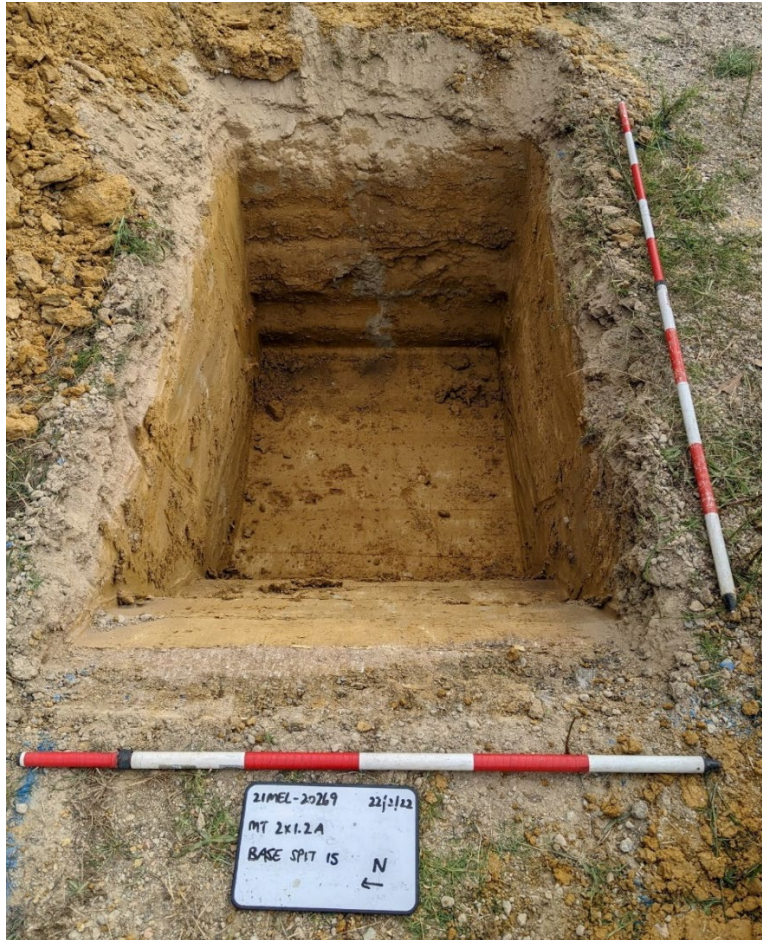
Figure 43: MT 1, base of excavation (spit 15), facing east (C. Hawker 22 February 2022)

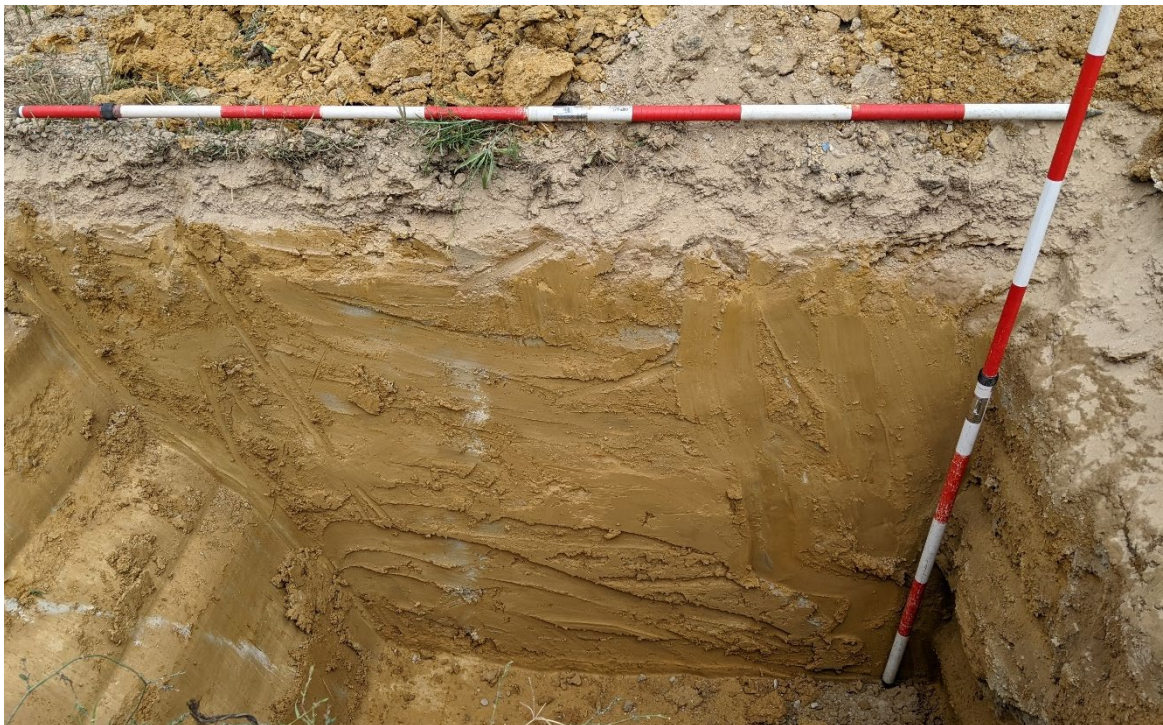
Figure 44: MT 1, north section (C. Hawker, 22 February 2022)

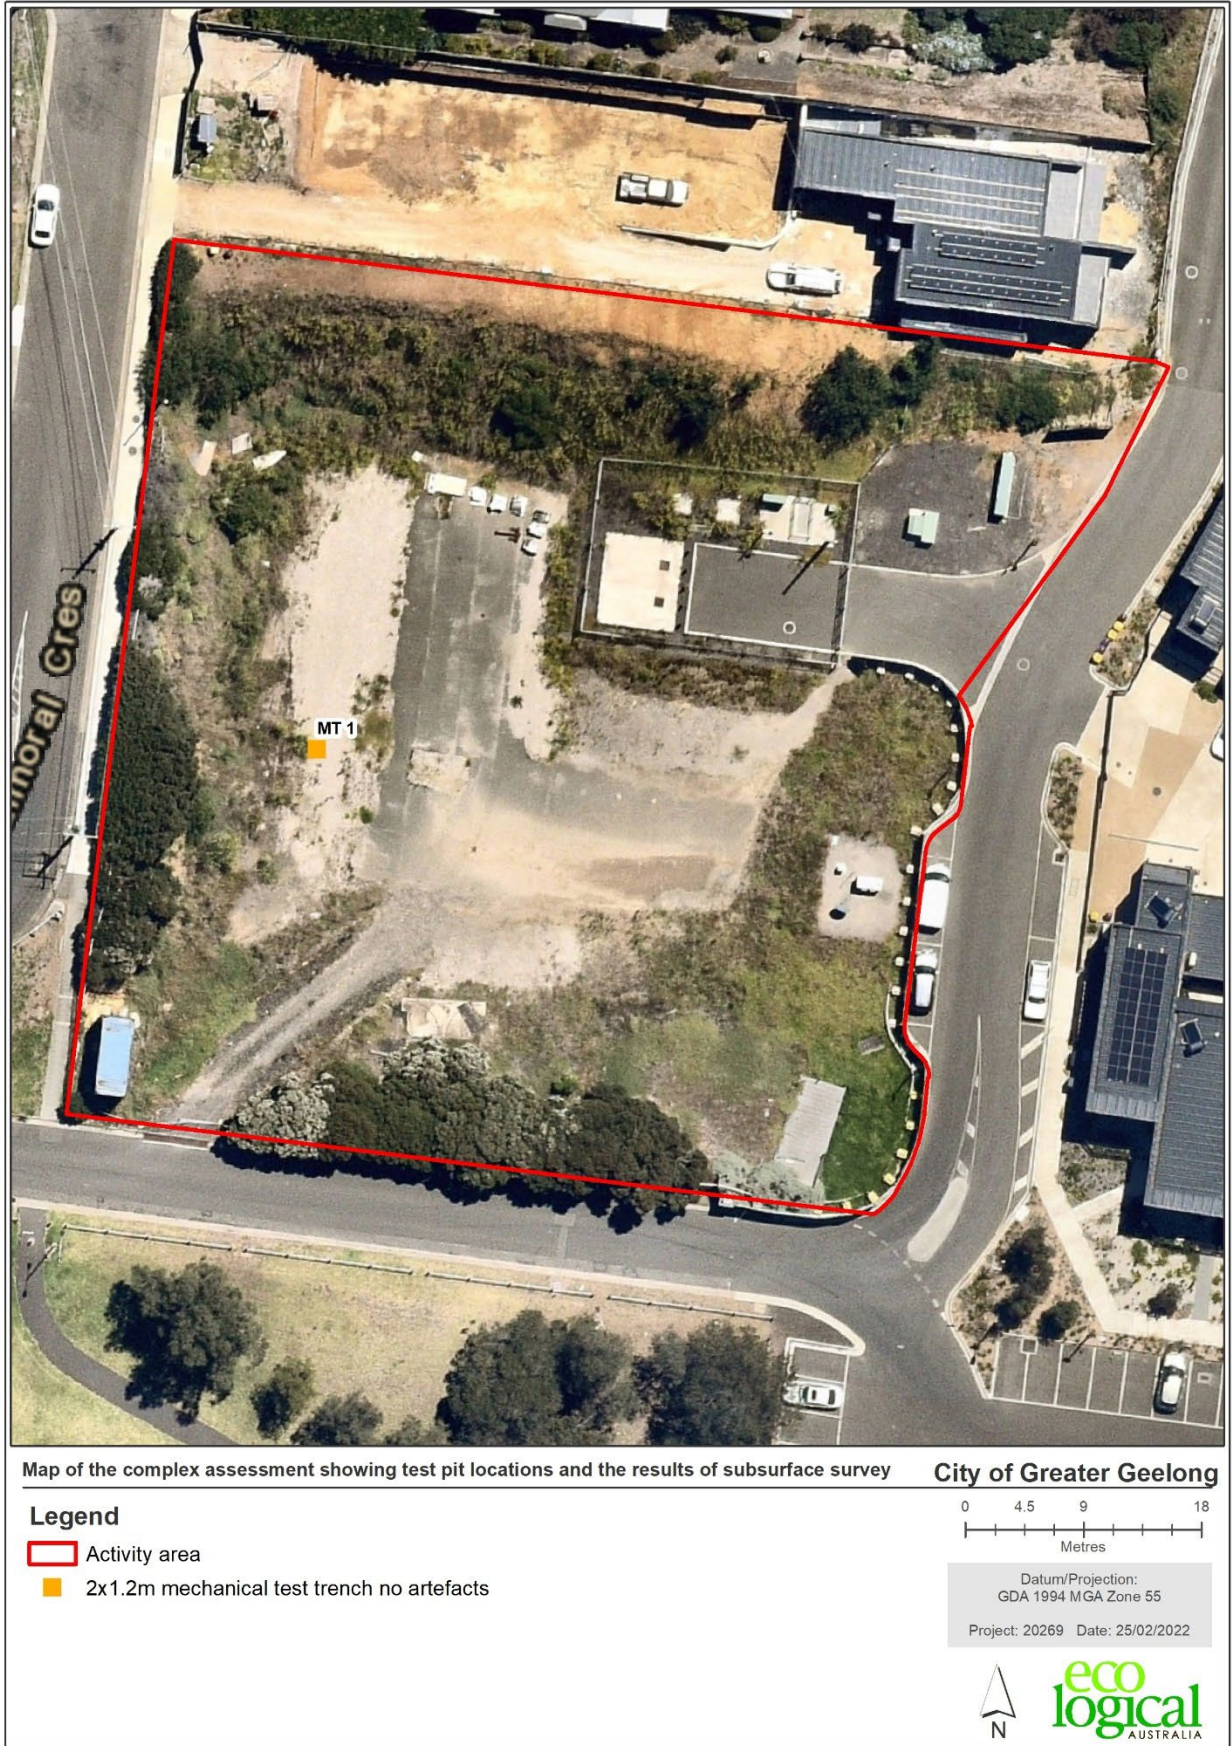
Figure 45: Results of the complex assessment excavation program

- The stratigraphy encountered reflects the history of disturbance of the site, whereby ground surfaces were excavated out to a depth of approximately 10 m from their original level for the construction of former shipyards, resulting in a heavily truncated soil profile.
- Context 1 is associated with introduced gravel fill surfaces present within the rear of the former shipyards.
- Context 2 is likely associated with the Tertiary age Fyansford Formation geological deposit, which dates to 10-15 mya.
- No Aboriginal cultural heritage material was identified during the complex assessment excavation program.

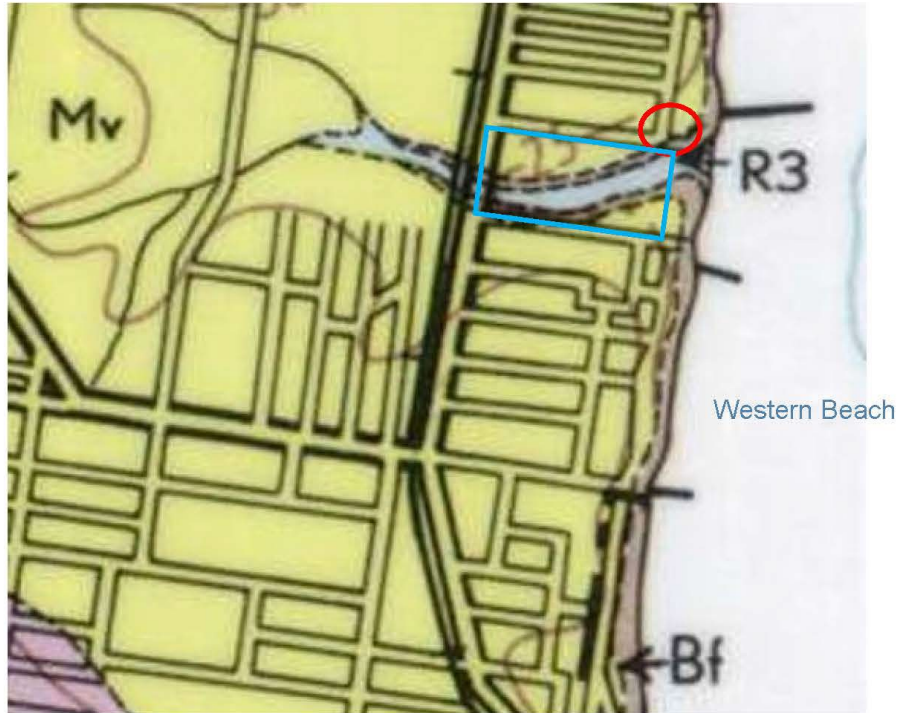
Figure 1 Part copy 1:63,360 Geelong Geological Sheet

Red circle = site; Blue oblong = Rippleside Park

Mv – yellow = Moorabool Viaduct Sands; Bf – brown = Fyansford Formation
