**Norlane Community
Initiatives G1939
4 – 8 Spruhan Ave,
NORLANE, 3214**

**TREE ASSESSMENT
MANAGEMENT PLAN
For development of the site**

This report has been commissioned by:
Select Architects

Date: September 2022

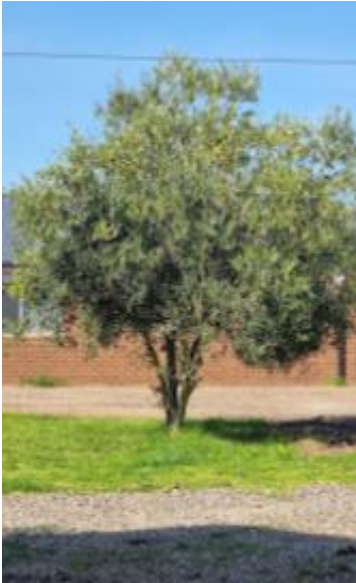
Trees 1, an Olive tree, is the only tree on the allotment. Insignificant and without contribution to the landscape. The tree is proposed for removal pre development of the site.

Tree 1, *Olea europaea* – Olive

The tree numbered 1 is impacted by works and to be removed before commencement.

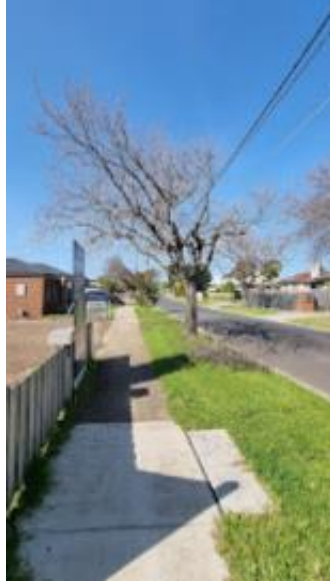
Tree 2 is a specimen of English Oak. It grows on the municipal naturestrip and is not impacted by the development. The tree will require tree protection fencing during development. *Refer to tree management plan page 10.*

Tree 2, *Quercus robur*

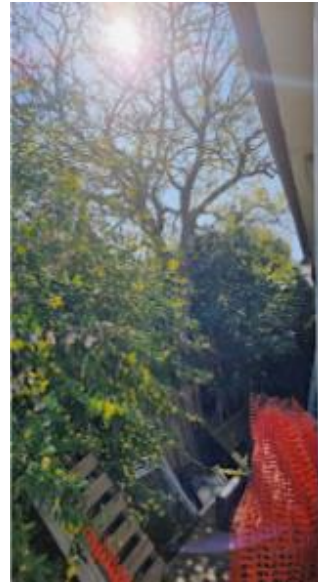
Tree 3 is a Jacaranda on the neighbouring allotment to the West. It grows approximately 1m from the boundary. The tree is in poor health, the canopy lost due to drought stress and possum attack. The tree will not be impacted by the

development, however the boundary will need fence maintained / rebuilt to offer protection. Tree protection fencing will protect this tree in development.

Tree 3, *Jacaranda mimosifolia* - Jacaranda

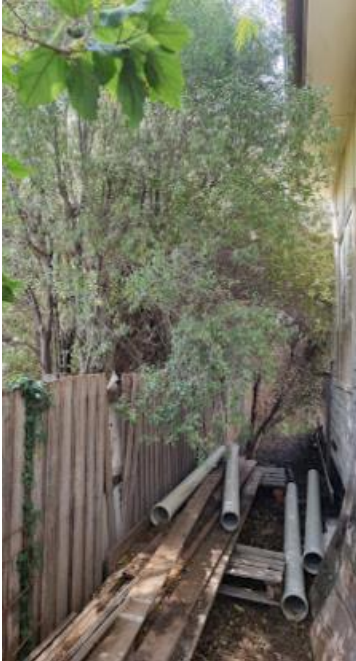
Tree 4, 5, 6 and 7 are all the same species. Specimens of Pittosporum, these trees are small growing, and do not have a large spreading root zone. They are separated from the development site by the boundary fence. Retention of the fence will provide suitable protection for these trees.

Trees 4, 5, 6 and 7 *Pittosporum Irene Paterson* – *Pittosporum*

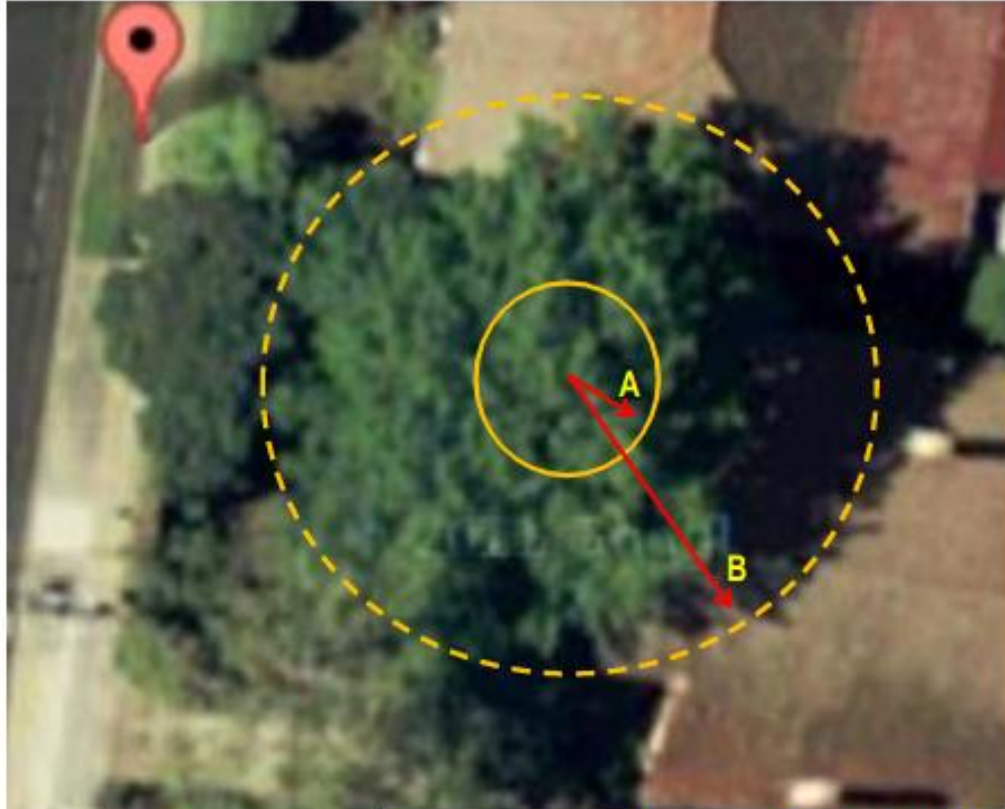
The diagram below indicates how the dimensions of the Structural Root Zone and the Tree Protection Zone are applied.

A = SRZ m Radius
 B = TPZ m Radius

- The tree protection zone is always expressed as a metres radius and depicted as a metres diameter.
- NO works should be undertaken inside the Tree Protection Zone unless guided by an Arborist and AS4970-2009 Protection of Trees on Development Sites.
- NO works should be undertaken in the Structural Root Zone under any circumstances.

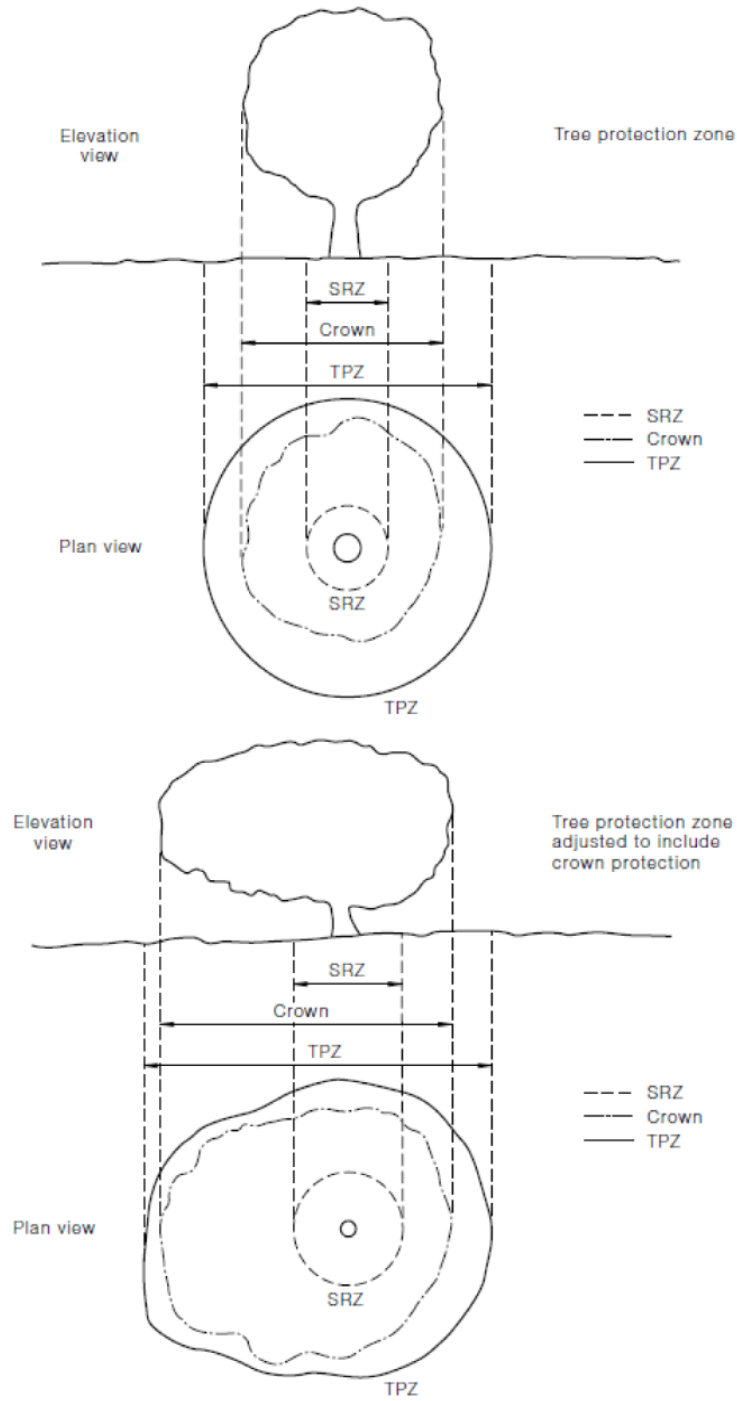
FIGURE 2 INDICATIVE TREE PROTECTION ZONE

NOTE: Refer to Clause 3.2 for calculation of TPZ.

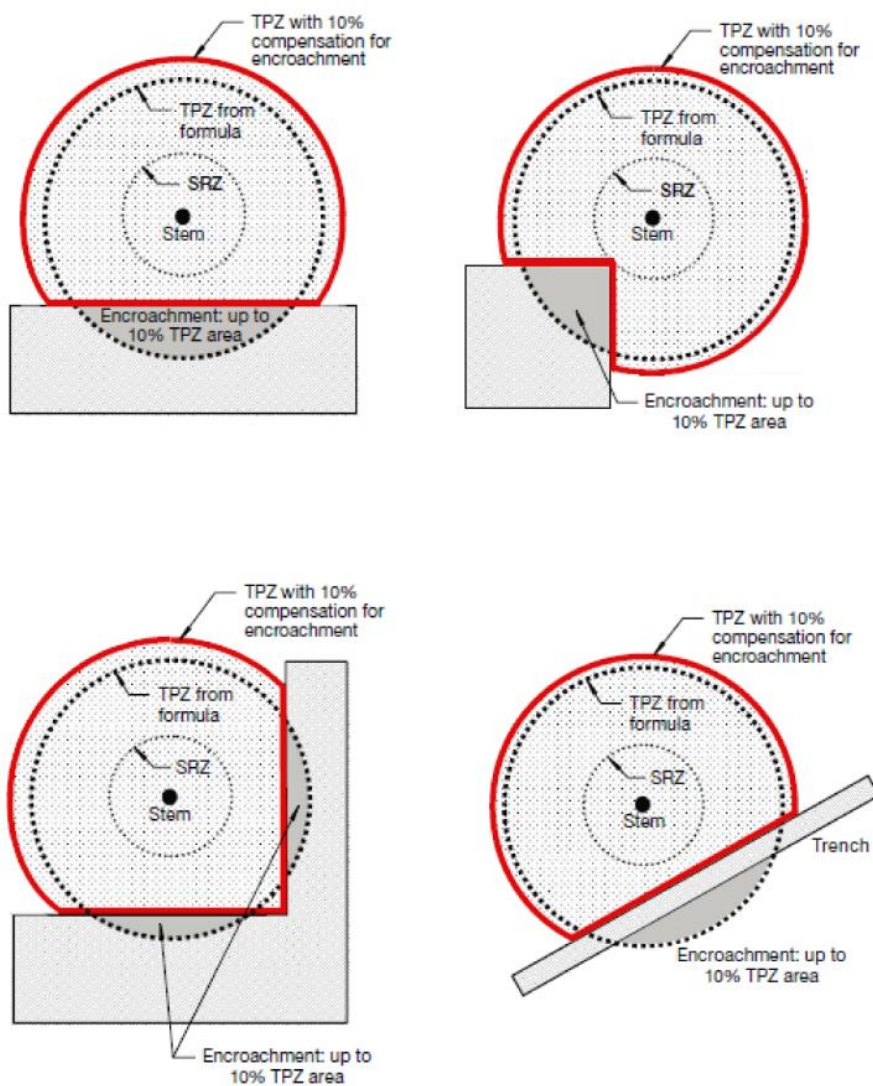
FIGURE D1 EXAMPLES OF MINOR ENCROACHMENT INTO TPZ

Encroachment into the tree protection zone (TPZ) is sometimes unavoidable. Figure D1 provides examples of TPZ encroachment by area, to assist in reducing the impact of such incursions.

NOTE: Less than 10% TPZ area and outside SRZ. Any loss of TPZ compensated for elsewhere.

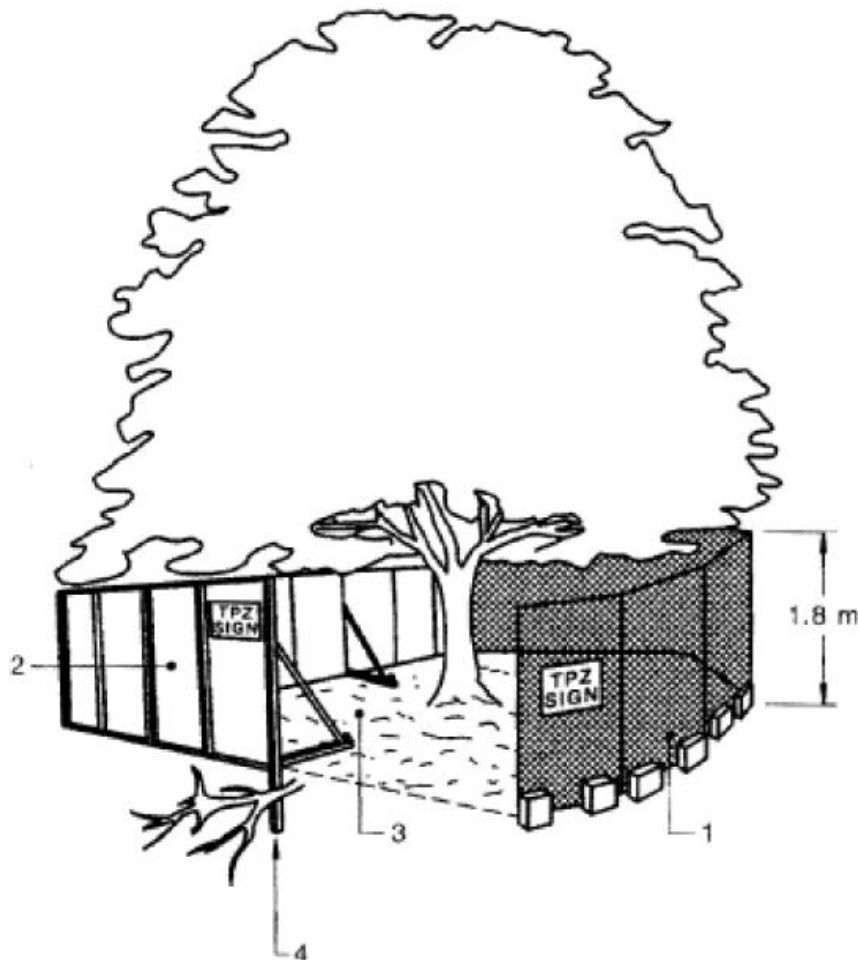
FIGURE 3 PROTECTIVE FENCING

Signs identifying the TPZ should be placed around the edge of the TPZ and be visible from within the development site (refer Figure 3). The lettering on the sign should comply with AS 1319. Appendix C provides an example of a suitable TPZ sign.

- 1 Chain wire mesh panels with shade cloth (if required) attached, held in place with concrete feet.
- 2 Alternative plywood or wooden paling fence panels. This fencing material also prevents building materials or soil entering the TPZ.
- 3 Mulch installation across surface of TPZ (at the discretion of the project arborist). No excavation, construction activity, grade changes, surface treatment or storage of materials of any kind is permitted within the TPZ.
- 4 Bracing is permissible within the TPZ. Installation of supports should avoid damaging roots.

These trees are required to be protected by tree protection fencing as per figure 3 of this report.

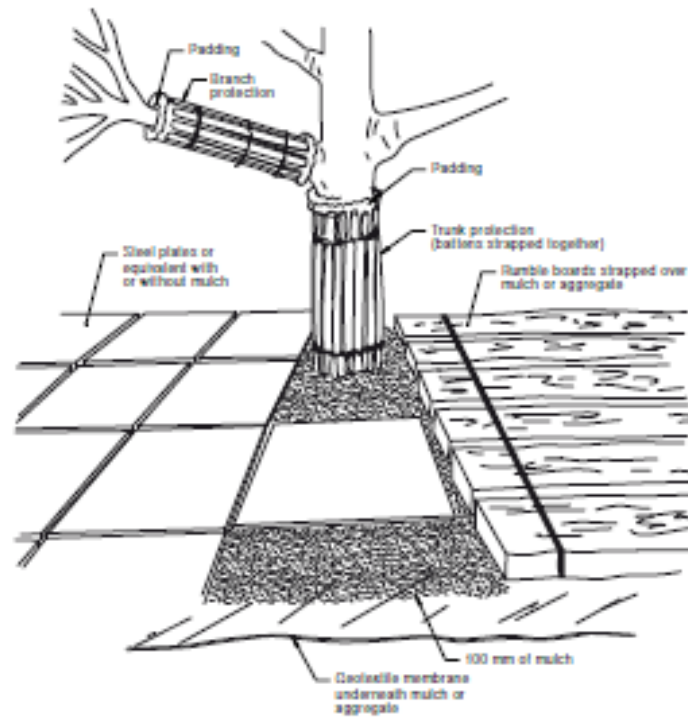
6.9 Ground Protection

- 1 For trunk and branch protection use boards and padding that will prevent damage to bark. Boards are to be strapped to trees, not nailed or screwed.
- 2 Rumble boards should be of a suitable thickness to prevent soil compaction and root damage.

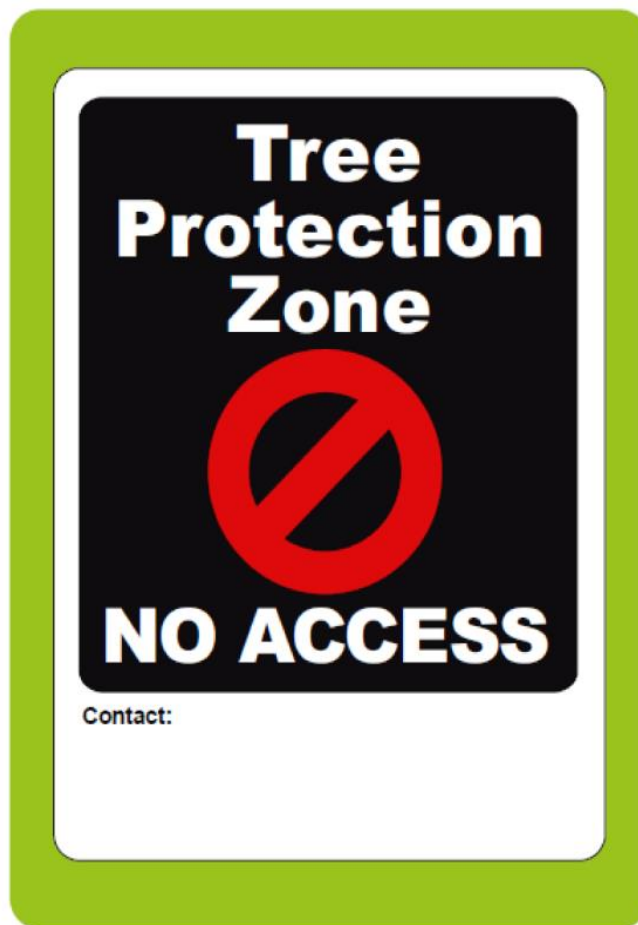
FIGURE C1 TREE PROTECTION ZONE SIGN

A TPZ sign provides clear and readily accessible information to indicate that a TPZ has been established. Figure C1 provides an example of a suitable sign.
