Hydraulic Calibration Report

Flood Risk Management Study – Lower Barwon River and Lower Moorabool River

Corangamite CMA, City of Greater Geelong and Golden Plains
Shire Council

January 2018

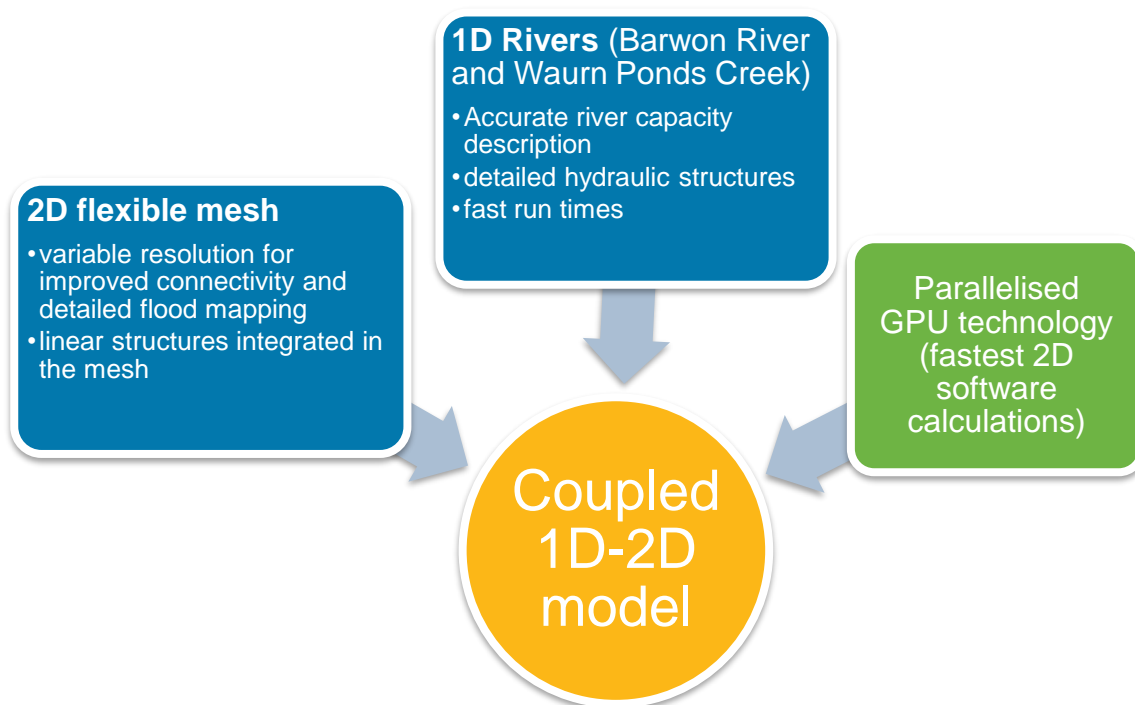
MIKE FLOOD 2017 allows for the coupling of a 2D flexible mesh domain with a 1D network. Simulations utilise parallelised calculations via the Graphics Processing Unit (GPU) for the 2D component and the Central Processing Unit (CPU) for the 1D component. This parallel solution technique results in increased calculation speed, allowing for higher precision (greater resolution) without drastically increasing simulation times.

Figure 2-1. 1D/2D modelling concept

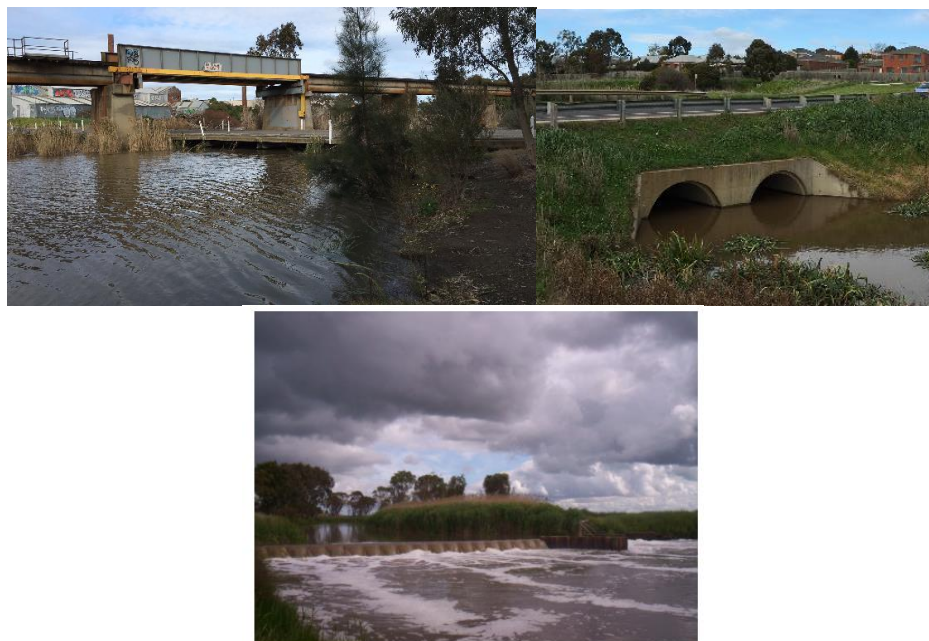
All structures impacting the flow along the main channel of the waterways are included in the 1D model. These include bridges, weirs and culverts. A few examples of structures in the model are given in the following figures.

Lower Barrage

Figure 2-8 Example of 1D structures (Breakwater Road and Lower Barrage on the Barwon River, Culverts under Rossack Drive on Warrnambool Creek).

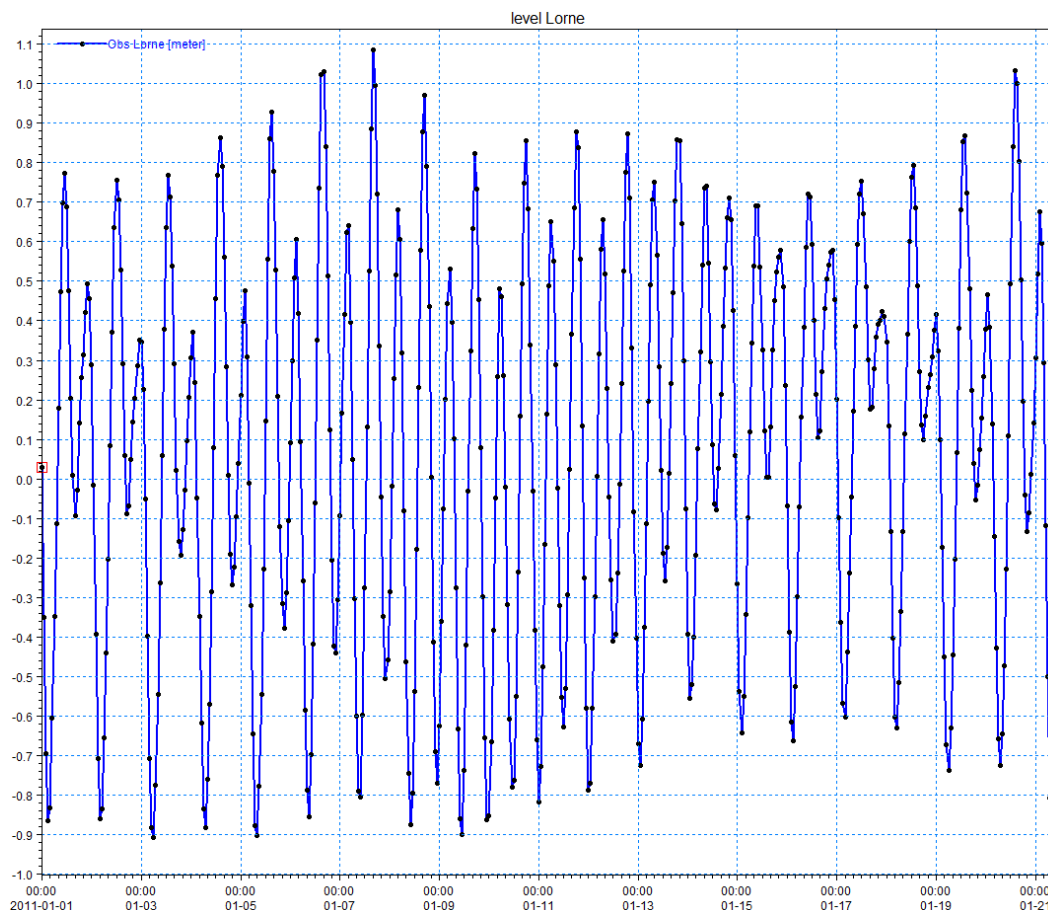
The tidal gauge at Lorne demonstrates a wide range of tidal conditions as shown in Figure 2-10 and Table 2-2-4, including a storm surge of approximately 0.4 m in addition to the spring high tide. The tidal range at Lorne is shown to be up to 1.8 m which is similar to Barwon Heads given their close proximity. Records (Hinwood and Wallis, 1979) indicate that tides at Barwon Heads can be up to around 10 cm higher than Lorne due to amplification of the M2 lunar tidal constituent that occurs from Western Bass Strait towards Central Bass Strait.

Figure 2-10 Ocean levels monitored at Lorne

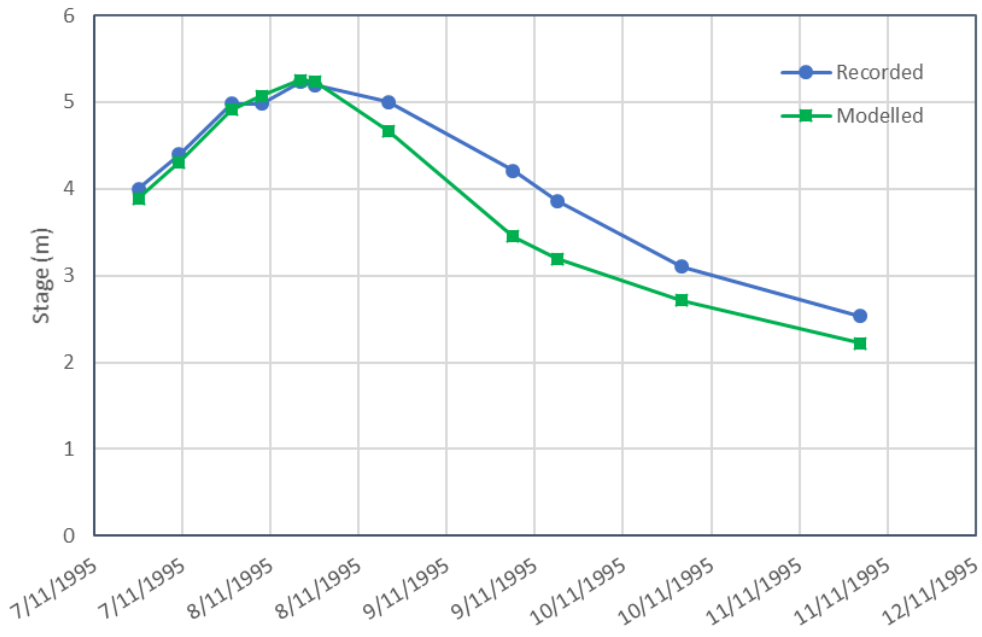
Information available from flood warning documentation (Rural Water Commission) indicate the following stage water heights at McIntyre Bridge as shown below in Table 3-3 and Figure 3-2. This shows that the modelled rising limb and peak of the flood match very closely, whilst the model under estimates levels on the falling limb. This suggests there may be missing volume in the falling limb of the hydrograph.

Figure 3-2 November 1995 flood – recorded and modelled levels at McIntyre Bridge

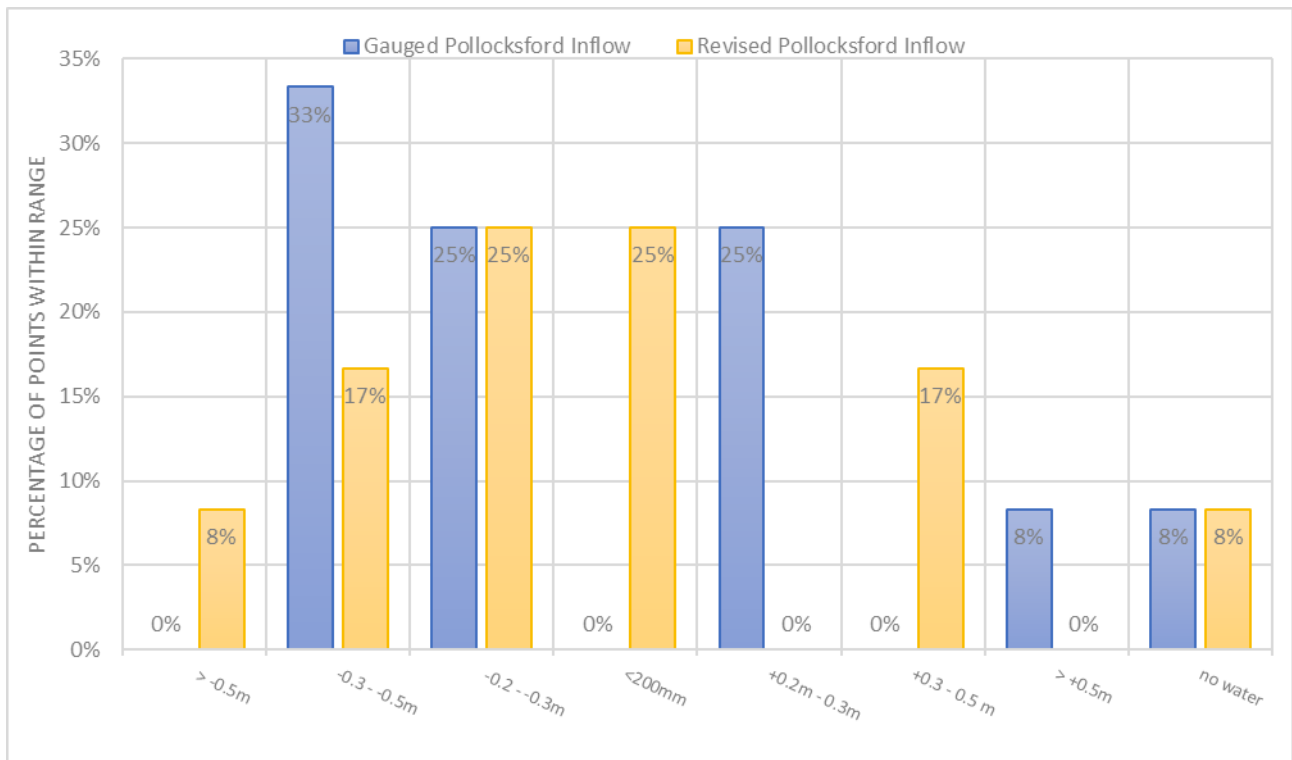
For the November 1995 flood a total of 11 flood marks were surveyed. The difference between the model results of the two scenarios and the flood marks are presented in Figure 3-6. These results show two marks upstream of the McIntyre bridge that are overestimated by the model. Calculated levels are between -0.51 and 0.41 m around the surveyed levels, depending on the inflow used at Pollocksford. At the streamflow gauge, the maximum level calculated by the model is 5.25 m AHD reached on November 8th around 4am. The peak level estimated at the McIntyre Bridge gauge location for the event is 5.16 m AHD, at the same time and date. Flood marks further downstream show the model generally calculates levels below the observed marks, with levels 5 cm to 40 cm below the surveyed marks.

Figure 3-5 Flood marks. Level difference classification (November 1995)

In Figure 3-5, results using the current gauge data indicates water level differences at most of the flood marks are within 300 mm (7/11), and at three locations present a difference greater than 300 mm. When applying the revised hydrograph at Pollocksford, the calculated levels are approximately 7 cm higher, thus improving the classification for several floodmarks, while also worsening the match at some marks. Using the revised inflow hydrograph six flood marks are within 300 mm (5/11), and five present a difference greater than 300 mm.

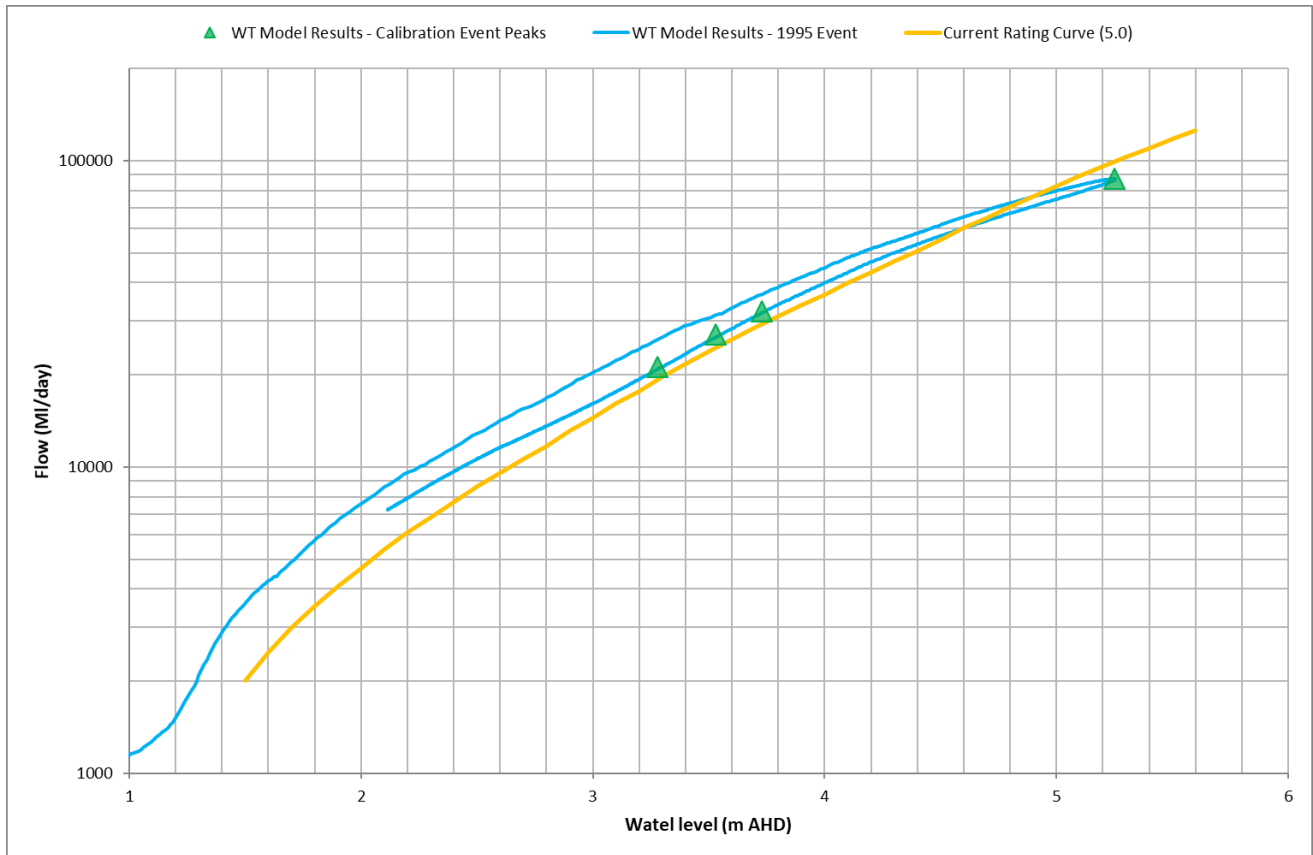
Overall it can be seen that the rating curve correlates well with the rising limb of the modelled hydrograph through the middle and upper flow range of the chart. There is some divergence in the curve at lower flow rates but given the model calibration has focussed on larger events it is possible the modelling is less reliable at lower flow rates. The McIntyre Bridge rating curve is discussed further below in Section 3.4.

Figure 3-9 Rating curve and model results at McIntyre bridge

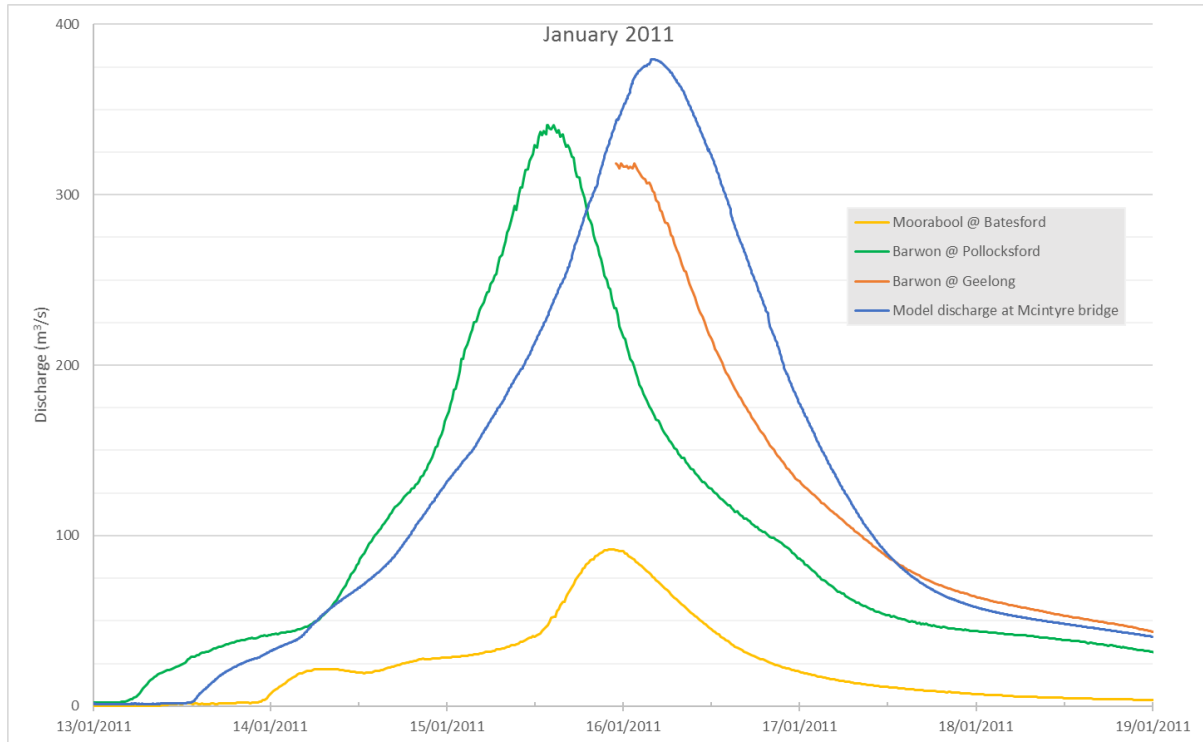
In January 2011 the Barwon River reached a peak flow of between 325 and 375 m³/s at McIntyre Bridge in Geelong. Streamflow data is incomplete, and the peak flow was unlikely to have been recorded by the gauge. The available observed data indicates a peak flow of 340 m³/s in the Barwon River at Pollocksford. It is considered unlikely the flow at Geelong was lower than the flow measured upstream due to the input of the Moorabool River and other tributaries. Gauged and modelled hydrographs for the Moorabool and Barwon Rivers are shown in Figure 3-16.

Figure 3-16 January 2011 flood event – streamflow gauges

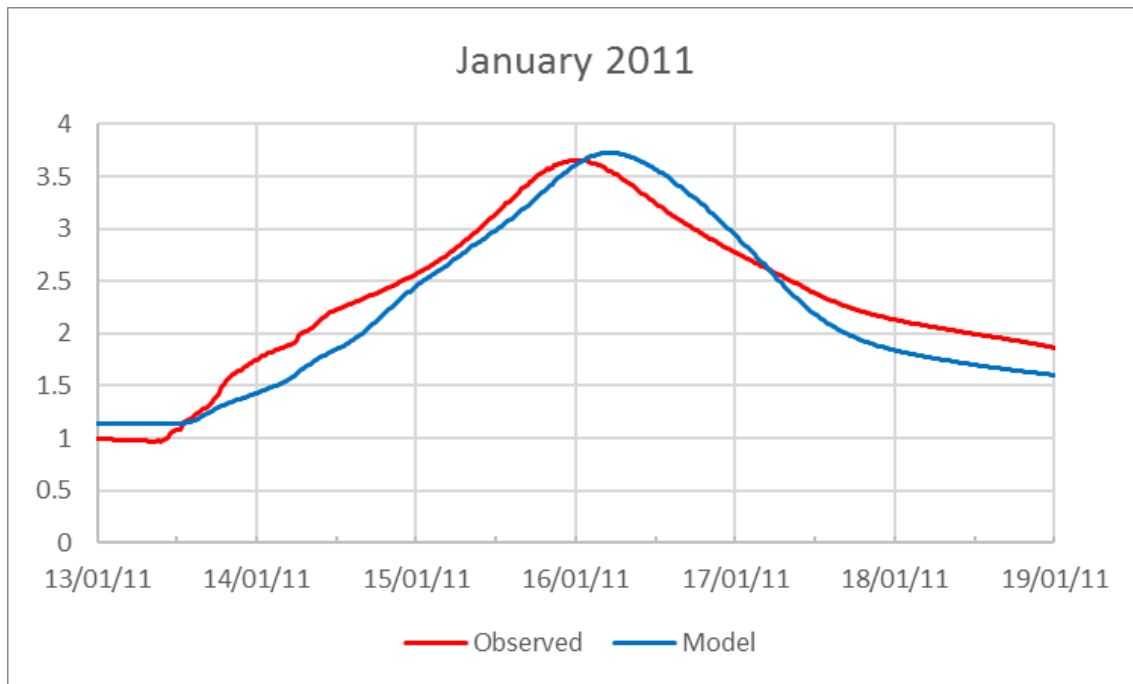
The recorded water levels at the Barwon River at Geelong gauge were also compared and are shown in Figure 3-17. The peak levels match well, with a relative difference between observed and calculated peak flow of 70 mm. Figure 3-19 shows a map of water level differences between observed and modelled. Figure 3-20 shows a map of flood extent and depths for the modelled January 2011 flood.

Figure 3-17 Water level comparison at McIntyre bridge, January 2011

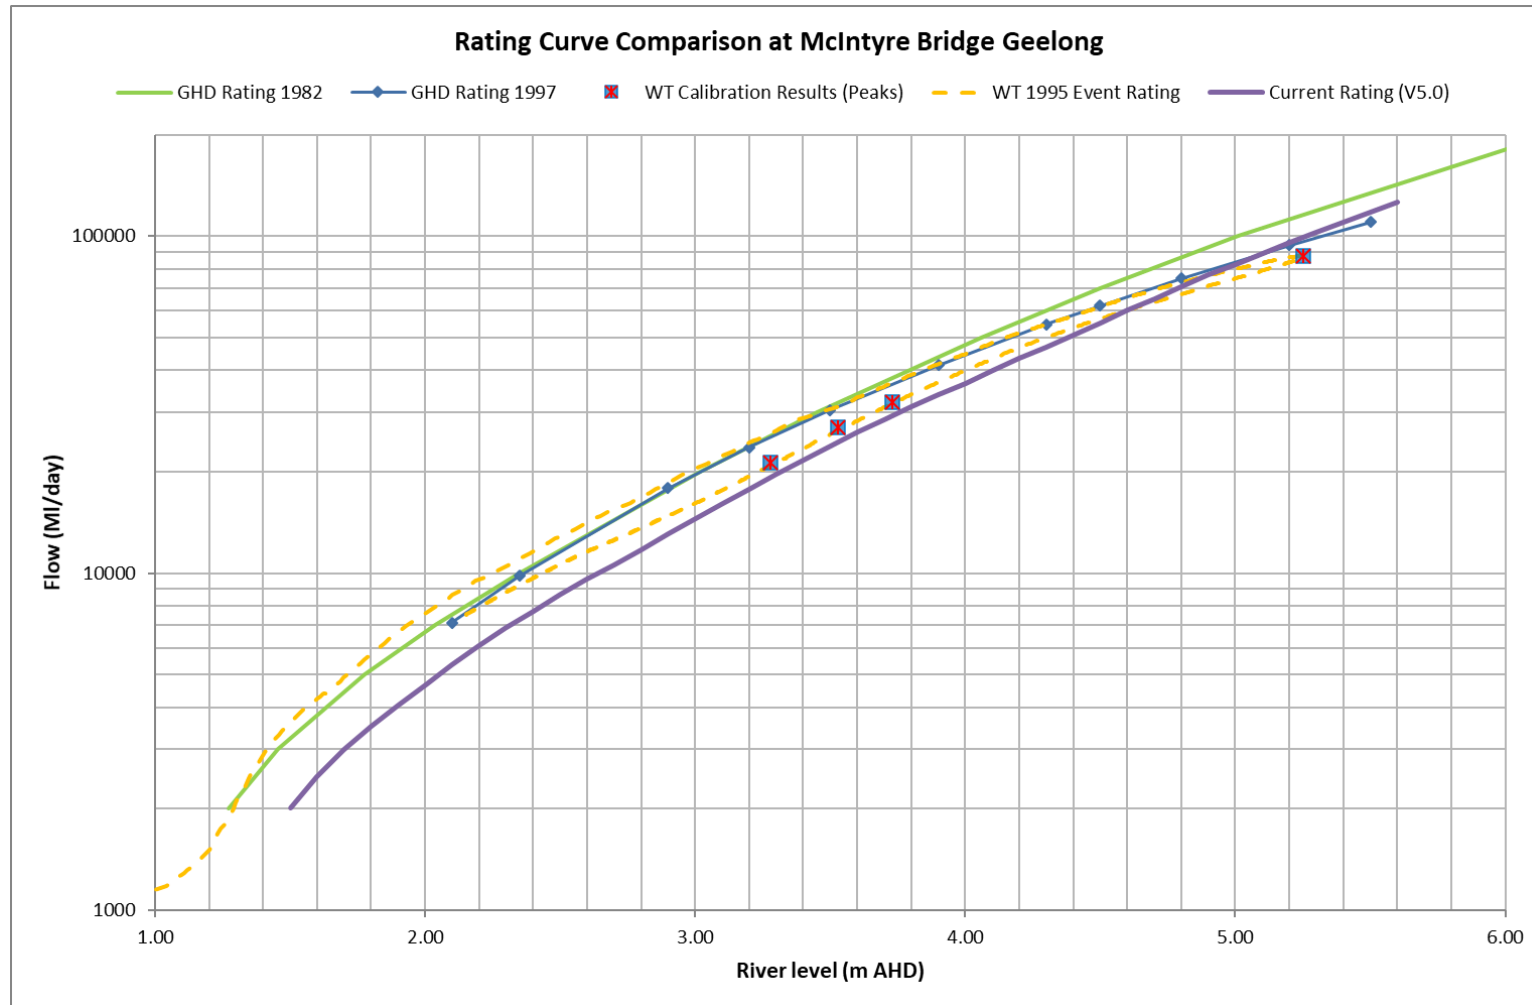
- for levels between 3 and 5 m AHD the existing rating curve and model rating curve correlate very closely. The model results indicate marginally higher flow capacity than the rating curve at these levels. It is noted that through this section of the curve, both the existing rating curve and hydraulic model curves are lower than the older GHD curves i.e. predict a lower flow rate for the same water levels.

- for levels above 5 m AHD the rating curve indicates higher flow rates than the model results. The curves begin to diverge beyond 5 m, however both curves don't extend far above 5 m. It is noted that the current rating curve is extrapolated beyond 4.8 m and uncertainty is greater for that section of the curve.

Figure 3-30 Rating Curve Comparison at Barwon River at Geelong (McIntyre Bridge) Gauge

Based on the analysis above it was concluded that the current rating curve performs well across a wide range of flows and is appropriate for continued adoption. There appears no need for the curve to be modified unless additional information becomes available, such as observed stage-height information from large flood in the future.
