16 STORK AVENUE BELMONT

ARBORICULTURAL REPORT

MAY 8, 2026

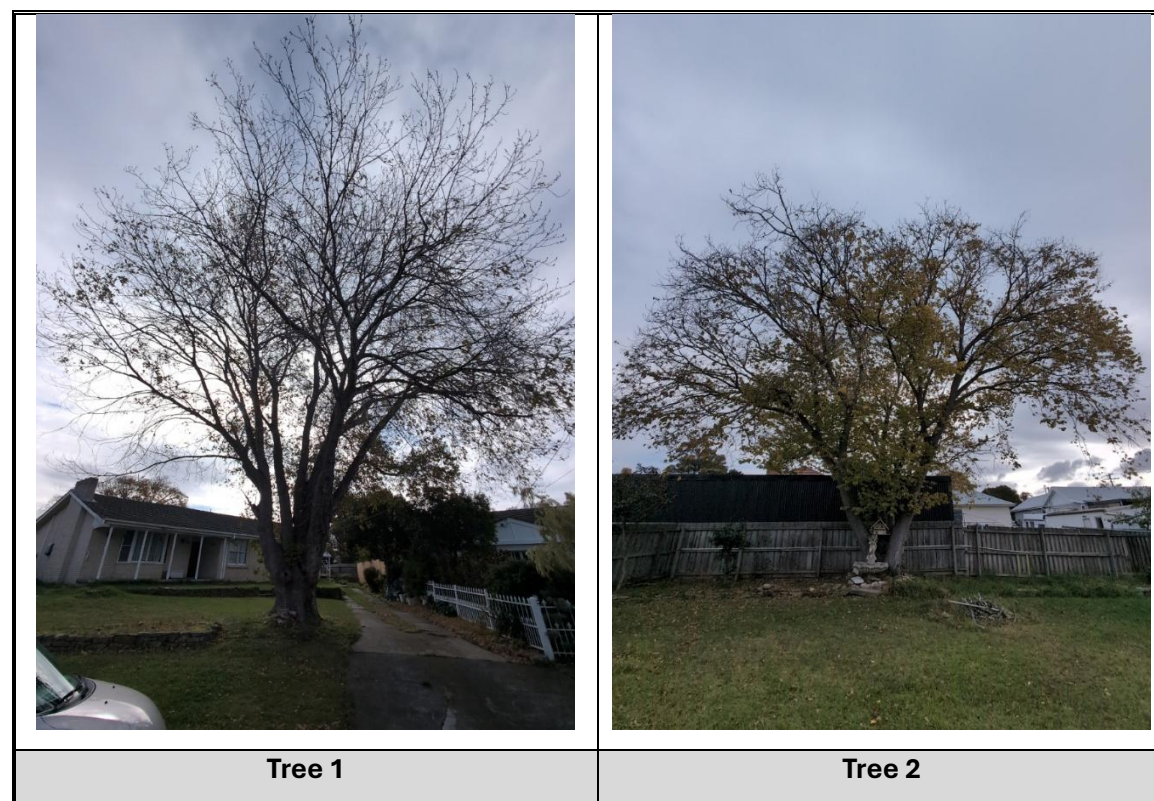
Tree 1

Num	Genus	Species	Location	Clause 52.37 (Canopy Trees)	Height	Span	Stem diameter @ 1.4 m	Stem circumference @ 1.4 m	Stem diameter @ base	Structural Root Zone (radius)	Tree Protection Zone (radius)	Observations	Health	Structure	Age	Useful Life Expectancy
1	Acer	saccharinum	Subject Property	Yes	13 m	15 m	131 cm	412 cm	116 cm	3.5 m	15.0 m	Large sections of decay in trunk, main leaders have poor stem attachments, history of limb failure, dieback in canopy, lifting driveway	Fair	Poor	Over Mature	Short
2	Ulmus	glabra	Subject Property	Yes	11 m	13 m	80 cm	251 cm	110 cm	3.4 m	9.6 m	Main leaders have poor stem attachments, heavy decay at base, decay in main leader, poor stem attachment in upper canopy	Fair	Poor	Mature	Medium
