Arboricultural Impact Assessment

Site Location: 11 Henry Street, Belmont, Victoria, 3216

Completed for: Rafferty The Wrecker

Inspection date: 20/12/2016

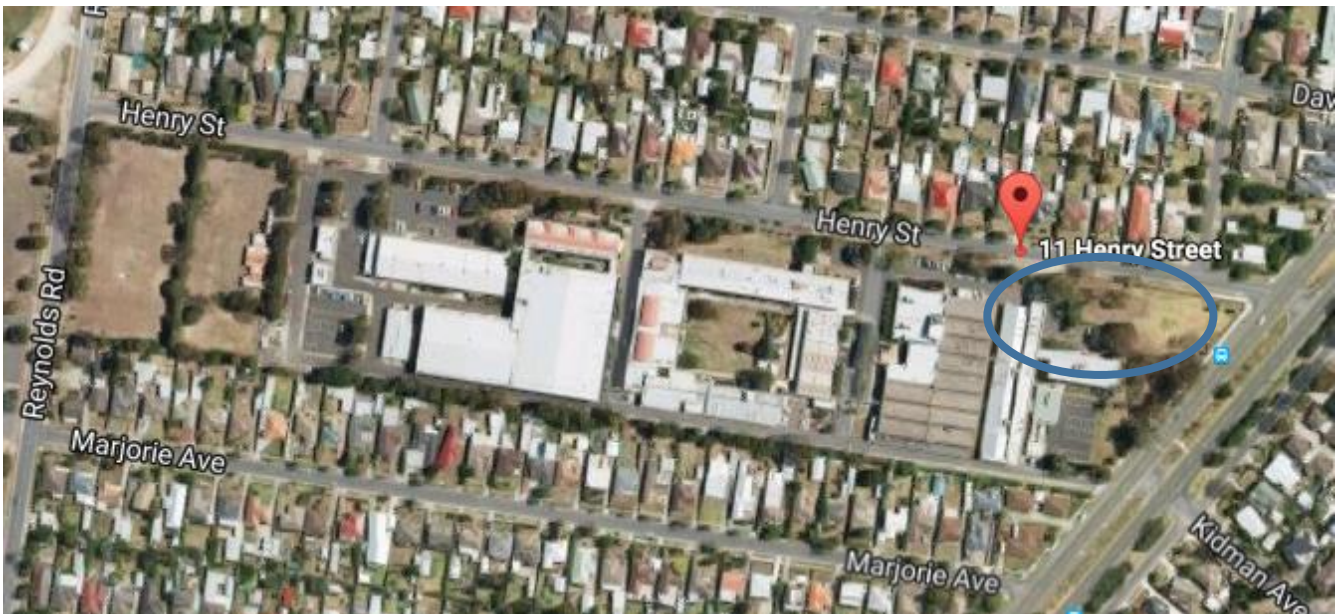
Plate 1 – Aerial view of site with location of trees in question highlighted in blue

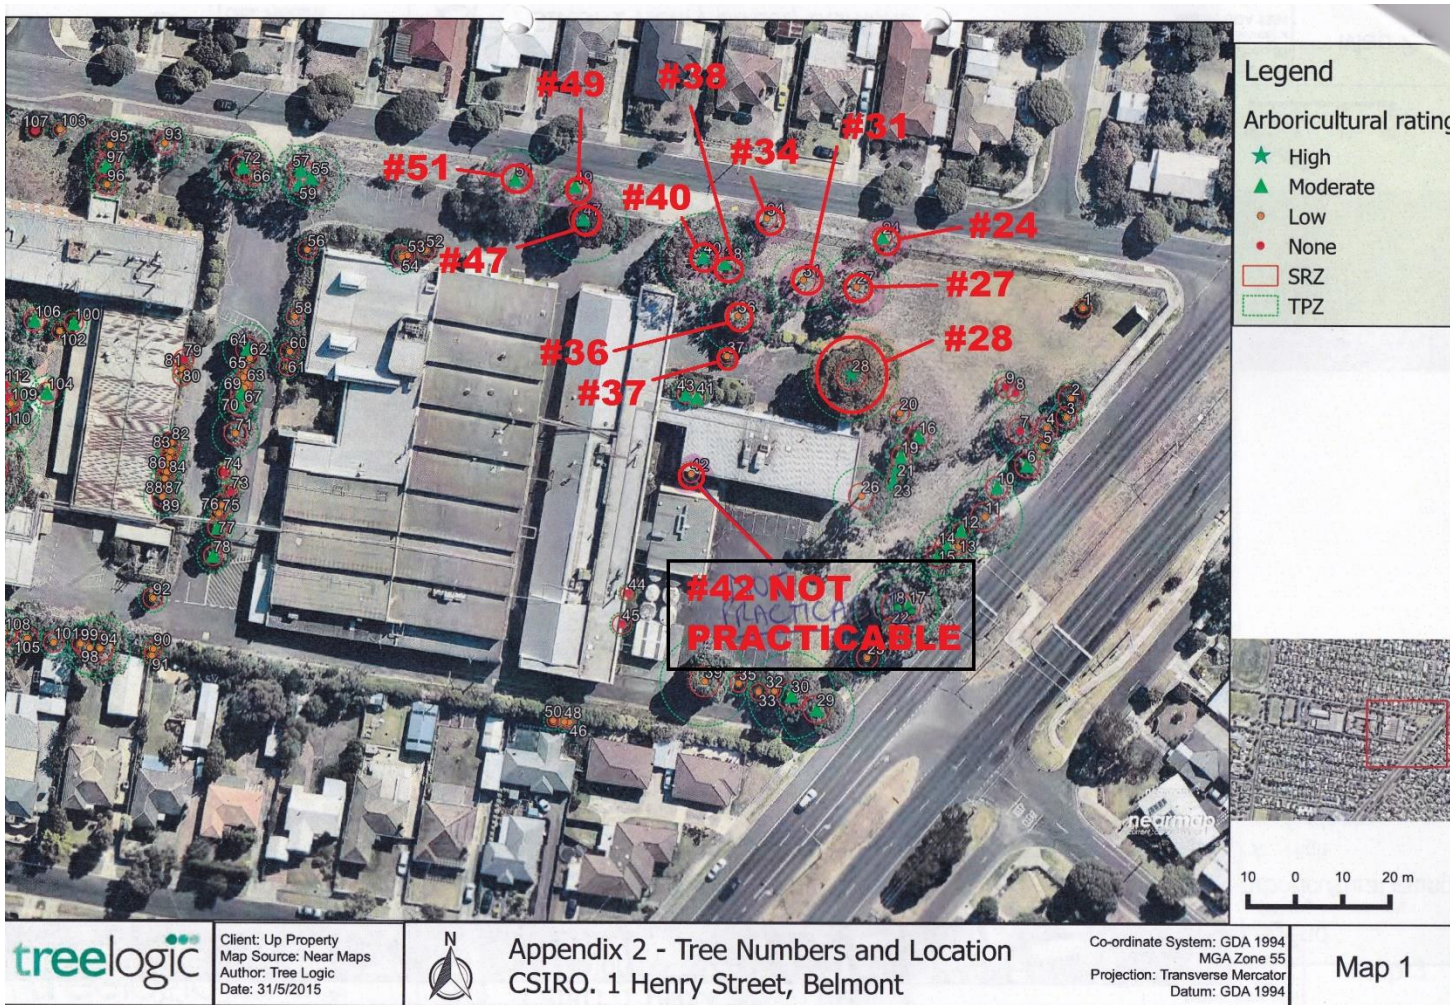
Plate 3 – Aerial view of site with location of trees in question highlighted in red (Tree Report – Tree Logic, Mark up (numbers) - Monaco Hickey)
