Greater Geelong Planning Scheme Amendment C354

STATEMENT OF EVIDENCE
ON ARBORICULTURAL ISSUES

**9 Bridge Street,
Barwon Heads**

ROB GALBRAITH – GALBRAITH & ASSOCIATES

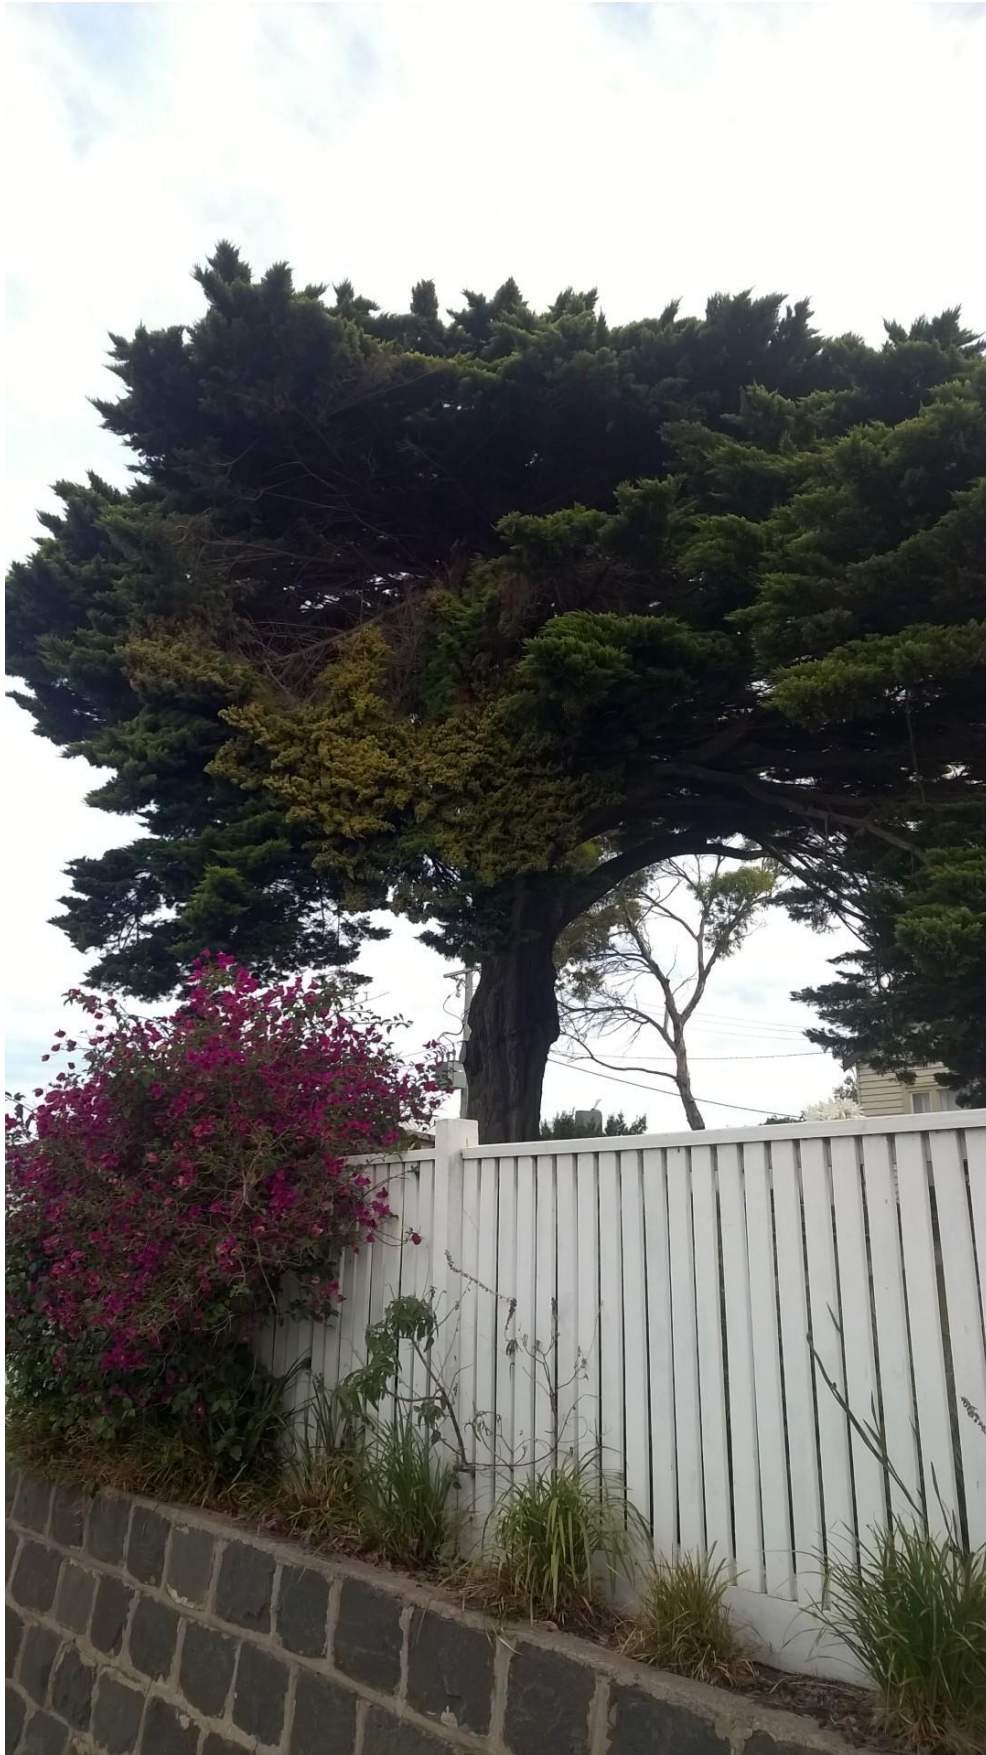
View of the tree from Bridge Street in early January 2017. The arrowed branch with the yellow foliage has recently fractured.
