LETTER OF SITE INSPECTION

TPZ Calculations Bellarine Rail Trail Stage 2 Jetty rd Urban Growth Plan

July 2022

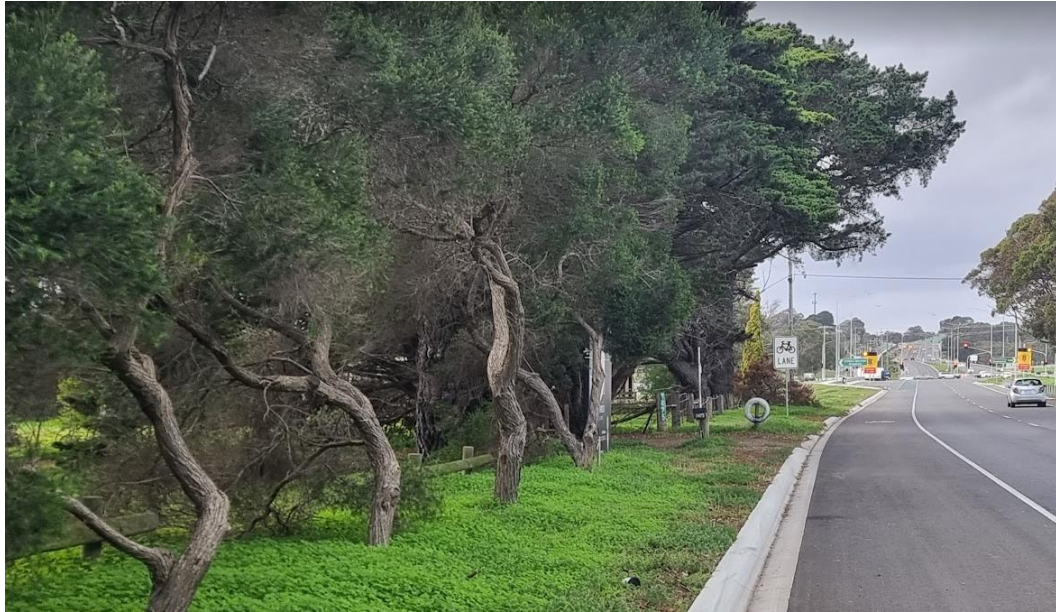
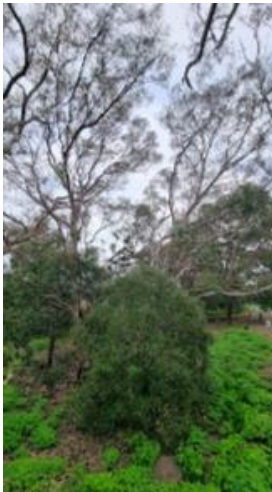
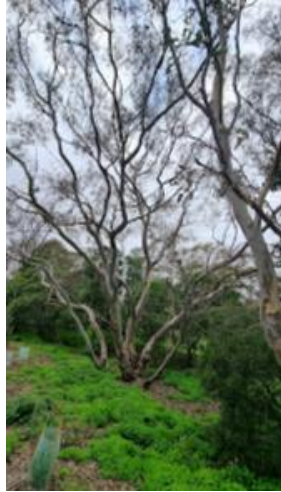
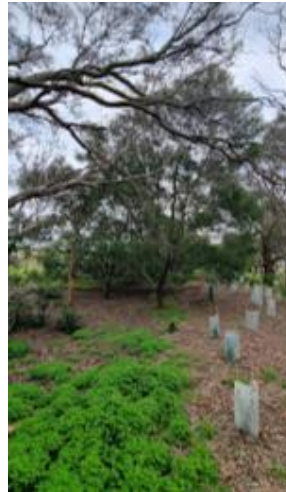
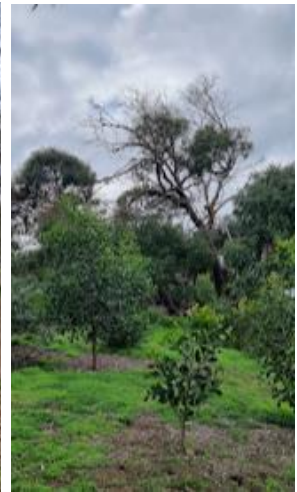
The following pictures were taken on site.

The trees of this report should be protected by a lineal steel mesh panel fence placed along the interface boundaries with the inspected public open spaces. This placement should be guided by AS4970-2009 protection of Trees on Development Sites.
