Statement of Evidence
9 BRIDGE ROAD BARWON HEADS

Amendment C354
City of Greater Geelong

23 February 2017

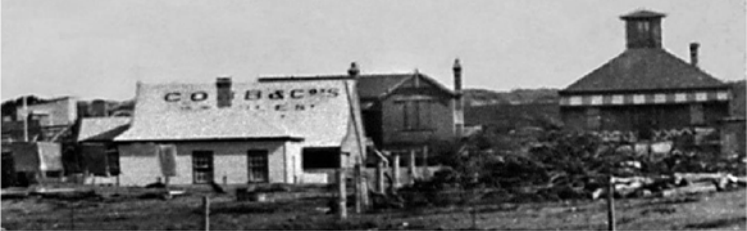
<p>c.1895 – Significance of this photo is as one of two photos so far discovered that show the original form before the addition of the second gable. Central chimney and roof form and gable end strapping still exists.</p>

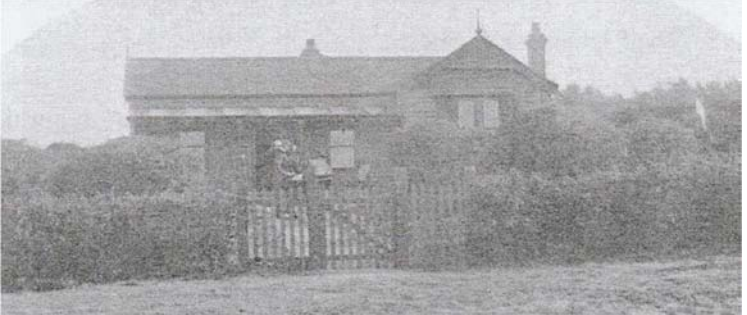
<p>c.1900 showing house with original form, detailing and colour scheme. Useful photo as the benchmark from which to understand subsequent changes.</p>

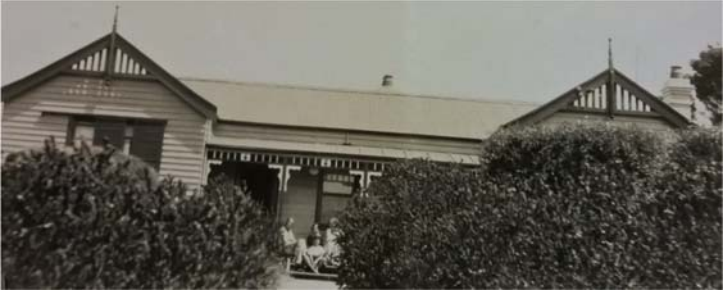
<p>C1930 – this photo is the earliest to show the left hand gable added and the relocated front door from the centre to the left. The roof form is the same today. The verandah fretwork design is clear for the first time, although this may have been altered.</p>

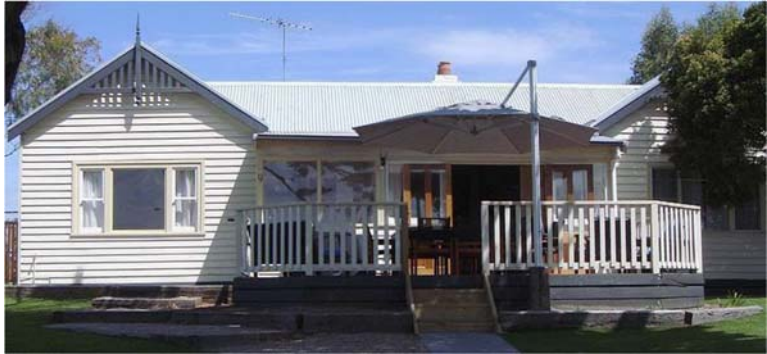
<p data-bbox="679 1211 1449 1335">The main form of the house and gable end strapping is from c 1890 - c1910, the central chimney from 1890. The porch retains elements from 1939 and the front windows from c.1940. Doors and the deck are contemporary alterations.</p>

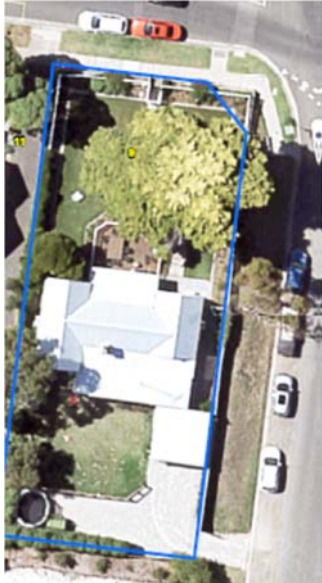
<p data-bbox="679 1928 1449 1995">Aerial photo showing the roof form today which corresponds to that of 1939 apart from the rear extension. Source: City of Greater Geelong</p>

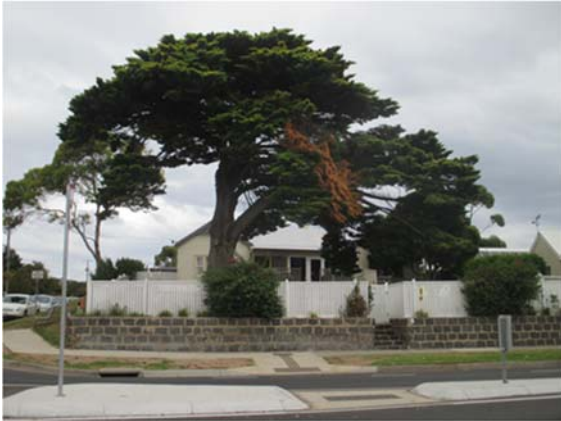
<p>The heritage significance of the tree is connected with the house, being planted in the 1940s. This is at a time when cypress trees were a common street tree in Hitchcock Avenue and Bridge Road. The tree is a link with these plantings and a focal point at the end of Hitchcock Avenue. It provides a setting to the house and is therefor included as part of its significance. Tree controls are therefore recommended.</p> <p>It is generally the owner's responsibility to provide an arborist report on the health and longevity of a tree if removal or trimming is required.</p>

Grounds for objection	Comment
Cypress tree a poor specimen and a risk to health and safety of occupants and visitors to the subject property.	The health of this tree is outside the scope of my expertise and is not relevant to heritage significance.
The amendment is being proposed for an ulterior motive in an attempt to thwart the redevelopment of the property generally in accordance with the planning scheme.	This is not relevant to the consideration of heritage significance.
