Sparrovale Model Farm Complex, Charlemont and Armstrong Creek  
Statement of Significance  
August 2024

| Heritage Place: | Sparrovale Model Farm complex, 95-97 Sparrovale Road, Charlemont; 1-87 Groves Road, Armstrong Creek; 225 Baenschs Lane, Armstrong Creek; and 111-215 Sparrovale Road, Charlemont. | PS ref no: | HO2033 |

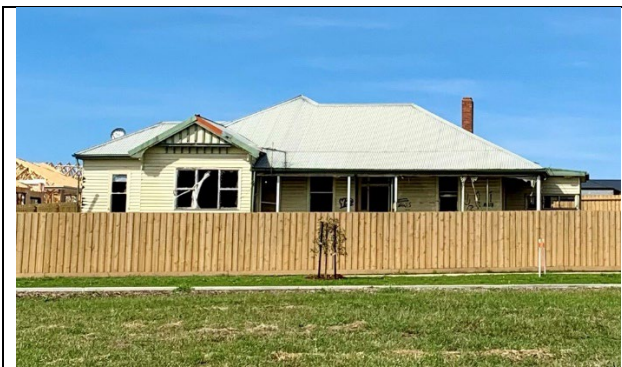
| <p>Former Manager's Cottage<br/>Source: Janine Barrand October 2024.</p> | <p>Intersection of drain with levee bank and site of early windmill.</p> <p>500 x 34 x 4.5m Barwon Channel excavation and levee bank.<br/>Source: Nearmap 2019.</p> |

The former Manager's Cottage is a substantial single storey weatherboard farmhouse in the Federation style, built in 1907.

- The original 1907 single storey, asymmetrical, horizontal weatherboard house with complex roof forms clad in sheet metal comprising a dominant hipped roof with minor hips and a gable projecting to the side and street frontage
- Return verandah under the dominant hipped roof
- Gable brackets and gable infill (brackets, panelling, and battening)
- Early timber framed double hung windows arranged singularly under the verandah, and four panel-entry door with glazed upper panel set in a recess with side and top lights
- Early, altered, unpainted brick chimney (once two) – ornamental chimney top removed
